# ASOTIN COUNTY WATERSHED ASSESSMENT:

## TECHNICAL DOCUMENT & APPENDICES

Bennett, S., Camp, R., Wheaton, J., Bouwes, N., O'Brien, G., Hill, A., Floyd, B., and Drury, T. Asotin County Watershed Assessment: Technical Document and Appendices. Prepared for Asotin County Conservation District. Providence, UT. 220 Pages.

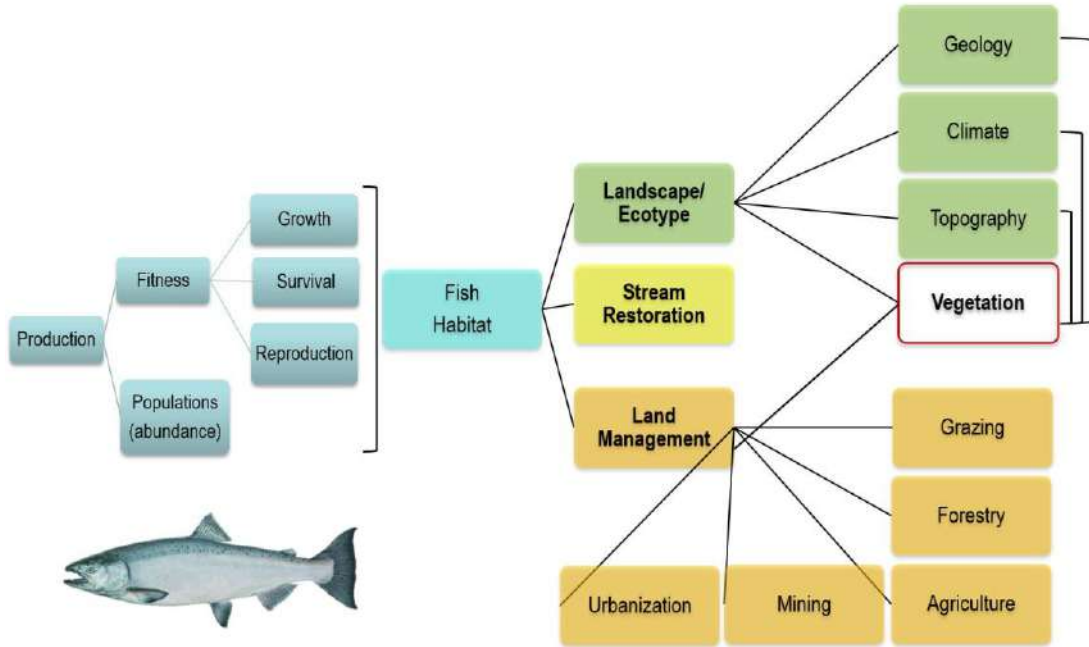
**Figure 2. Landscape setting and land management activities that control the physical, chemical, and biological processes that lead to formation, sustainability, and spatial and temporal distribution of fish habitat. The availability of habitat in turn has direct influence on the fitness (e.g., growth, survival, reproductive success), abundance, and ultimately production of fish populations. Figure adapted Spence et al. (1996).**

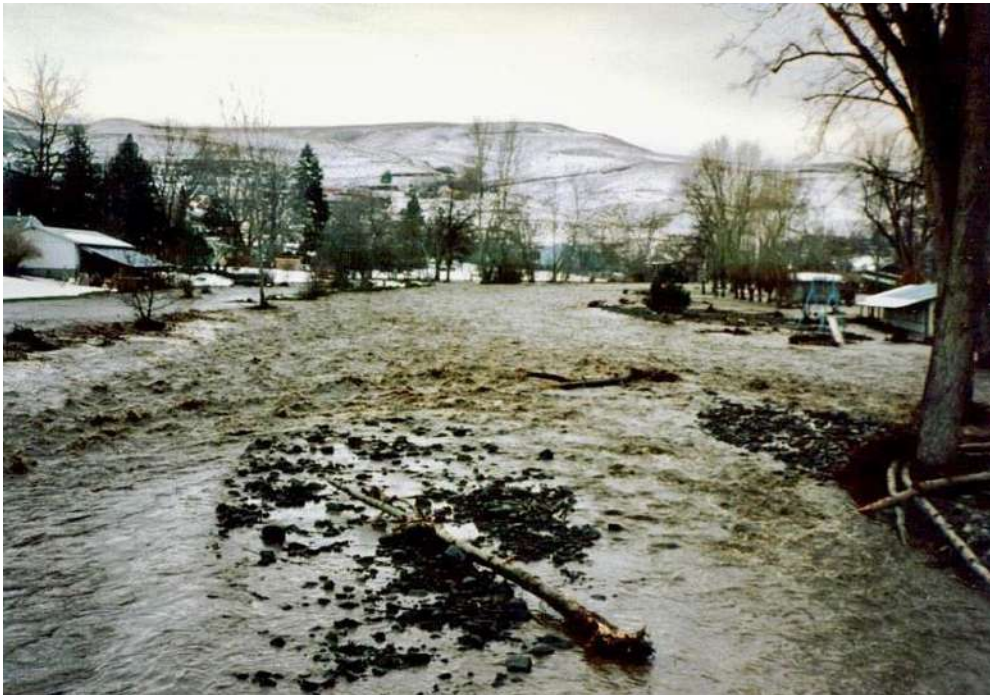
**Figure 7. View looking upstream on mainstem Asotin Creek at Asotin City Park near the mouth: January 1, 1997.**

We combined the mainstem monitoring data from all current and historic USGS gauges (13334050, 13334500, and 13334700) to form an 82-year record of peak discharges (1929-2017 with 1983-1989 missing). We had to extrapolate data collected from above the confluence with data collected below the confluence where the years of data collection overlapped (1990-1996) and used regression to back-calculate discharge at the mouth (Figure 6). There were three significant peak flows during the period of record with the maximum peak discharge recorded 6,334 cfs. These large peak floods caused significant damage to properties and fish habitat along the mainstem and tributaries (Figure 7).

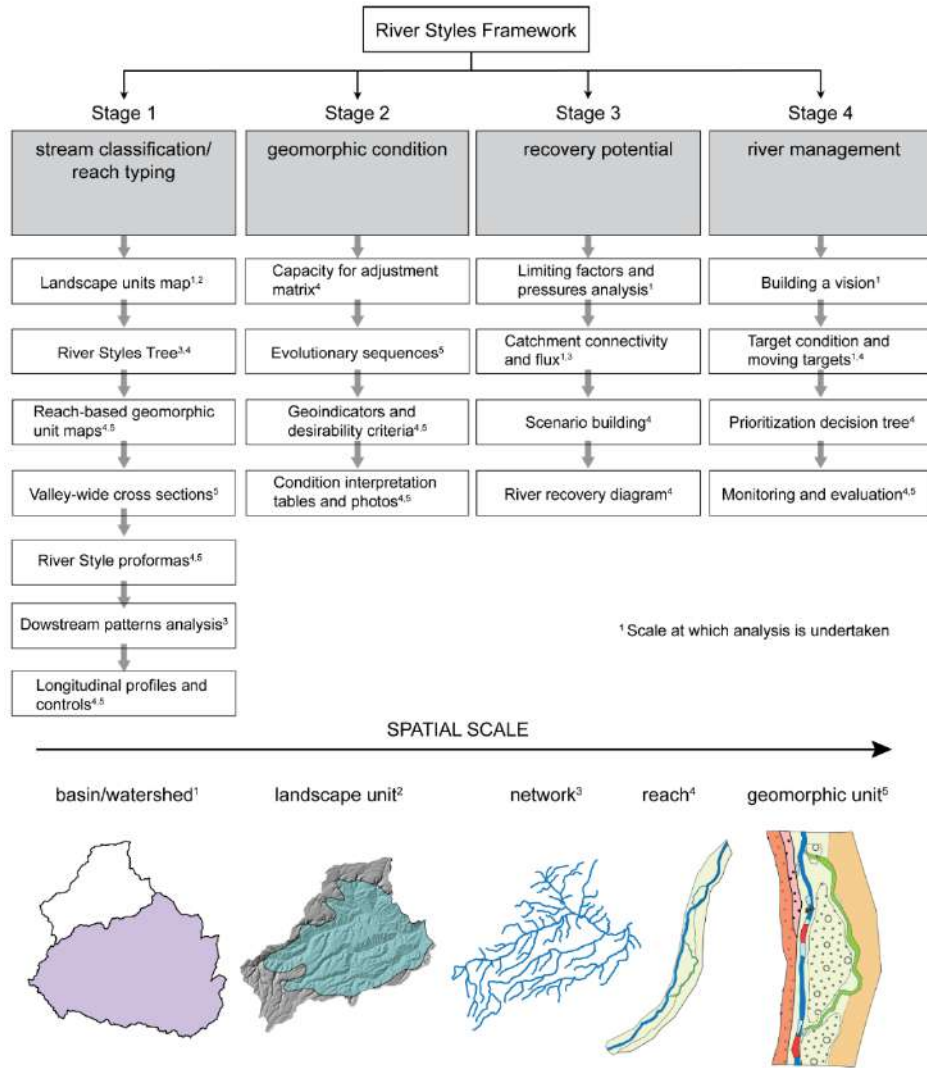
**Figure 13. Summary of our modified River Styles framework as described in Brierley and Fryirs (2005) and O'Brien et al. (2017).**

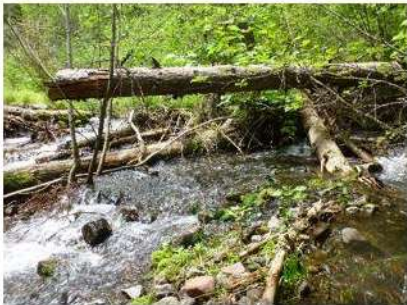
<b>Channel Planform</b>	Usually single, but sometimes multiple channels forced by organic structural elements. Low sinuosity along valley margin, moderate sinuosity when traversing to opposite valley margin. Moderate lateral stability, and adjusting when conditions permit. Planar features are separated by forced bar and pool complexes. Riparian zone is relatively wide with mix of cottonwoods, alders, and native conifers.	Almost always single channel and low sinuosity. Laterally unstable with accelerated bank scour, but limited lateral expansion. Mostly planar geomorphology, with some forced pools and bars. Occasional private levees restrict access to floodplain. Limited riparian zone with mixed native and exotic canopy. Much of the floodplain has been converted for agriculture.	Single channel with low sinuosity. Laterally unstable, but no room for expansion. Almost entirely planar channel units with occasional pools. Floodplain has been converted to agriculture or urban use. Very limited riparian cover.

<b>Bed Material</b>	Well-sorted bed material with well-defined facies typically forced by structural elements. Bars are comprised of gravel and smaller classes. The channel bed is stable and sediment flux is balanced. Sediment transfer zone with pockets of storage.	Poorly sorted bed material with pockets of defined texture around infrequent structural elements. Limited roughness due to lack of instream vegetation and woody debris. Bed is stable and the sediment flux is balanced. Sediment transfer zone.	Homogenous bed material, mostly large clasts armoring the bed. Sediment is poorly sorted with limited pockets of defined texture. Unstable bed is incising in most areas. Sediment transfer zone.
<b>Photograph</b>	Upper Charley Creek

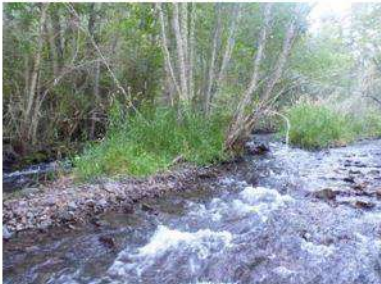
<b>Photograph</b>	<b>Middle North Fork Asotin</b>

<b>Bed Material</b>	Well sorted bed material with well-defined <del>facies</del> typically maintained by channel planform and structural elements. Bars are comprised of gravel and smaller classes, but larger floods can result in large cobble sheet deposits that develop into islands. The channel bed is stable and sediment flux is balanced. Long-term depositional zone.	Generally, bed material <del>is poorly sorted</del> with pockets of defined <del>facies</del> near structural elements and gradient breaks. Bar material is more skewed to larger classes, but typically sizes typically taper. The channel bed is typically stable, but large floods may cause local degradation in entrenched sections. Still dominantly a depositional zone over long reaches.	Bed material <del>is poorly sorted</del> and consists of a uniformly distributed cobble/gravel matrix. The channel bed is relatively stable. Sediment transfer zone.

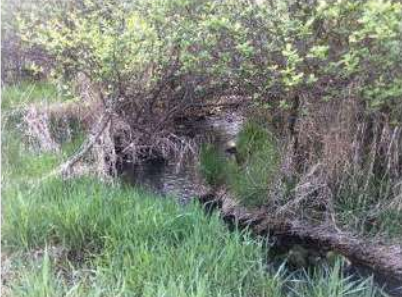
<b>Channel Planform</b>	Single thread channel with low sinuosity and occasional meanders. Floodplain pockets are small but frequent and easily accessible during bankfull floods. Gradient is relatively high, and dominant geomorphic units are runs, rapids, riffles, forced pools, and forced bars. Laterally stability is typically high; however, floodplain pockets often erode and new pockets develop during larger floods. Riparian vegetation is typically dense, but species composition is dependent on precipitation levels (e.g., canopy species may not be prevalent, but shrubs typically are).	Usually single thread channel, wider sections will have multiple shallow channels. Sinuosity is low. Gradient varies with lower gradient sections separated by headcuts. Dominant geomorphic units are runs and rapids. Lateral stability varies and often low on one side while high on the other as the channel responds to disturbance. Riparian vegetation varies and still primarily dependent on precipitation levels.	Single thread channel with very high lateral stability. Geomorphic units assemblage is dominated by planar units, most common are runs, rapids, and cascades. Riparian vegetation on the floodplain is sparse or non-existent; however, as inset floodplain surfaces develop, shrubs, willows, and alders may be present.

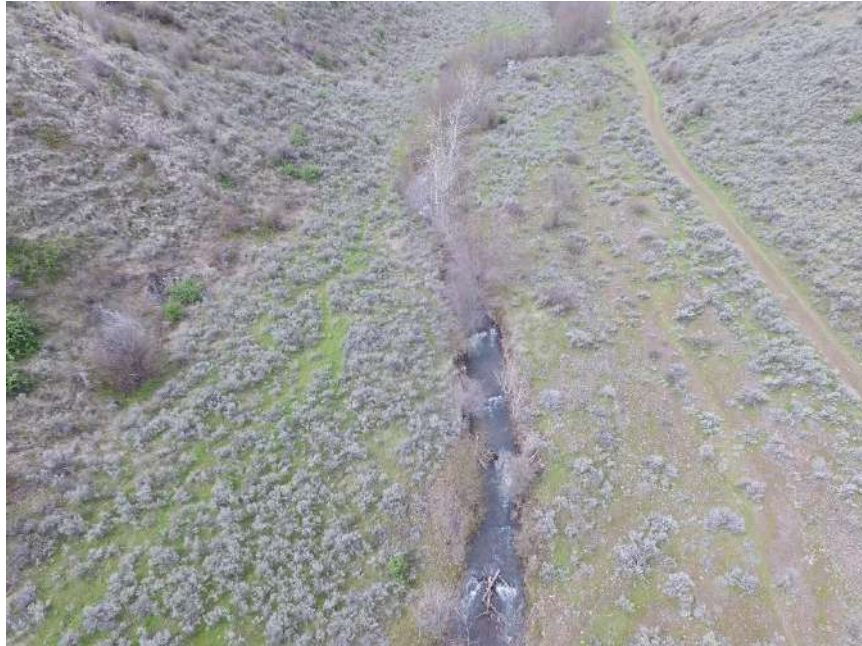
*Photo 1. Example of a large departure from historic riparian conditions along Charley Creek in the Asotin Creek watershed. The riparian area is thin and grassland and sage brush has encroached to within a few feet of the channel on both sides of the creek.*

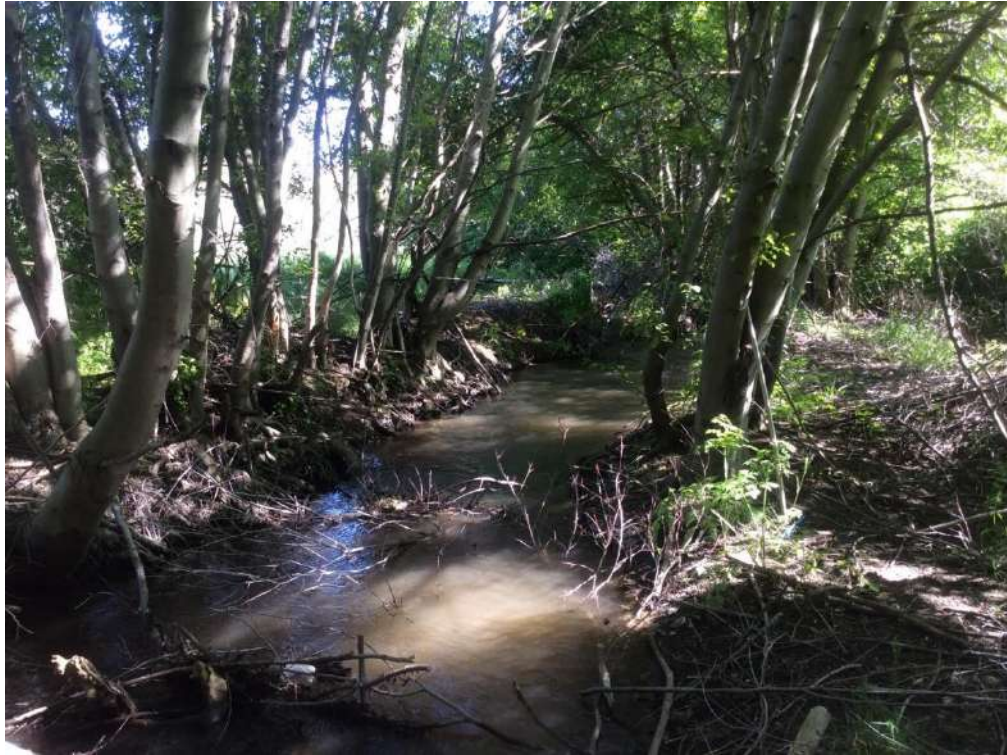
*Figure 18. View of the channel under relatively dense canopy cover in reach AP\_01.*

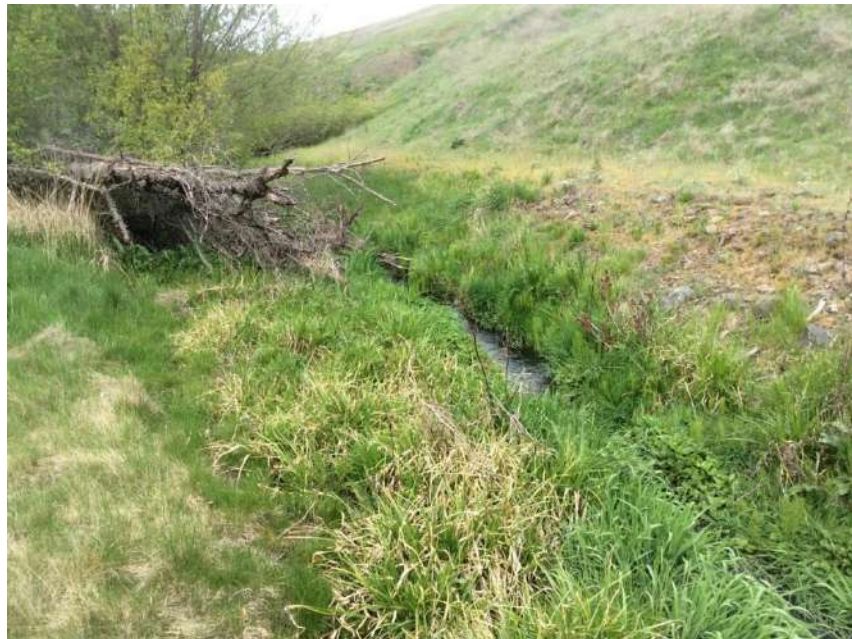
*Figure 19. View of reach AP\_03.*

Reach **AP\_03** begins at RM 13.9, just upstream of Dresser Spring, and extends to RM 19.6, upstream of Kidwell Gulch. The reach is located entirely within private lands. Access to this reach is limited to private ATV trails and primitive roads. Grazing and some agriculture are the primary land uses. There are multiple seeps, springs, and small wetlands throughout the reach.

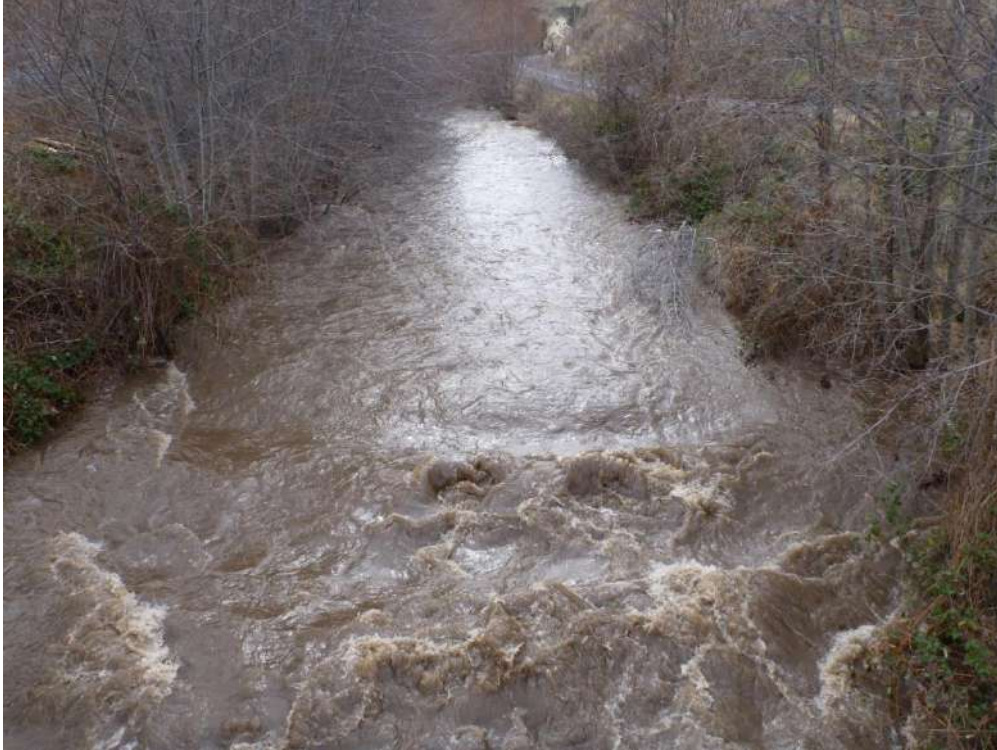
Reach AC\_01 is located from the mouth of Asotin Creek to the upstream end of Asotin City Park at RM 0.4. The reach is surrounded by urban infrastructure, with a narrow riparian zone consisting primarily of red alder. Although the valley bottom in this reach is the widest example in the study area, the channel is confined on both banks by rip-rap and levees to protect infrastructure. The stream flows under a bridge for Washington State Highway 129 and past the city of Asotin’s sewage treatment plant before entering the Snake River.

*Figure 21. Reach AC\_01 on the mainstem of Asotin Creek looking upstream from the Highway 129 bridge during a high flow event. The channel is confined on both sides by rip-rap, restricting floodplain access.*

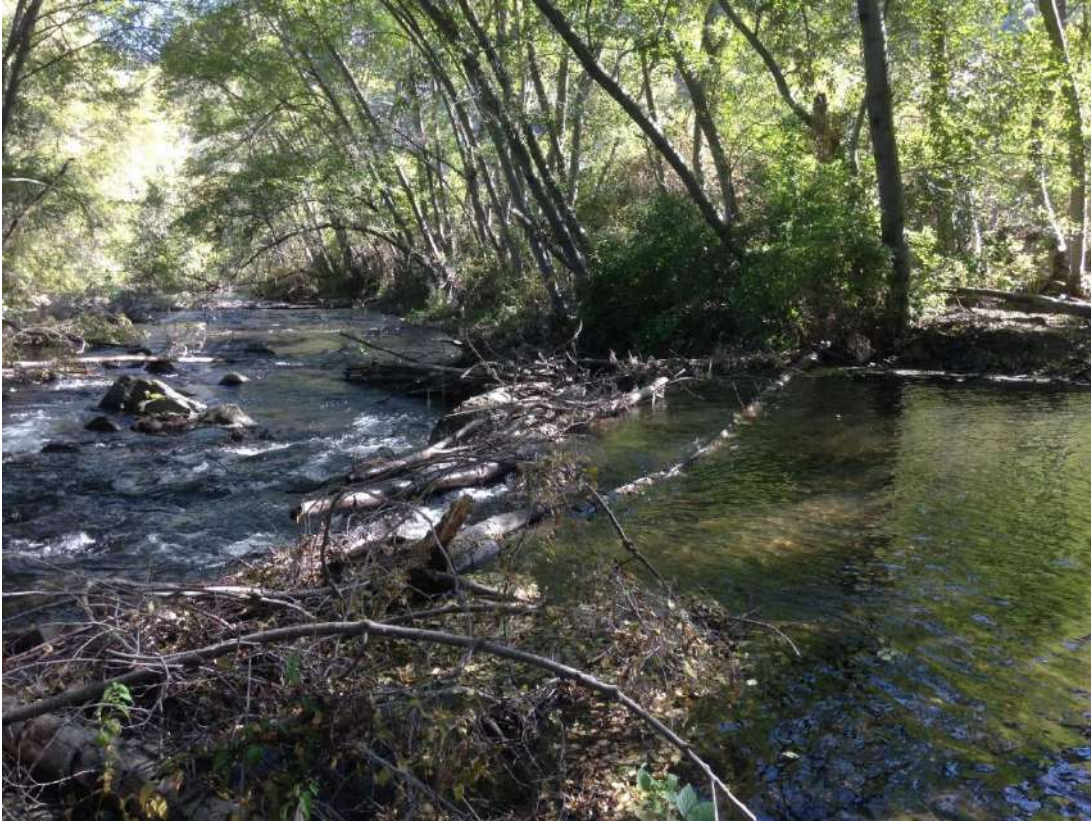
*Figure 22. Asotin Creek mainstem at approximately RM 10. Stream has good shade from alder dominated riparian area. Habitat complexity is moderate with some pools and LWD, but side-channels are rare, banks are relatively high, and floodplain access is limited.*

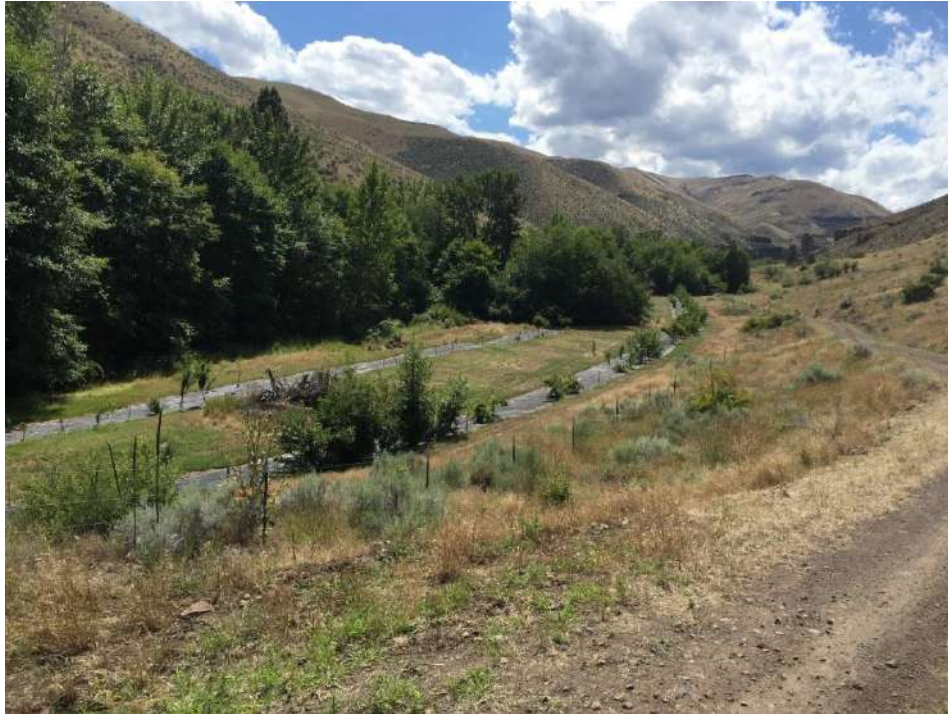
tagged fish entering and leaving the stream. Inside the riparian fencing is a dense stand of shrubs and trees with some patches of blackberry. There is a rough single lane gravel road that runs along the left side of the valley for over 10 miles. The road generally stays above the valley bottom but does encroach into the valley bottom in a few locations. Access is restricted by a locked gate at the entrance at Asotin Creek Road and controlled by WDFW and USFS. Local ranchers use the road seasonally to move cattle to grazing allotments. The lower reaches of Charley Creek were used to winter cattle and horses until WDFW purchased the property. Sections of stream that were not fenced in the past have been overgrazed, and now these areas have been invaded by weeds. ACCD and USFS have implemented intensive weed control and planting programs in these areas.

*Figure 23. Riparian enhancement area along Charley Creek above Asotin Creek road. Note road is above the valley bottom.*

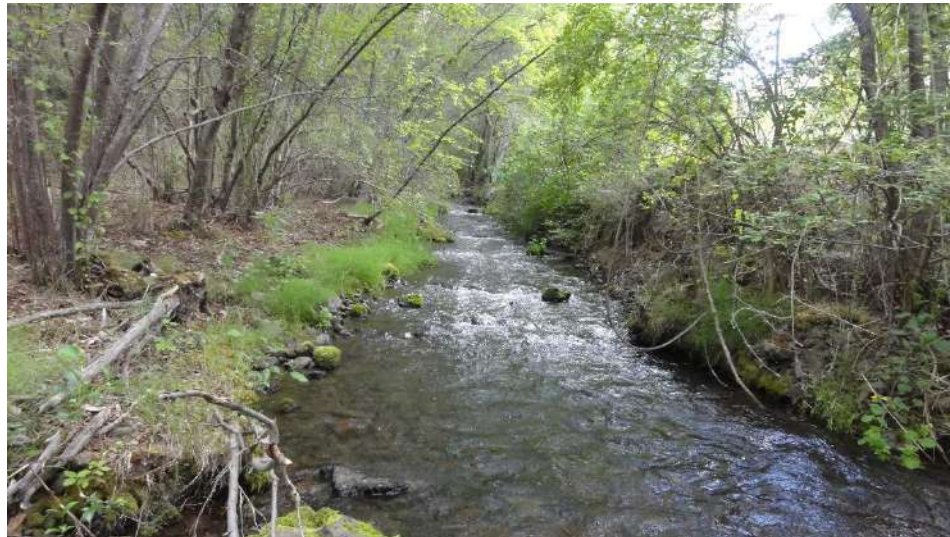
*Figure 24. Typical condition of Charley Creek with recovering riparian habitat and low instream diversity*

Figure 24. Typical condition of Charley Creek with recovering riparian habitat and low instream diversity .....80

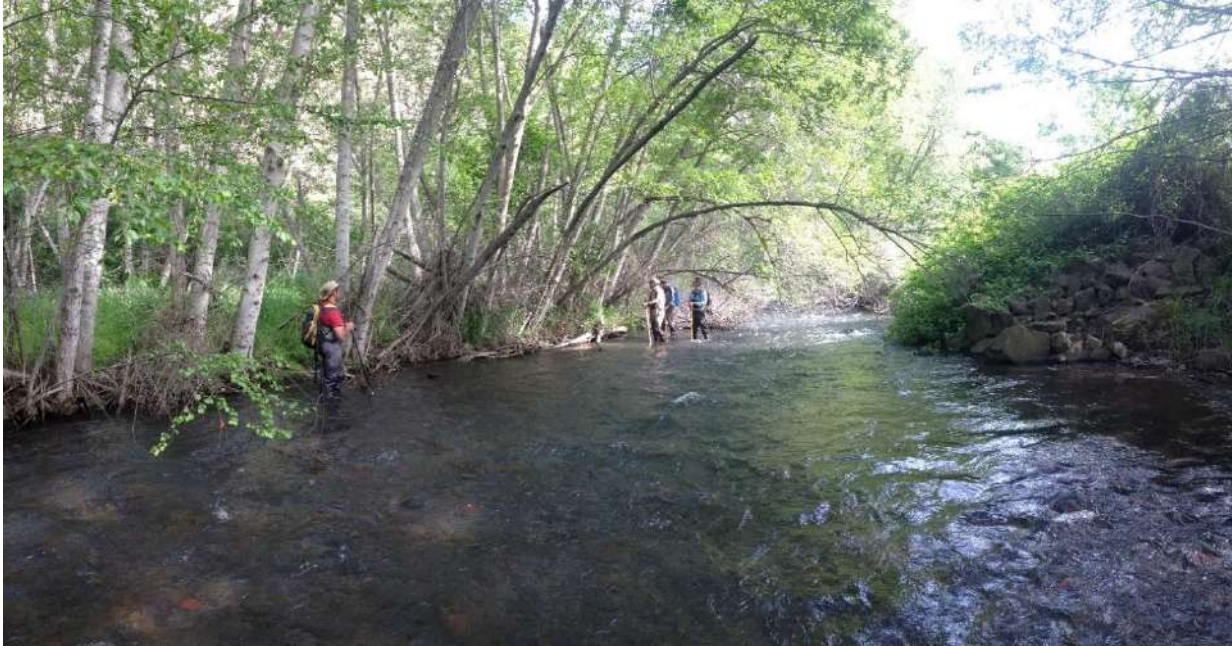
*Figure 25. Typical low diversity section in the lower North Fork Asotin Creek with large alder dominating the riparian. Note the boulders on river left are remains of old restoration structure.*

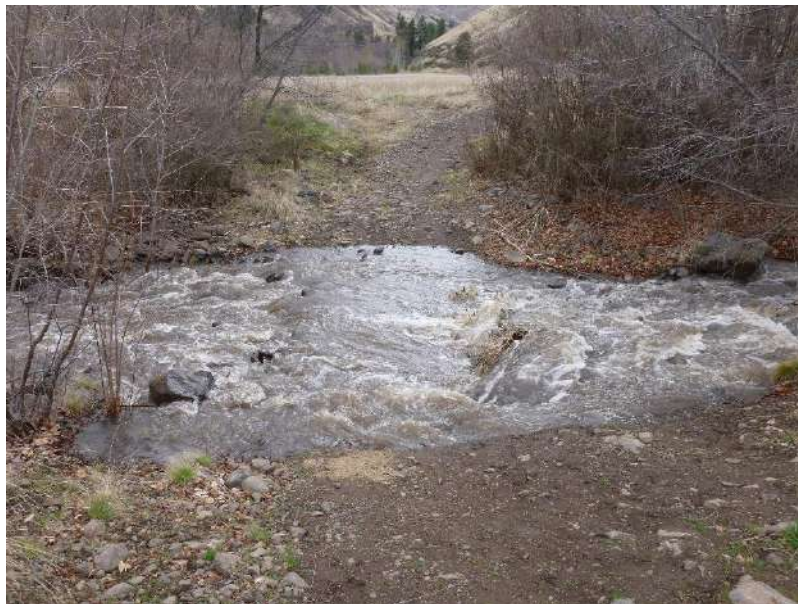
Lick Fork road borders the reach on river left as well as a large parking/camping area. The start of the North Fork Asotin Creek trail begins here and a rough access road used by hikers, horses, bikes, and WDFW/USFS staff crosses Lick Creek at a ford 100 yards from its confluence with North Fork Creek. A wheat field managed by WDFW borders the creek on river right. The stream has been realigned to flow straight down Lick Fork road. Historically it flowed into the North Fork Creek valley and then ran parallel to North Fork Creek, entering several hundred yards downstream from where it currently enters.

*Figure 26. Lick Creek ford just upstream of confluence with North Fork Asotin Creek during spring high flow.*

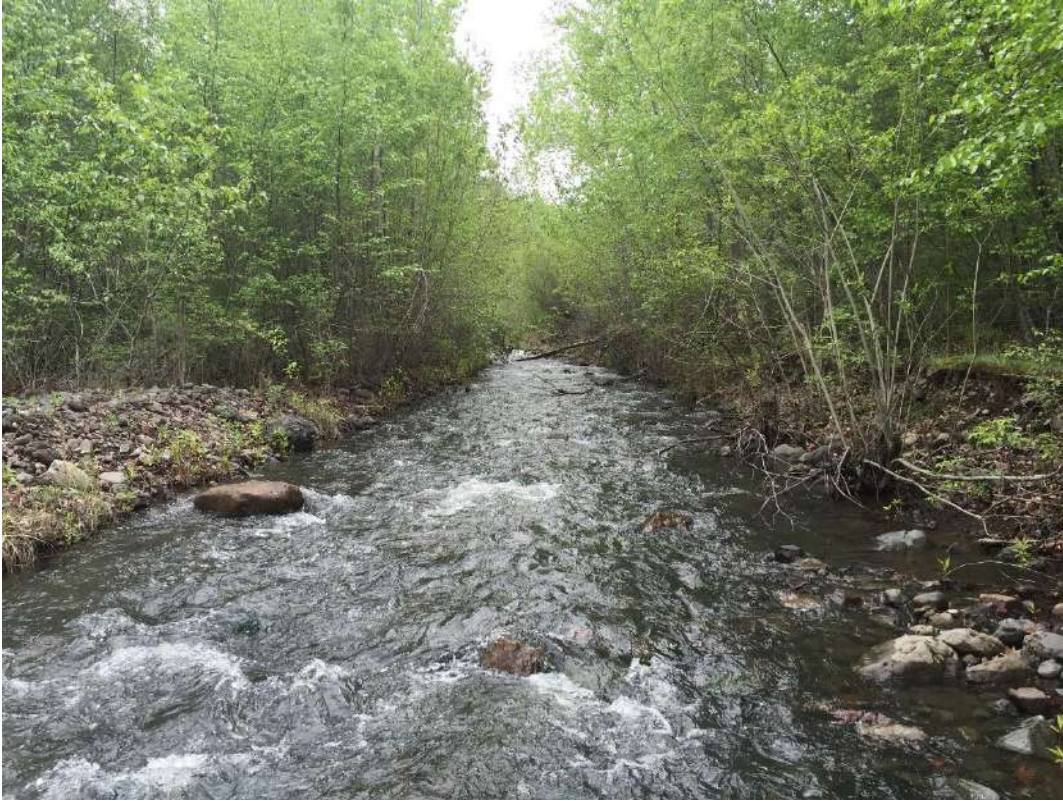
*Figure 27. South Fork Asotin Creek with typical recovering riparian and low diversity habitat.*

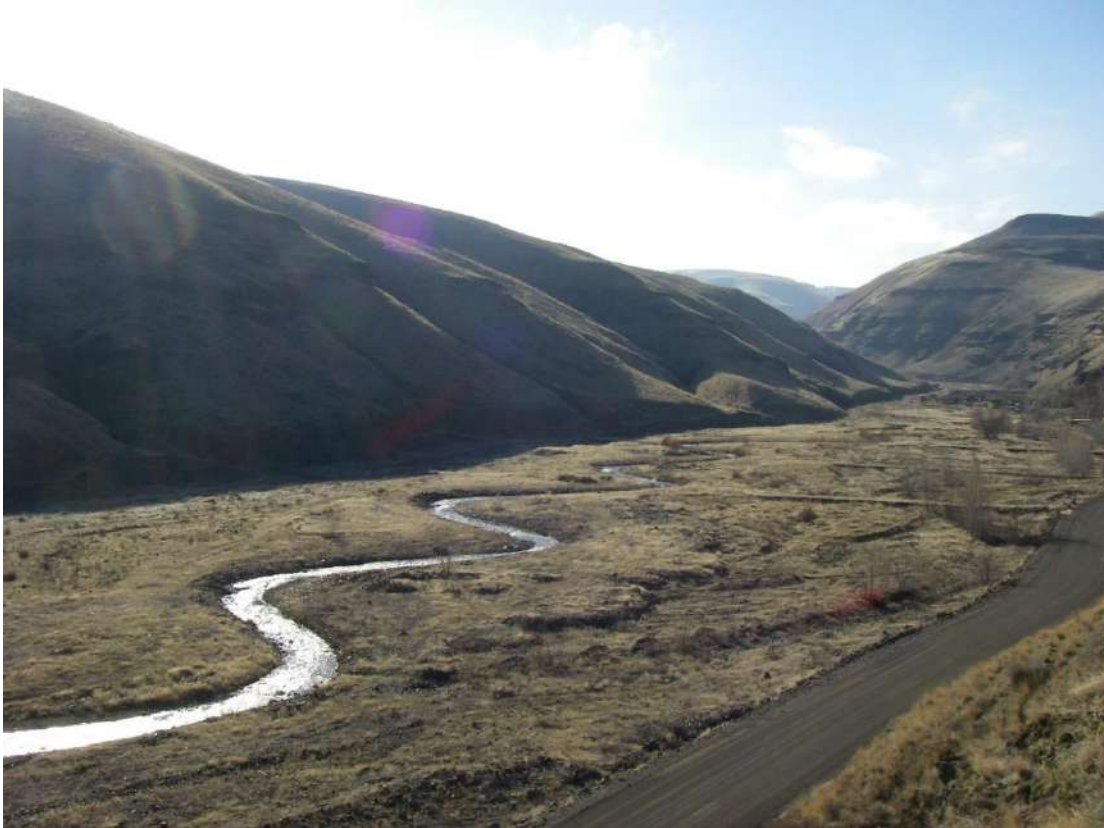
*Figure 29. Lower George Creek at site of a created meander reach.*

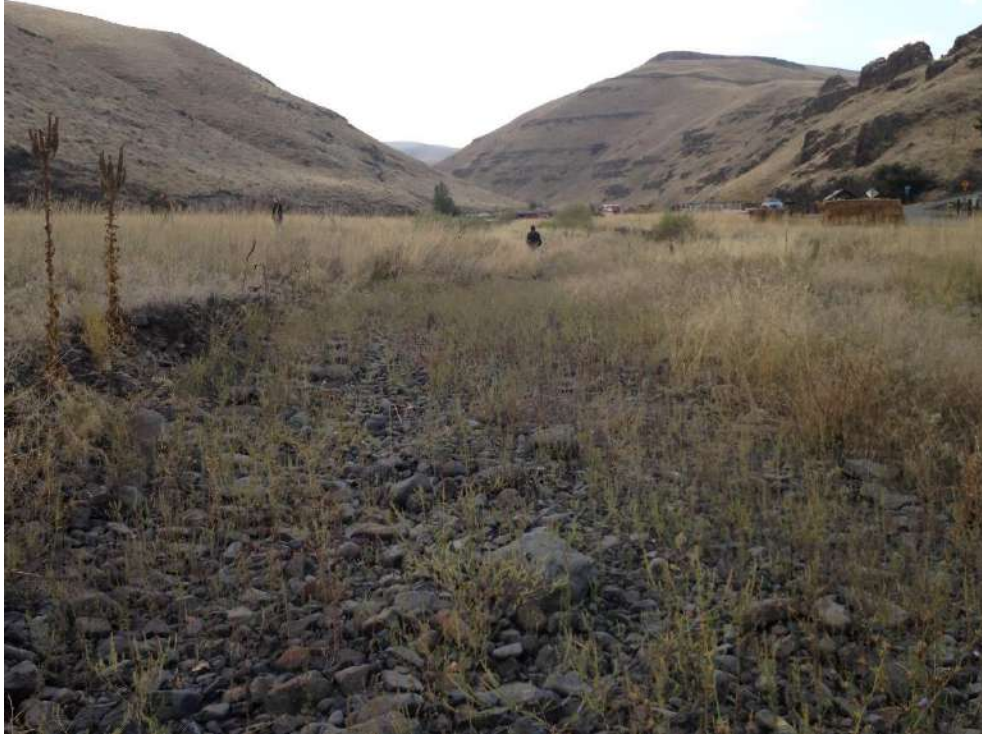
Reach **PC\_01** begins at the confluence with George Creek. From RM 0.0 to 0.6, the reach is a Wandering gravel bed with discontinuous floodplain reach type, where there is one dominant channel with several side channels, but only 1-3 may be active at a time. The stream regularly goes subsurface from RM 0.0 to 0.6 after spring flows recede in the summer. A natural pinch point in the valley near RM 0.6 marks the beginning of a confined valley setting, changing the reach type to Confined with occasional floodplain pockets. Most of the reach is within WDFW property.

*Figure 30. Lower Pintler Creek just above the confluence with George Creek. Flows in this section go dry each year.*

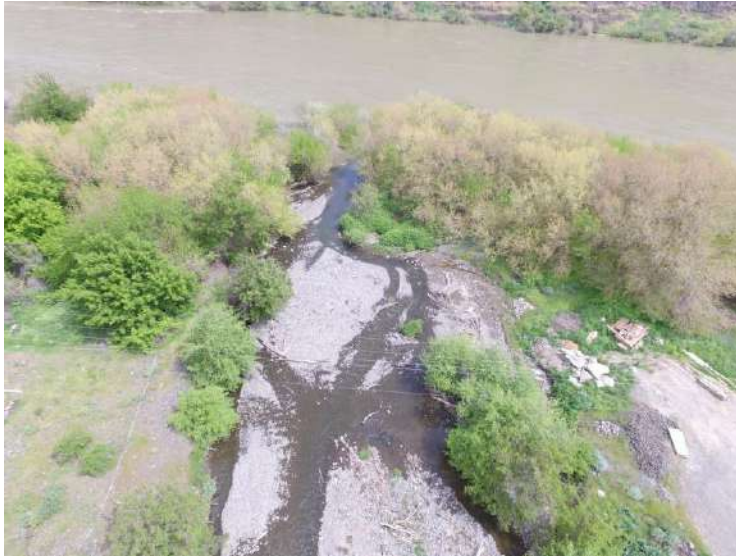
Reach **TM\_01** is located from the mouth of Tenmile Creek to about RM 4.5. The reach begins as an alluvial fan surrounded by private infrastructure with several levees to help contain high flows and protect private property. The reach crosses under several private and public bridges, creating pinch points in the channel and floodplain. Land use in this reach is primarily grazing and agriculture and intensity decreases upstream of Beckman Gulch at RM 1.1. The floodplain is well developed upstream of Beckman Gulch except from RM 2.2 to 2.8 where the valley is much more confined. The stream parallels the Snake River and is separated from it by Weissenfels Ridge.

*Figure 32. Alluvial fan at the bottom of reach TM\_01 as Tenmile Creek enters the Snake River.*

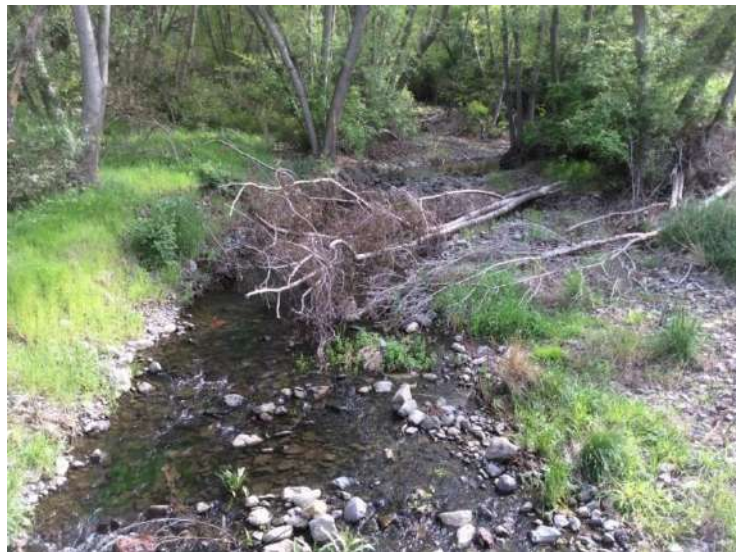
*Figure 33. Reach TM\_01 upstream of Beckman Gulch depicting the riparian canopy dominated by young alder. LWD in the channel is typically small and rare.*

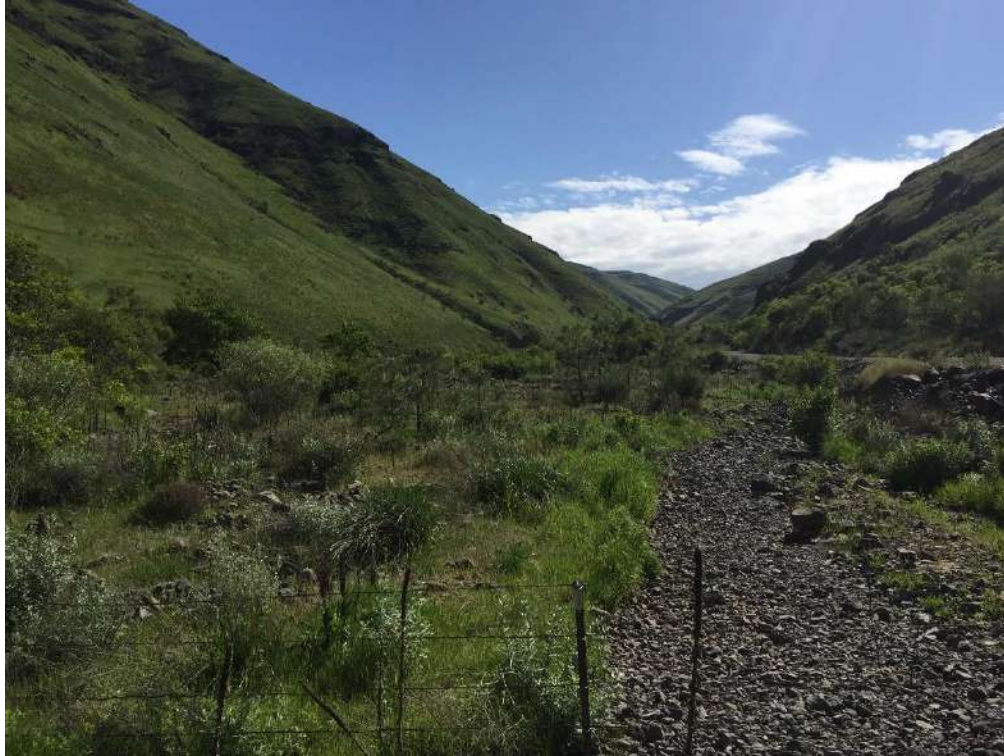
*Figure 35. Lower Couse Creek just upstream of confluence with the Snake River. Flows in this section go subsurface each year.*

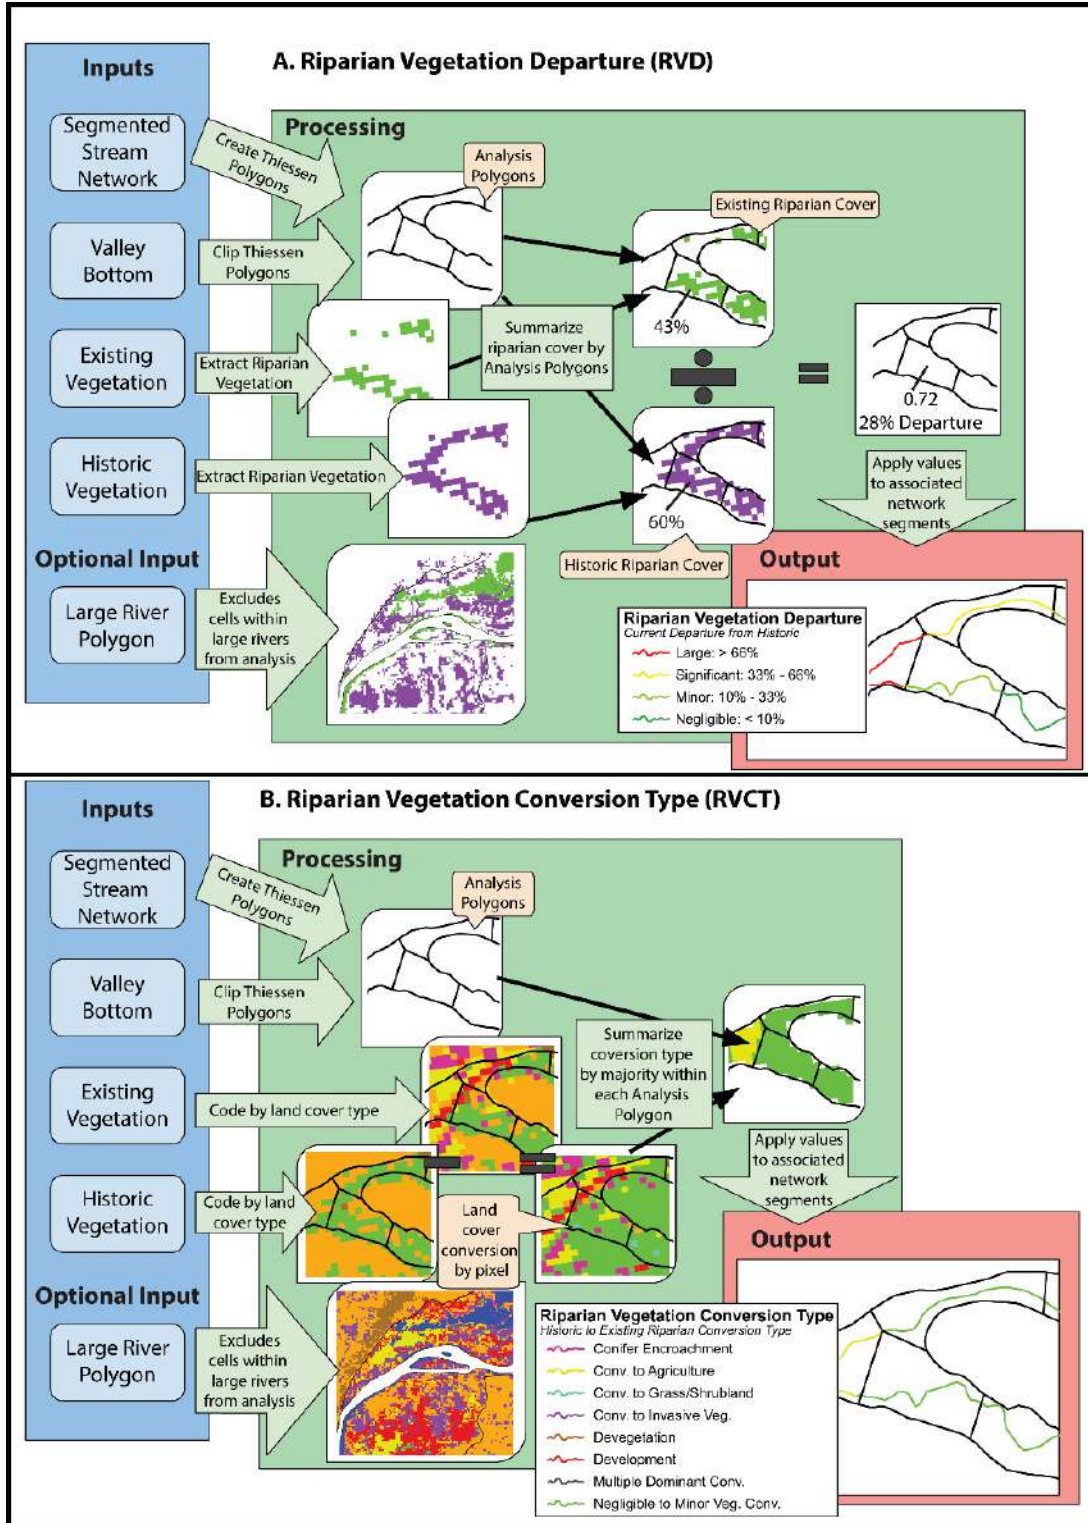
Appendix C. 2. Flowchart showing the workflow of the a) Riparian Vegetation Departure index and b) Riparian Vegetation Conversion Type Classification (MacFarlane et al. 2017).

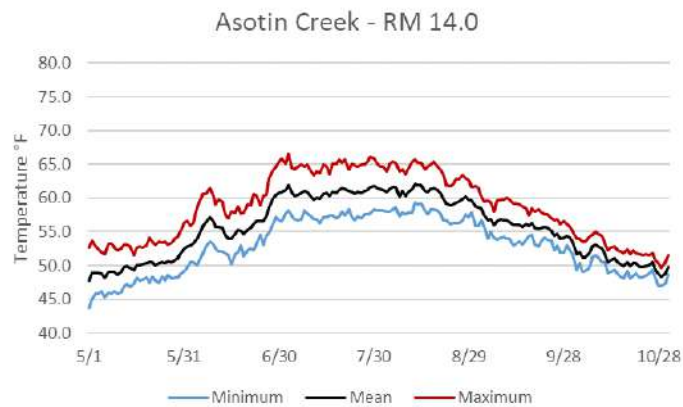
**Appendix C. 9. Average mean, minimum, and maximum stream temperature from May 1 to October 30: 2013-2016. Asotin Creek mainstem just above George Creek at river mile (RM) 3.2, Asotin Creek below the confluence of South Fork and Asotin Creeks (RM 14), and North Fork Asotin Creek (RM 22\*). North Fork RM 22\* represents the distance from the mouth of Asotin Creek to 6.8 miles upstream on North Fork Creek. Data are from the DOE stream gauge above George Creek and IMW temperature surveys.**
