Cougar Creek Fish Passage Barrier Removal  
Asotin County, Washington

### **Hydrologic and Hydraulic Analysis**

The Asotin County Conservation District (ACCD) proposes the removal of a fish passage barrier at the crossing of Cougar Creek and Grande Ronde Road. The fish passage barrier limits access to spawning and rearing habitat for anadromous salmonids, including Endangered Species Act-listed (ESA) Steelhead within Cougar Creek. To restore fish passage, this project proposes to replace the currently undersized culvert with a fish passable crossing structure and restoring the roadway.

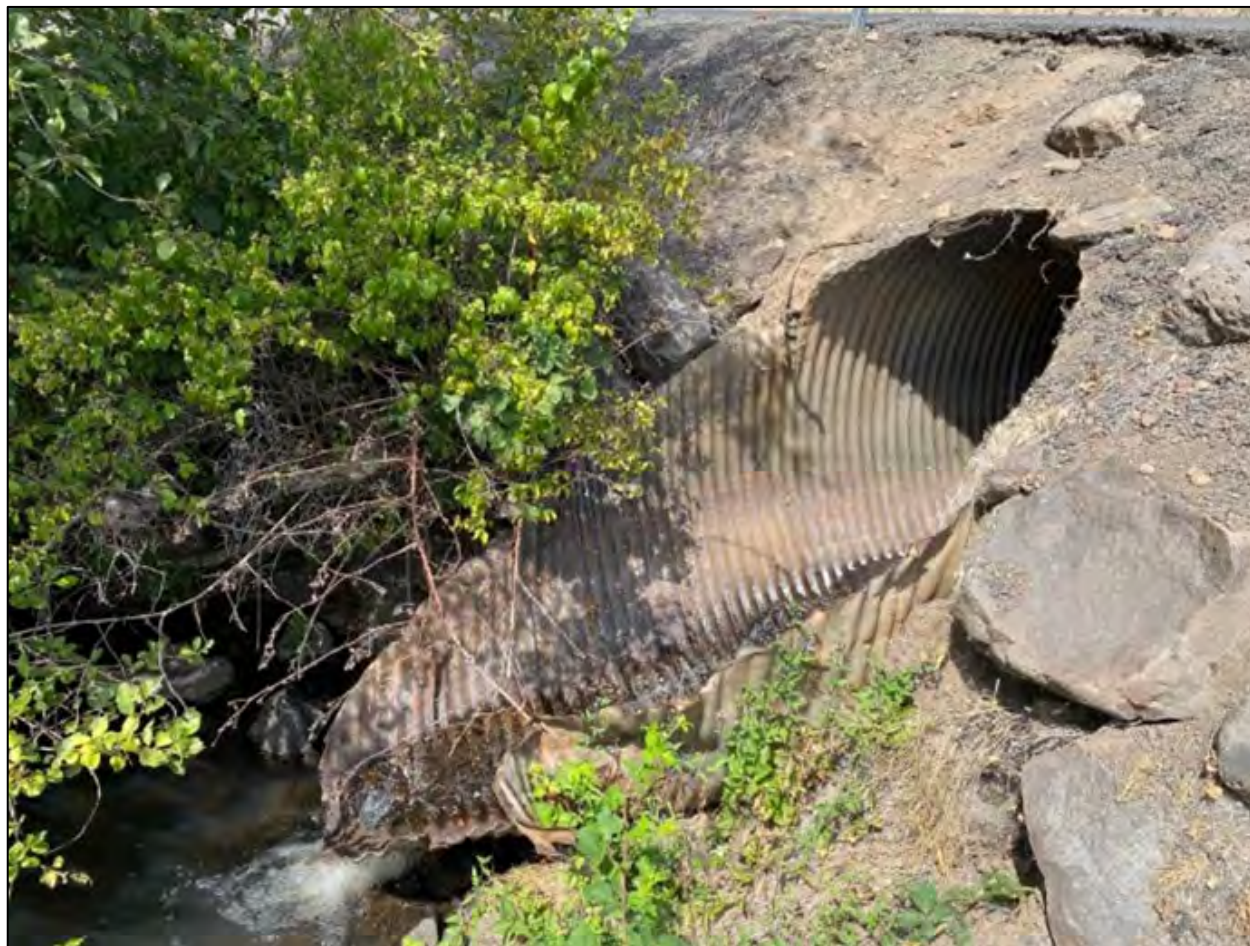
**Figure B-1**

**Cougar Creek Low Flow Conditions at Outlet**

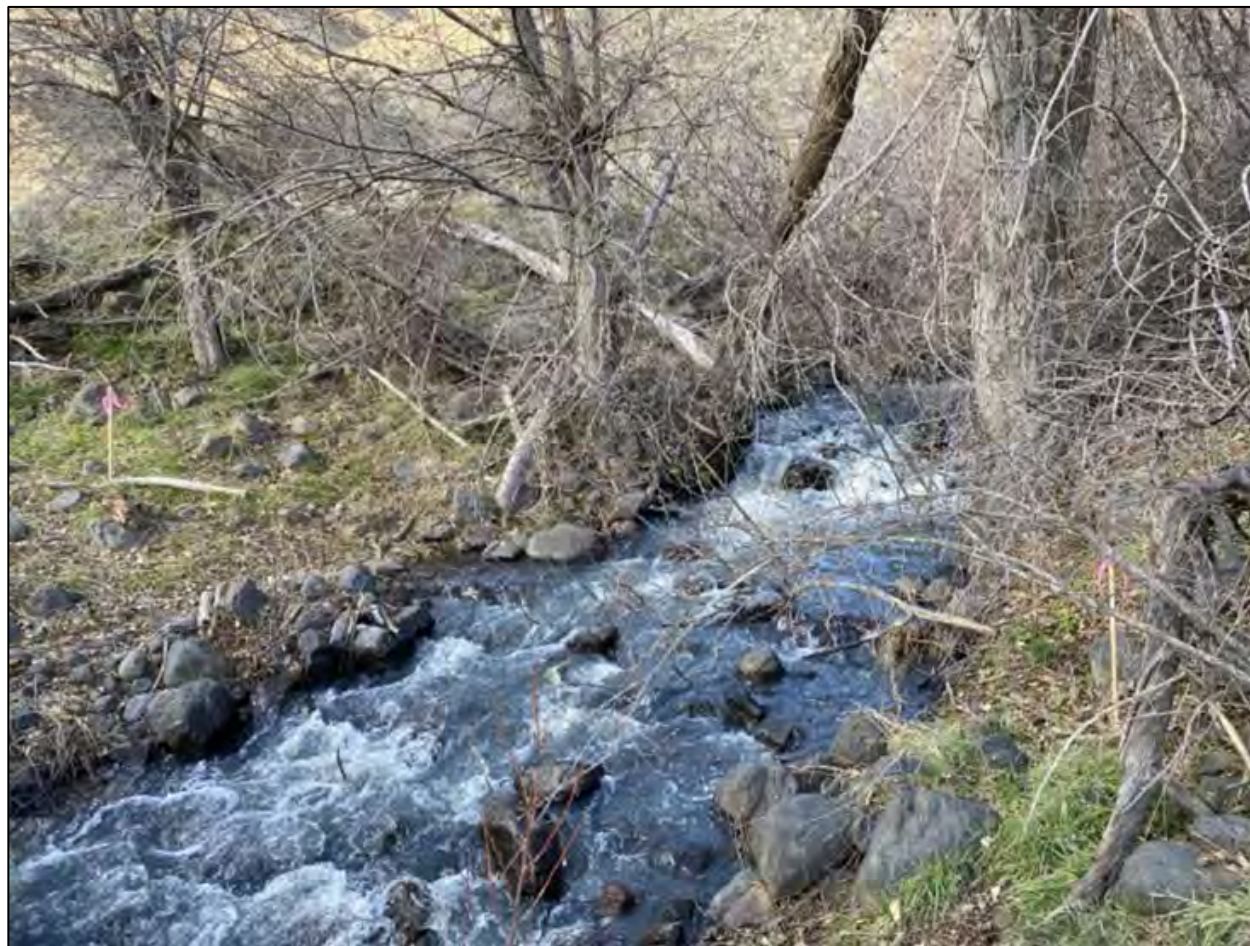
**Figure B-2**

**Roughened Channel Morphology  
Approximately 30 Feet Upstream of Inlet**

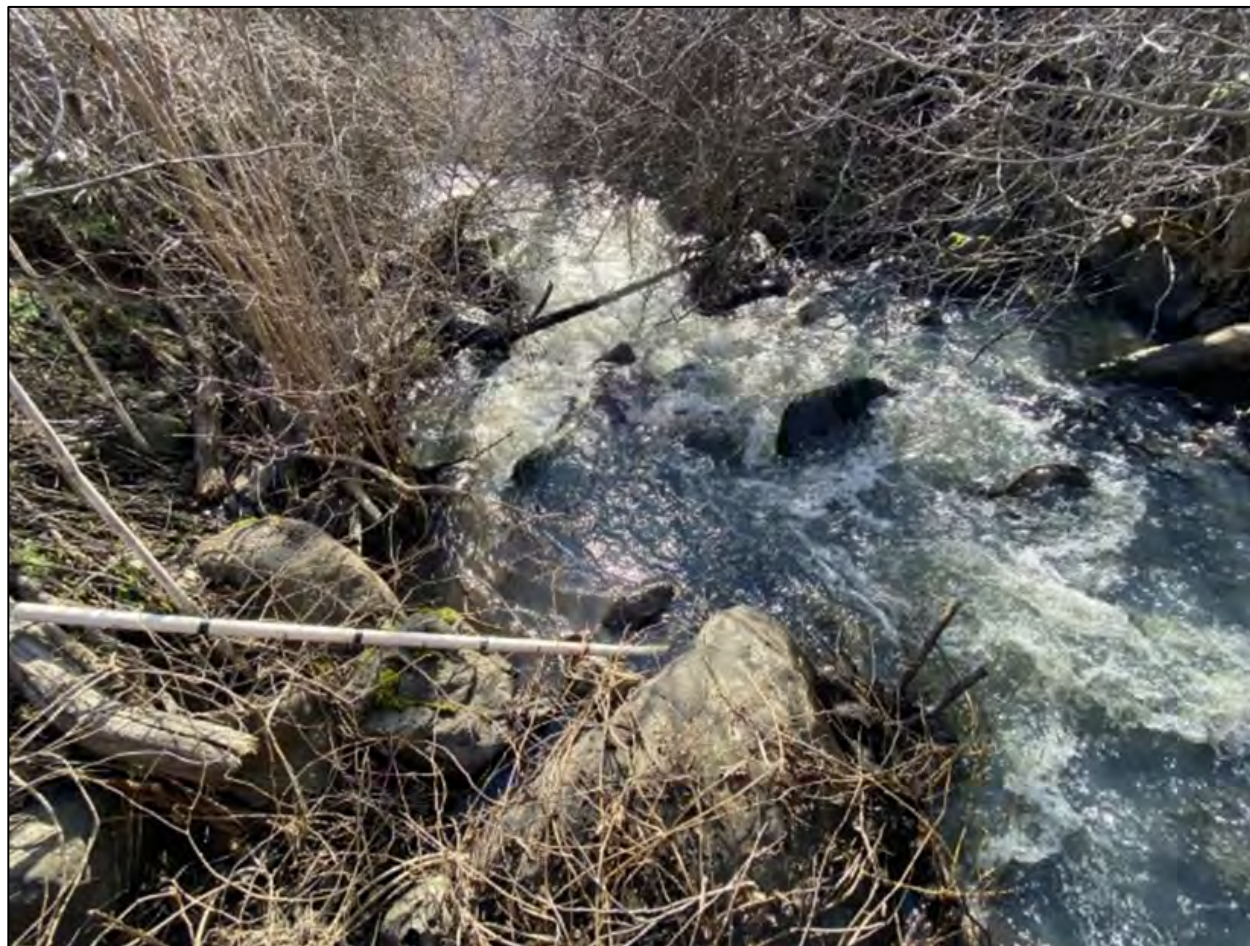
**Figure B-3**

**Step Pool Within Reference Reach  
Approximately 100 Feet Upstream of Inlet**

The proposed reconstructed channel will consist of channel-spanning porous weirs. Porous weirs are proposed with a longitudinal spacing of approximately twice the bankfull width to approximately match conditions observed in the reference reach. Hydraulic drop heights are limited to 0.5 feet to provide fish passage (NMFS 2011).

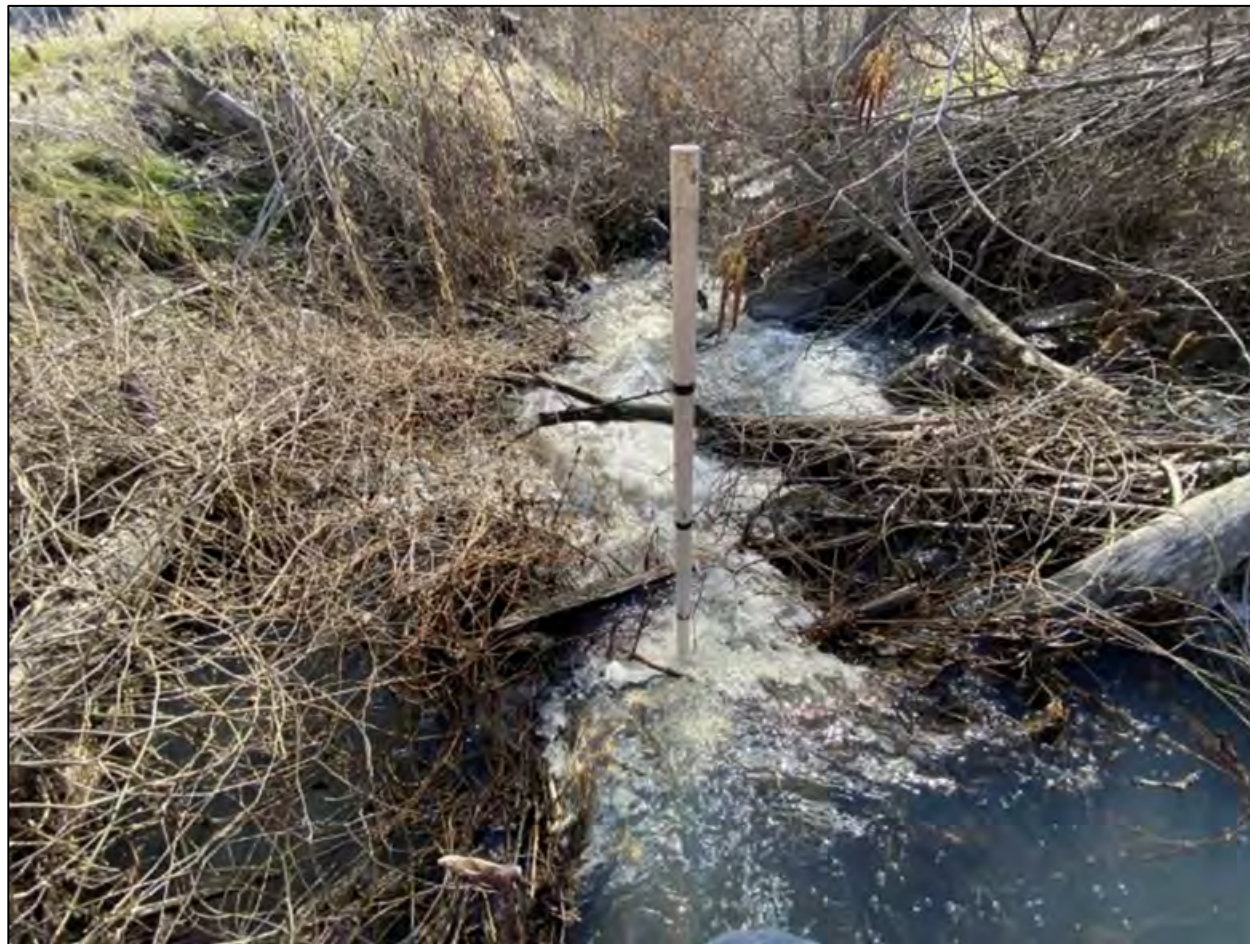
**Figure B-4**

**Large Woody Material and 5-6 Foot Drop Over  
25 Feet Approximately 165 Feet Upstream**

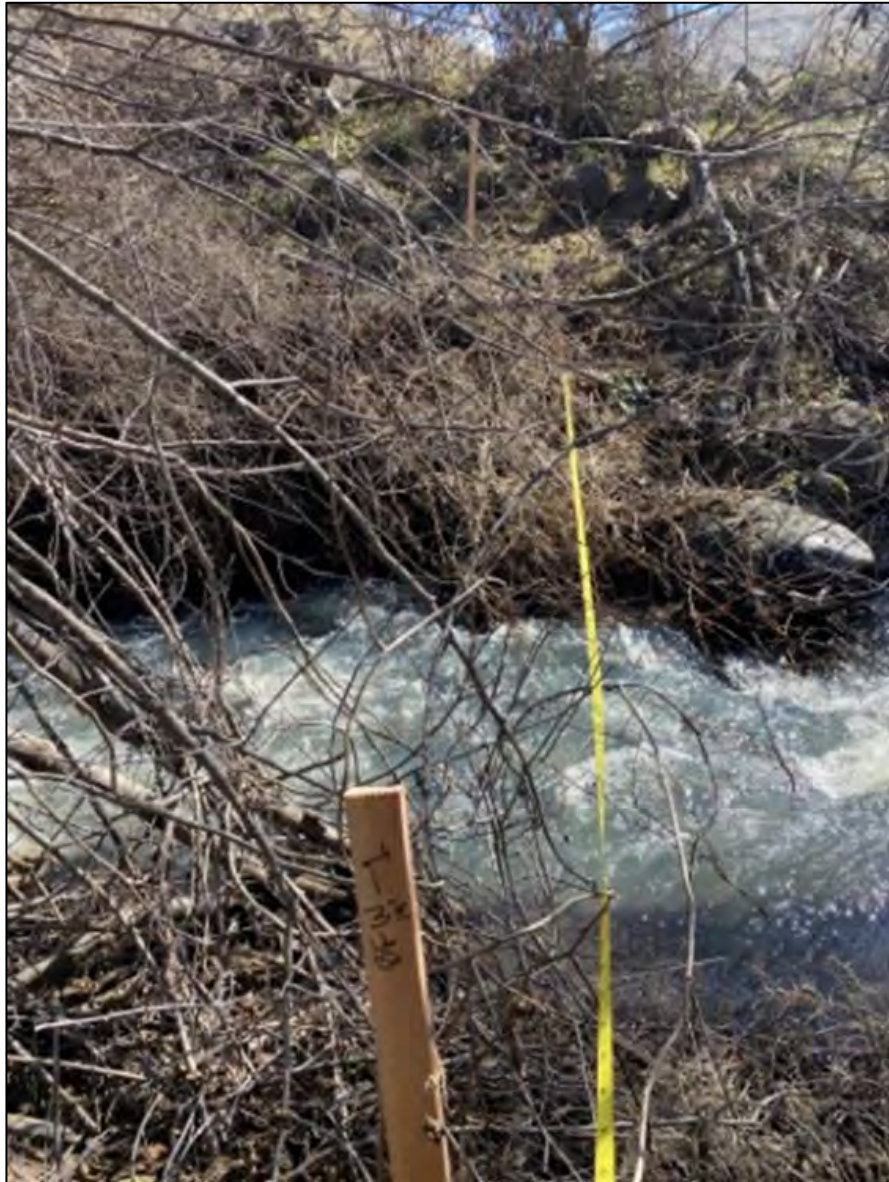
**Figure B-5**

**Bankfull Width Measurement #1 Approximately  
110 to 120 Feet Upstream of Inlet**

The proposed culvert has a 24-foot span to accommodate the minimum hydraulic opening width. The proposed span was designed to exceed the bankfull width times a factor of 1.5 based on BPA HIP guidelines (BPA 2021). The reference reach bankfull width was measured as 13.9 feet. Therefore, culvert replacement triggers are specific to the measured bankfull width upstream and downstream of the culvert. The measured bankfull width should remain less than 24 feet divided by a factor of 1.5 feet, or 16 feet to provide a clear and unobstructed opening (BPA 2021).

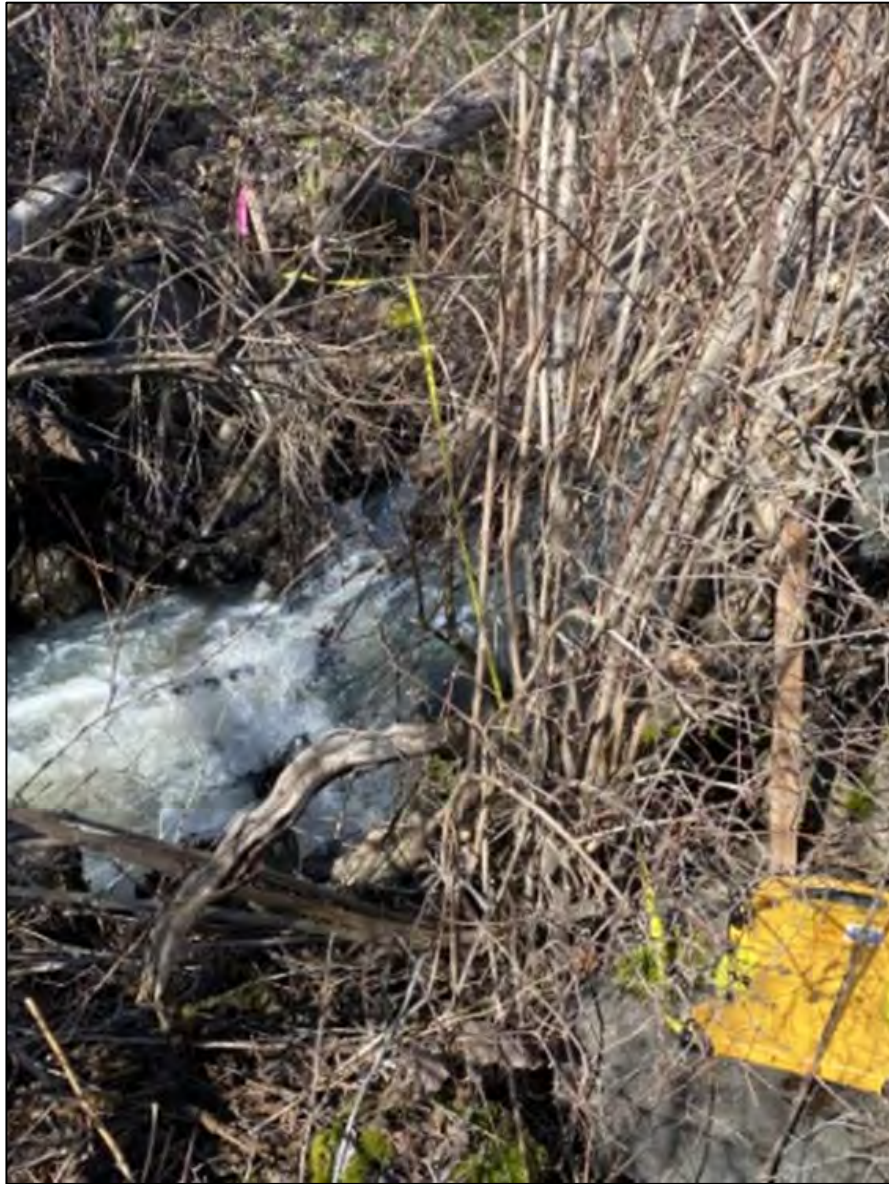
**Figure B-6**

**Bankfull Width Measurement #2 Approximately  
130 to 140 feet Upstream of Inlet**

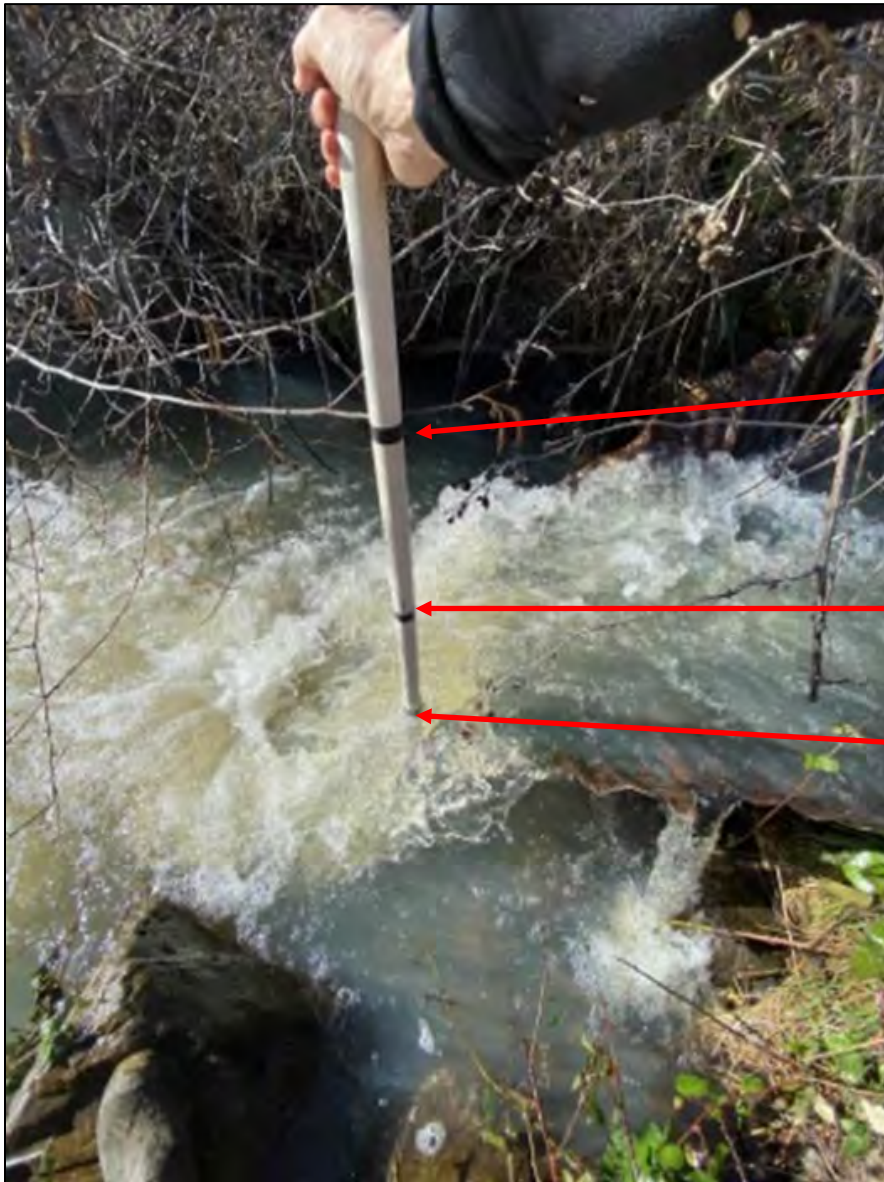
**Figure B-7**

**Perched Culvert Outlet with an Approximate  
2-Foot-Deep Pool and 6-Inch Hydraulic Drop**

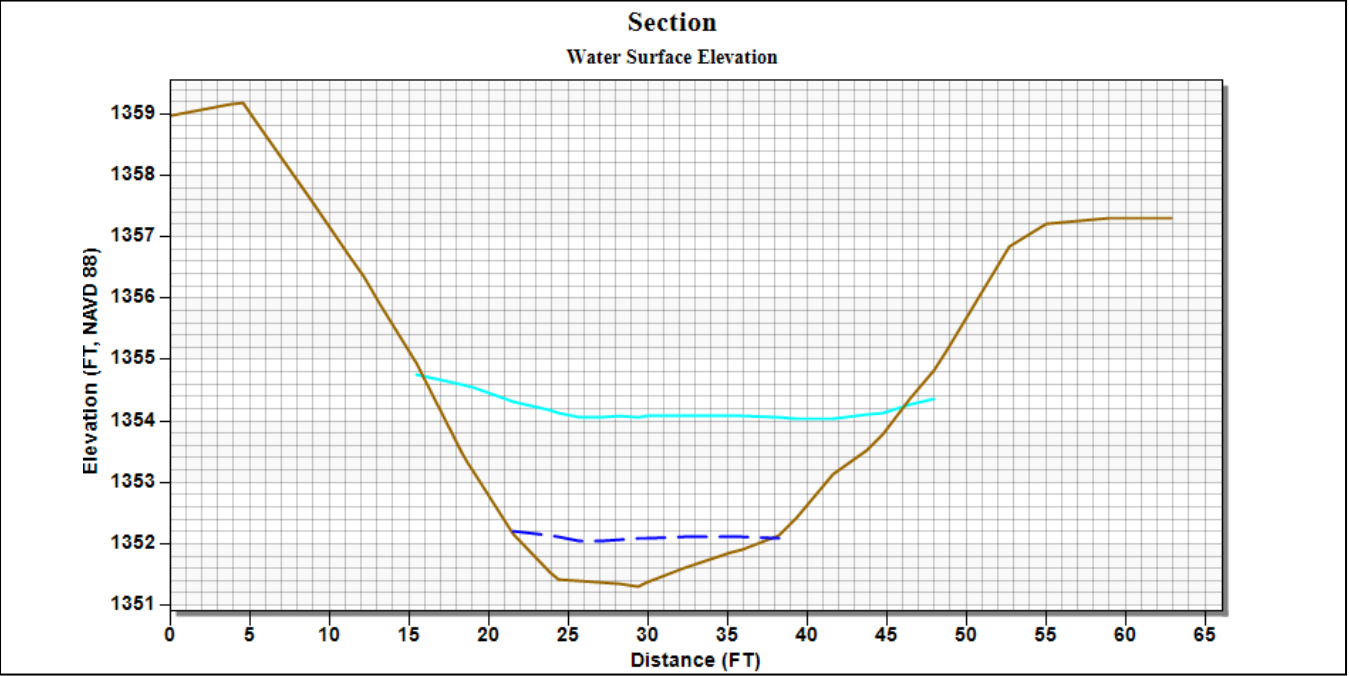
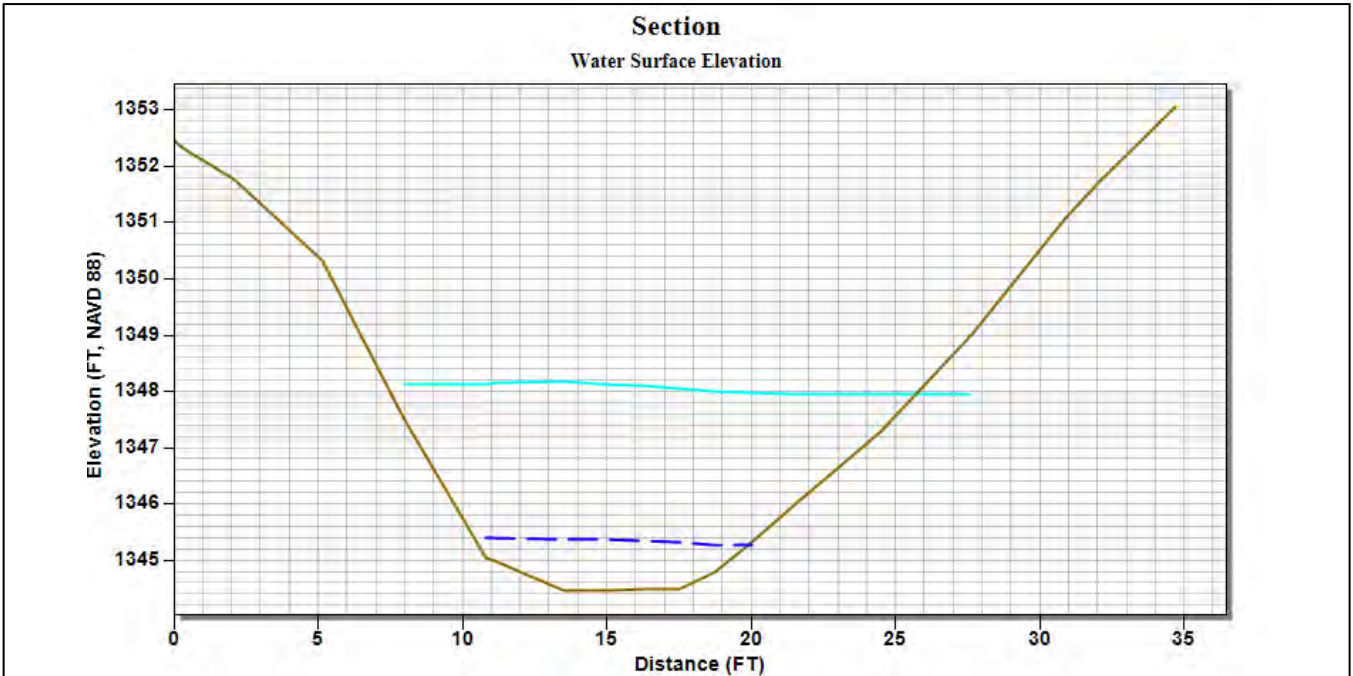
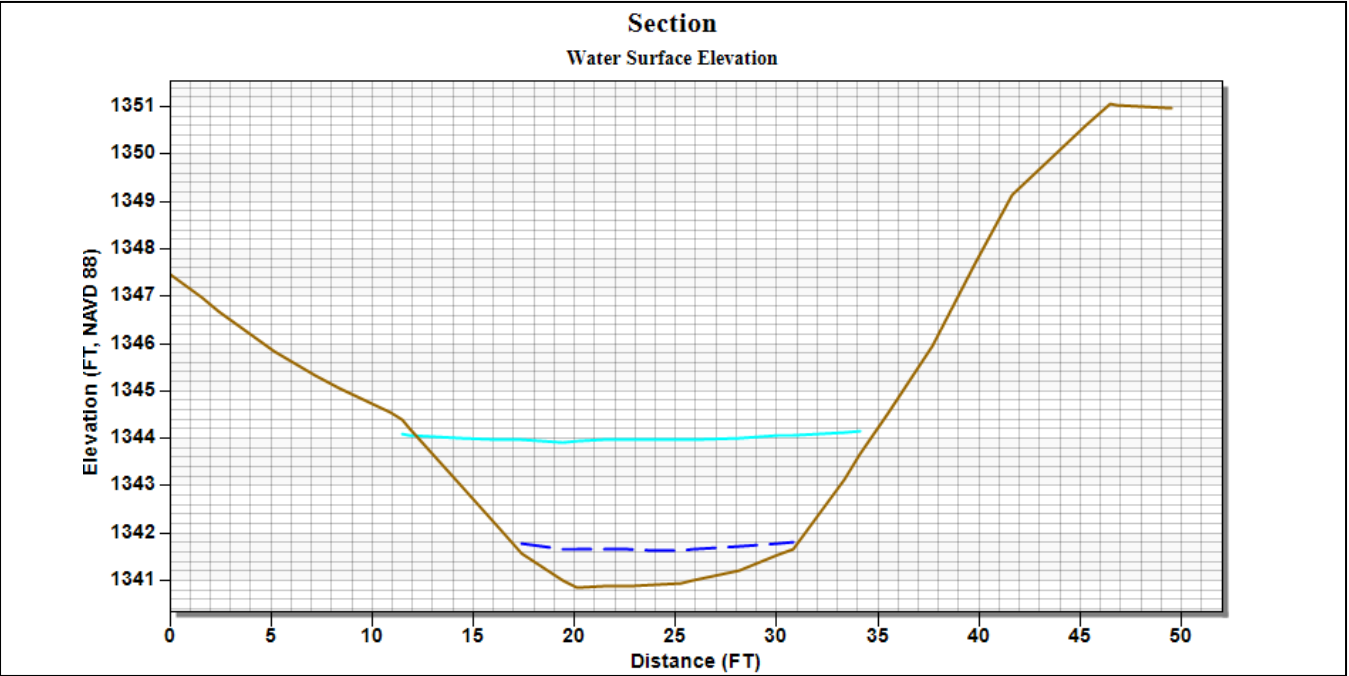
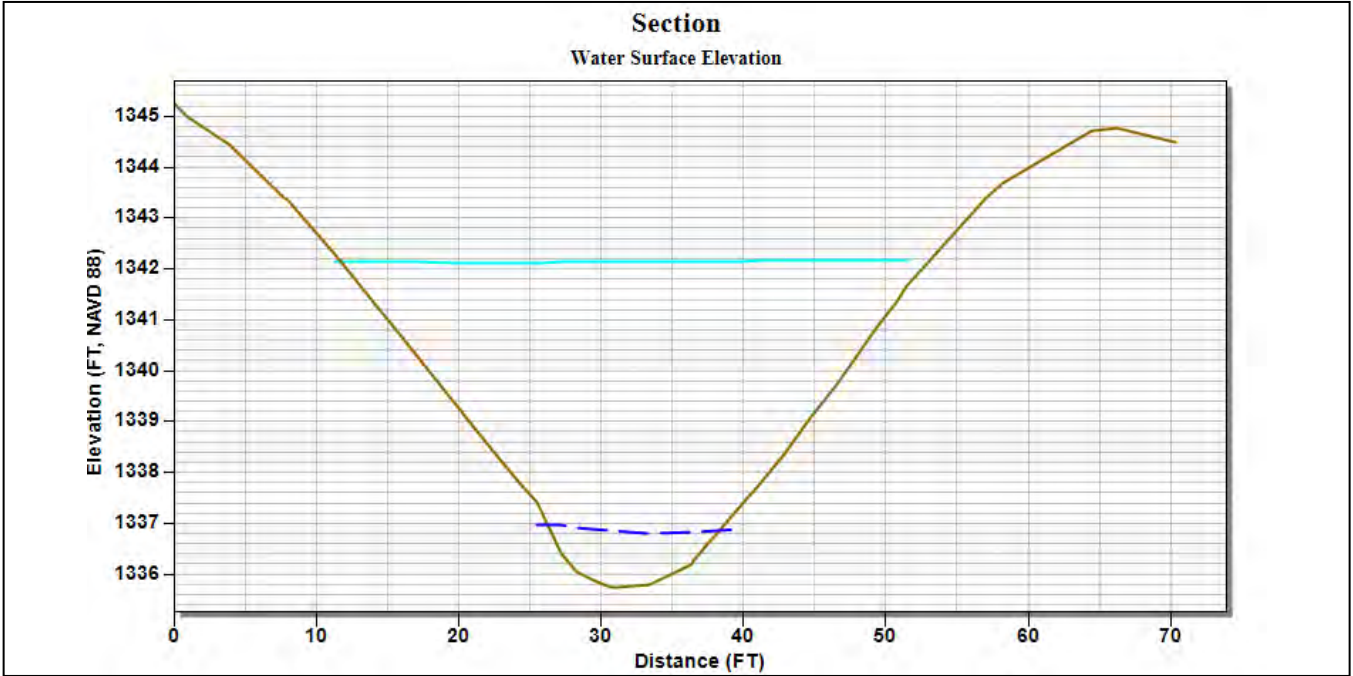
Figure C-2

Existing Conditions 2-year and 100-year Water Surface Elevation at Upstream Cross Sections

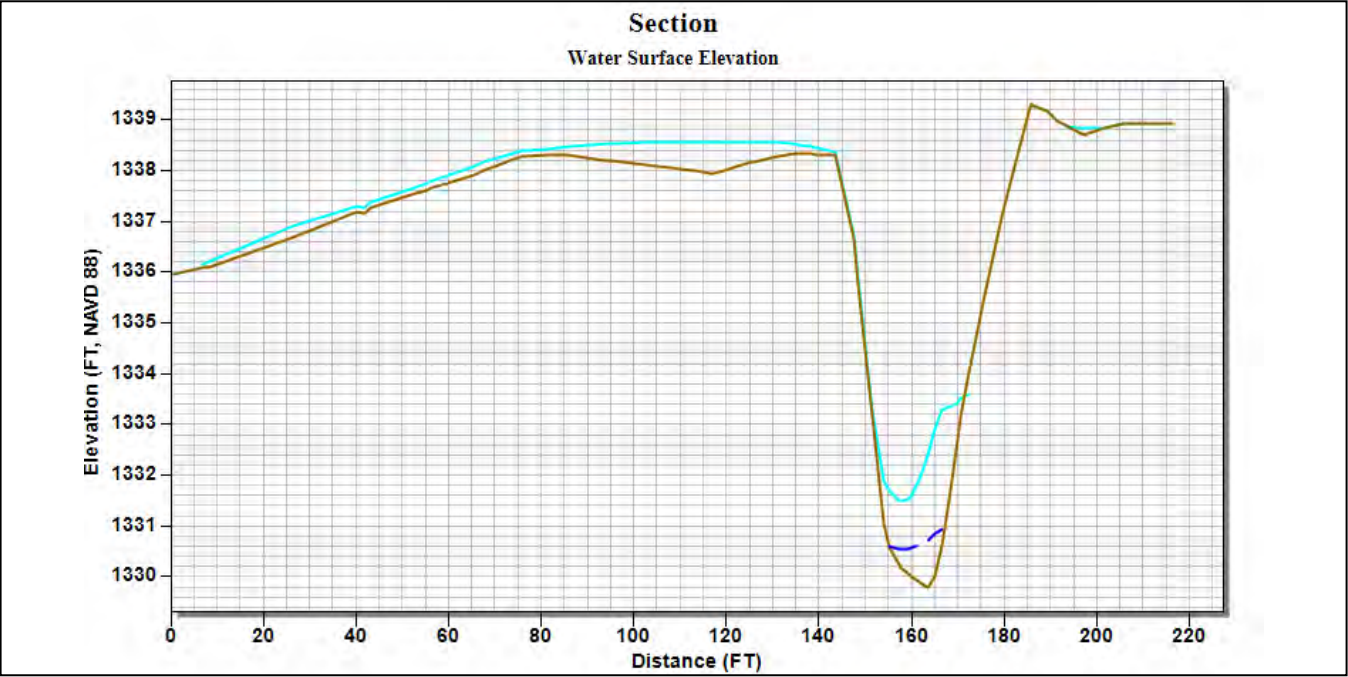
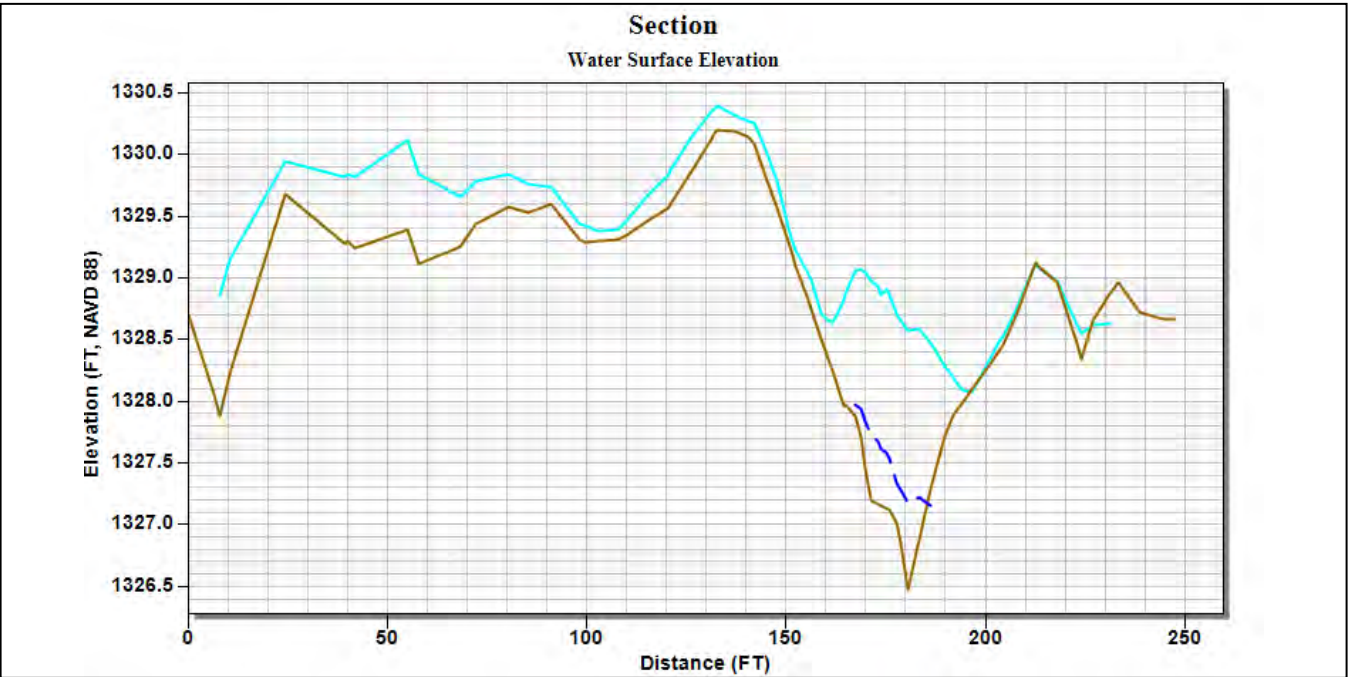
Existing Conditions 2-year and 100-year Water Surface Elevation at Downstream Cross Sections	
Cougar Creek Fish Passage Barrier Asotin County, Washington	
	Figure C-3

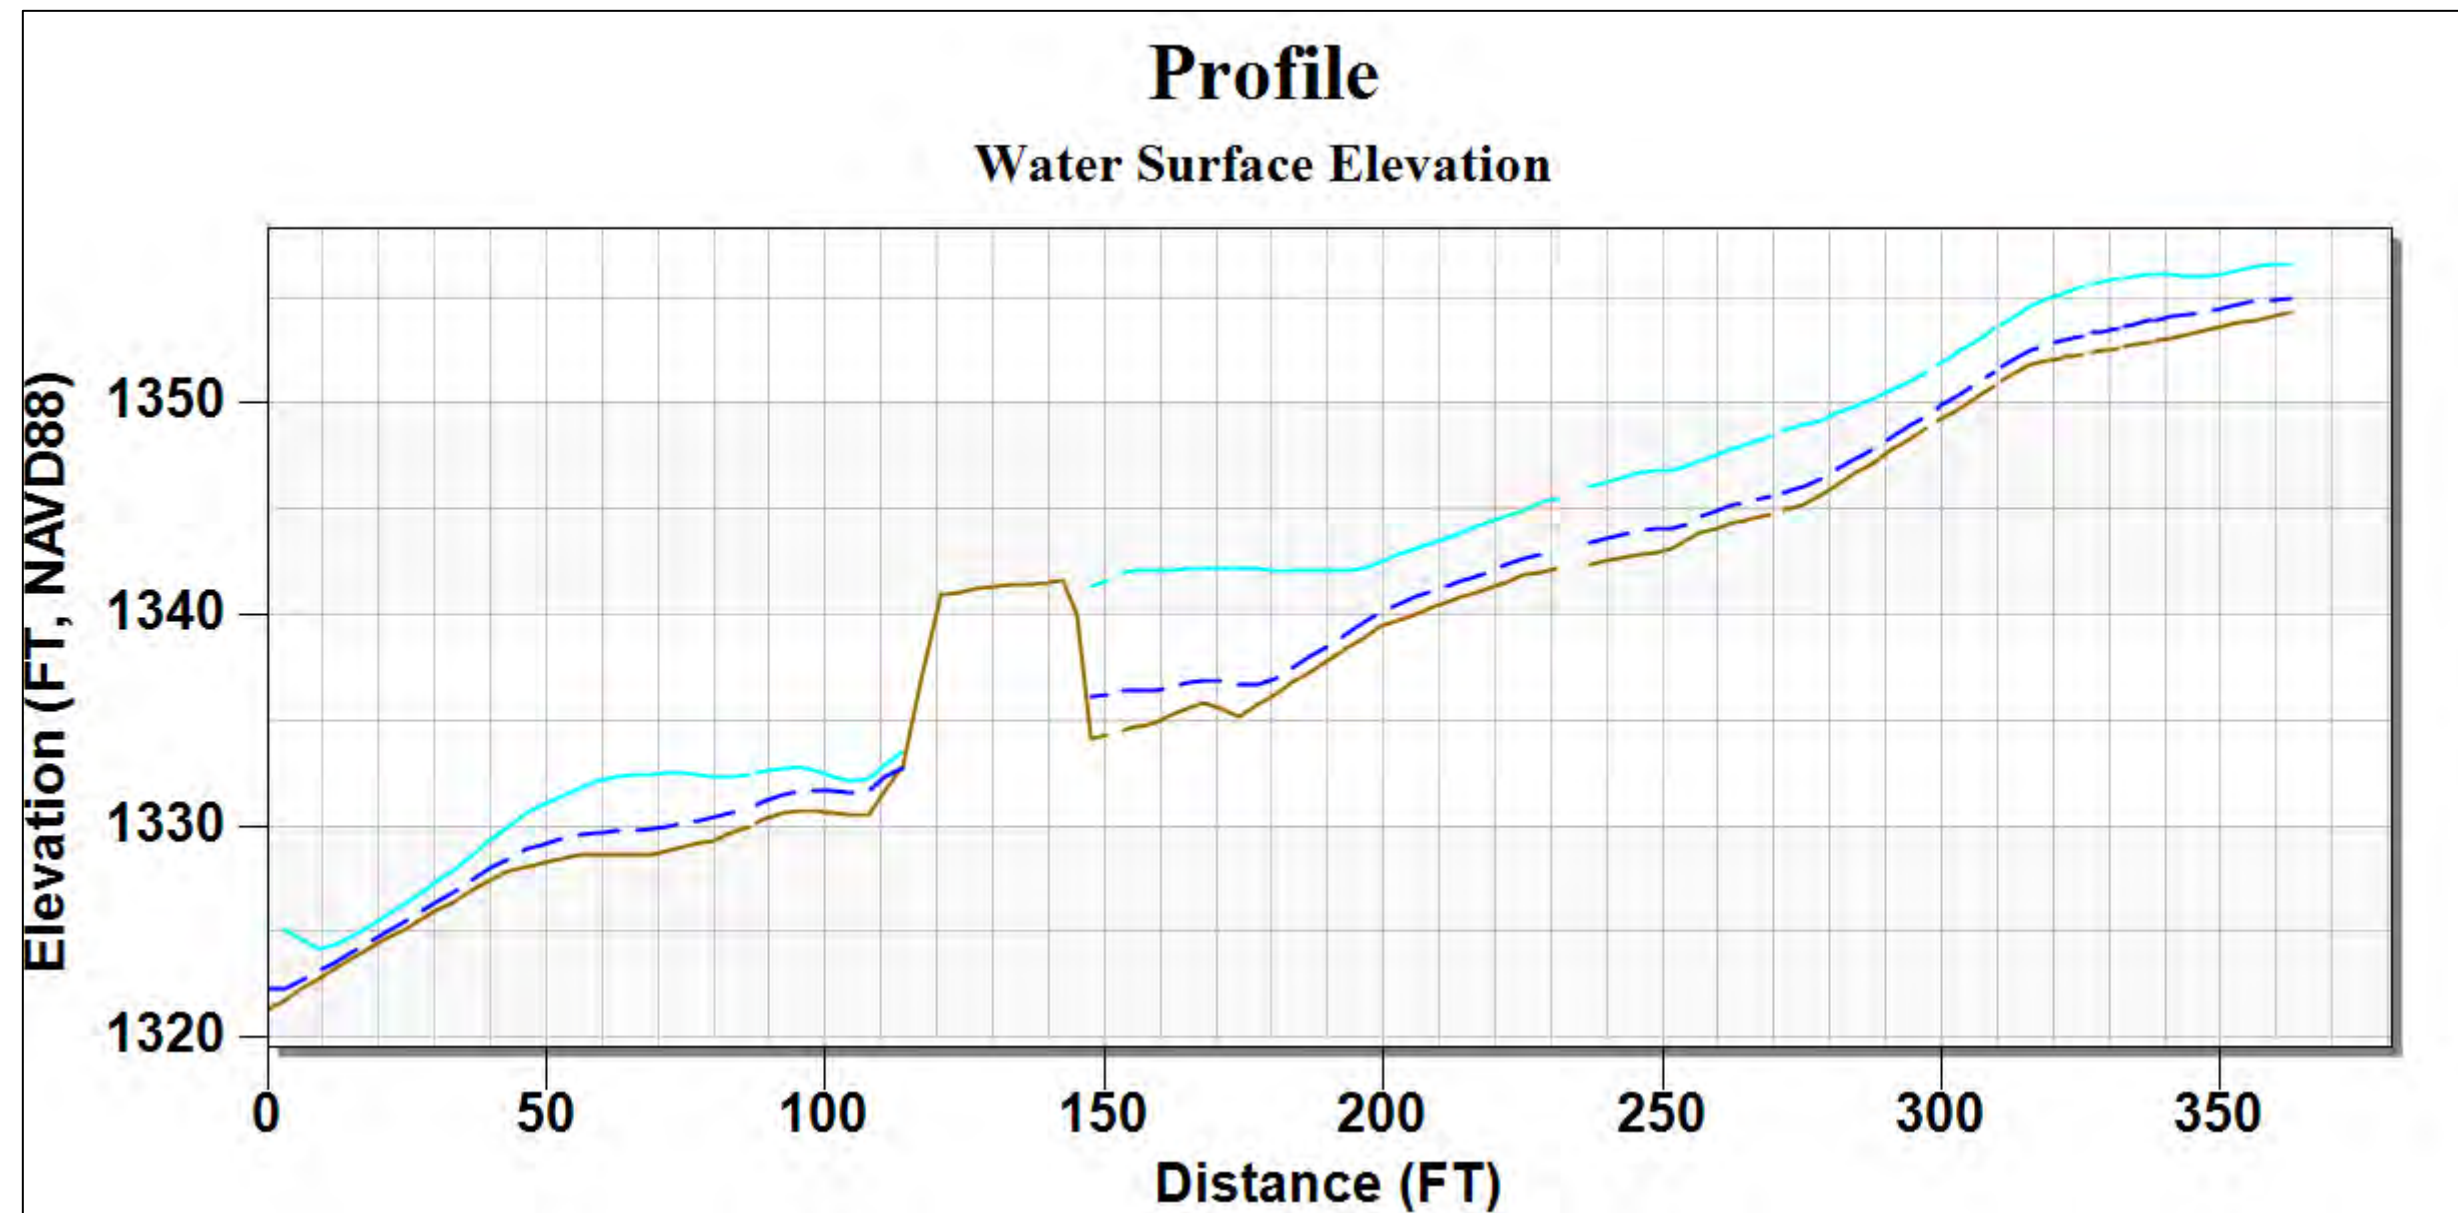
**Figure C-4**

**Existing Conditions 2-year and 100-year  
Water Surface Elevation Profiles**

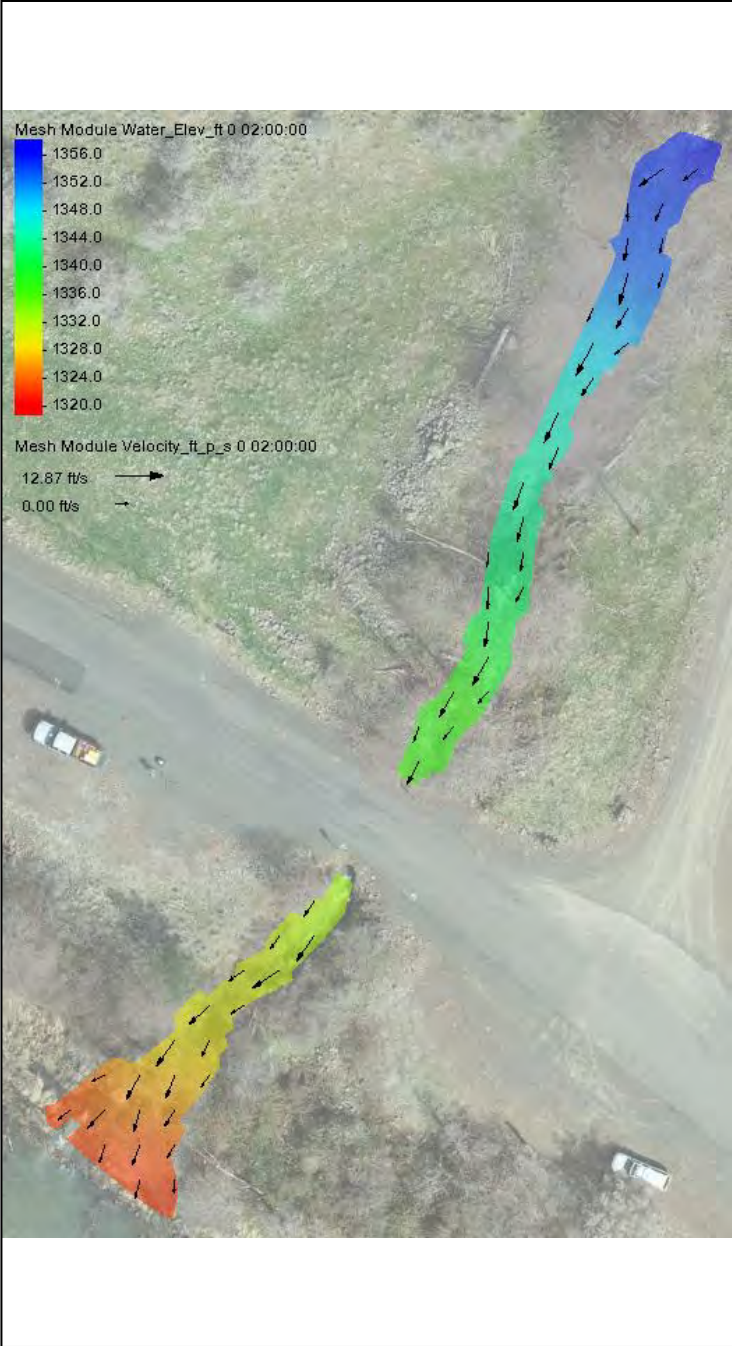
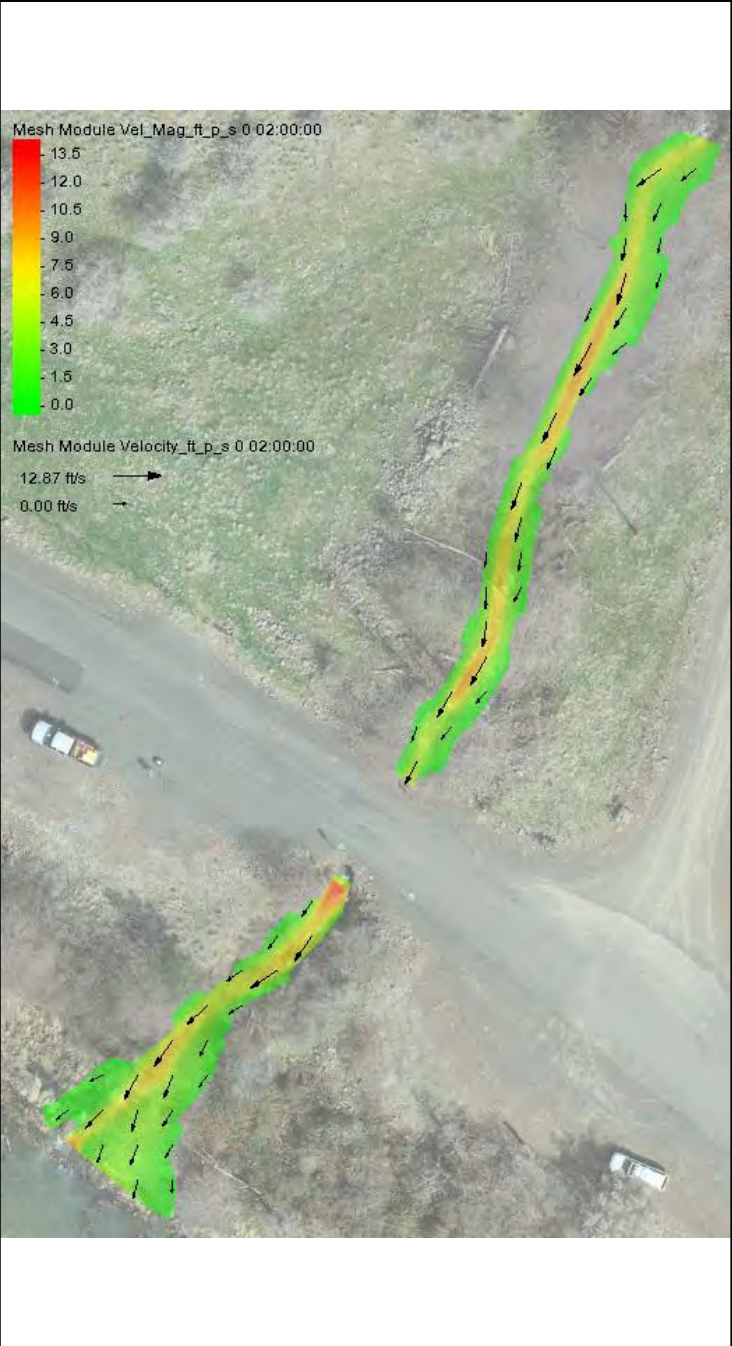
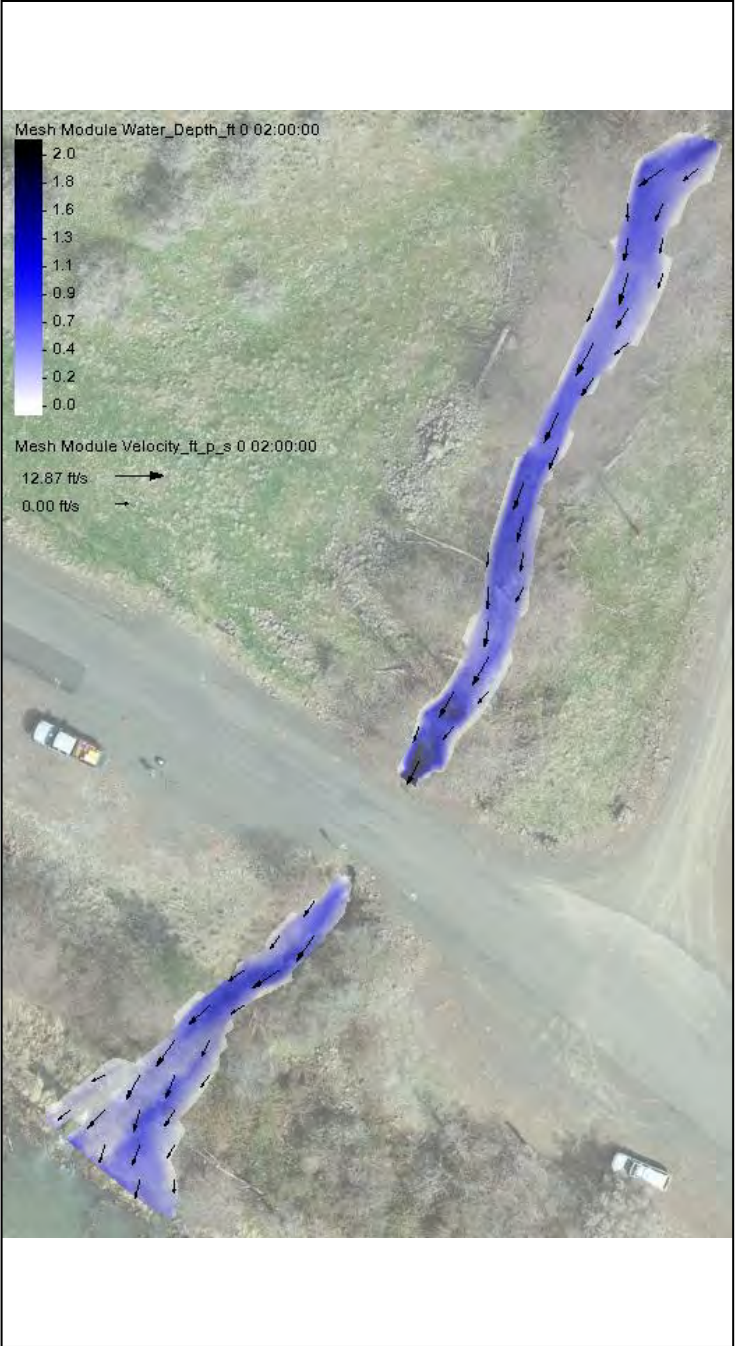
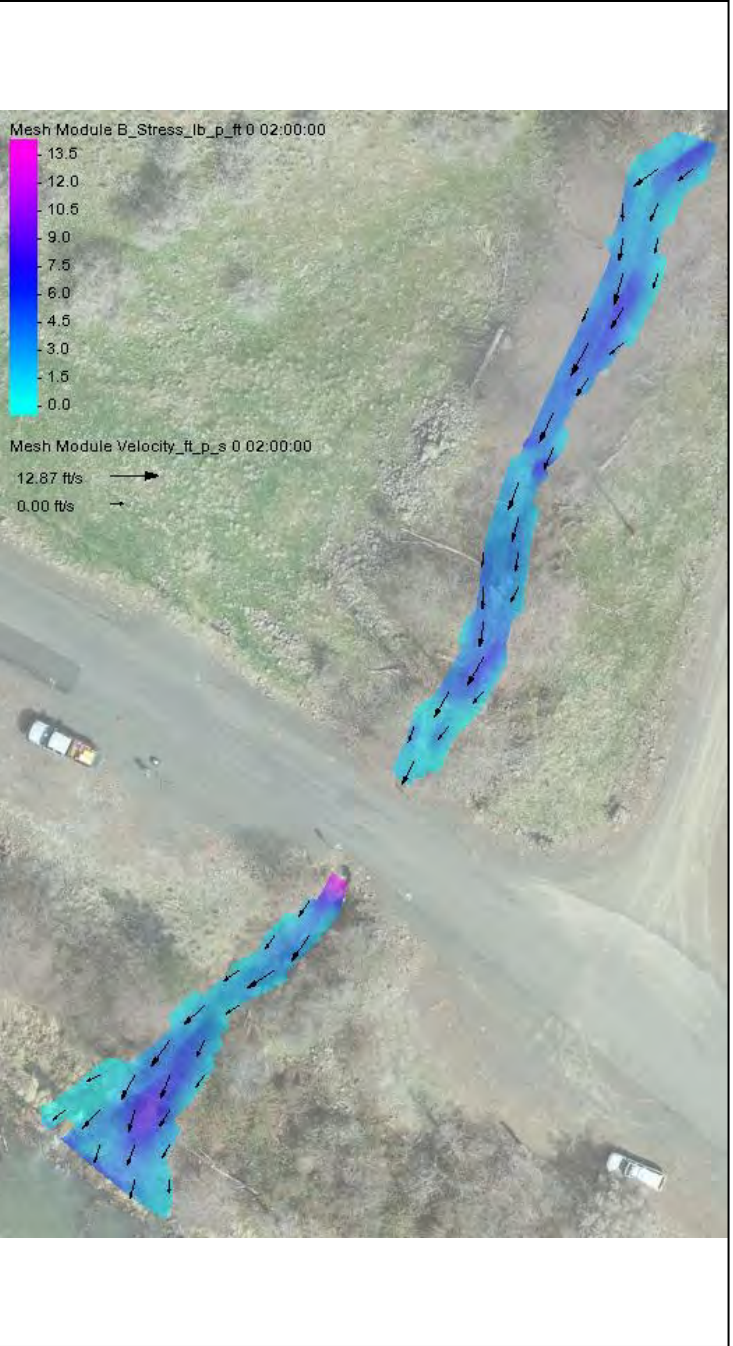
Figure C-5

Existing Conditions Plan Views  
2-year Flow (36 cfs)

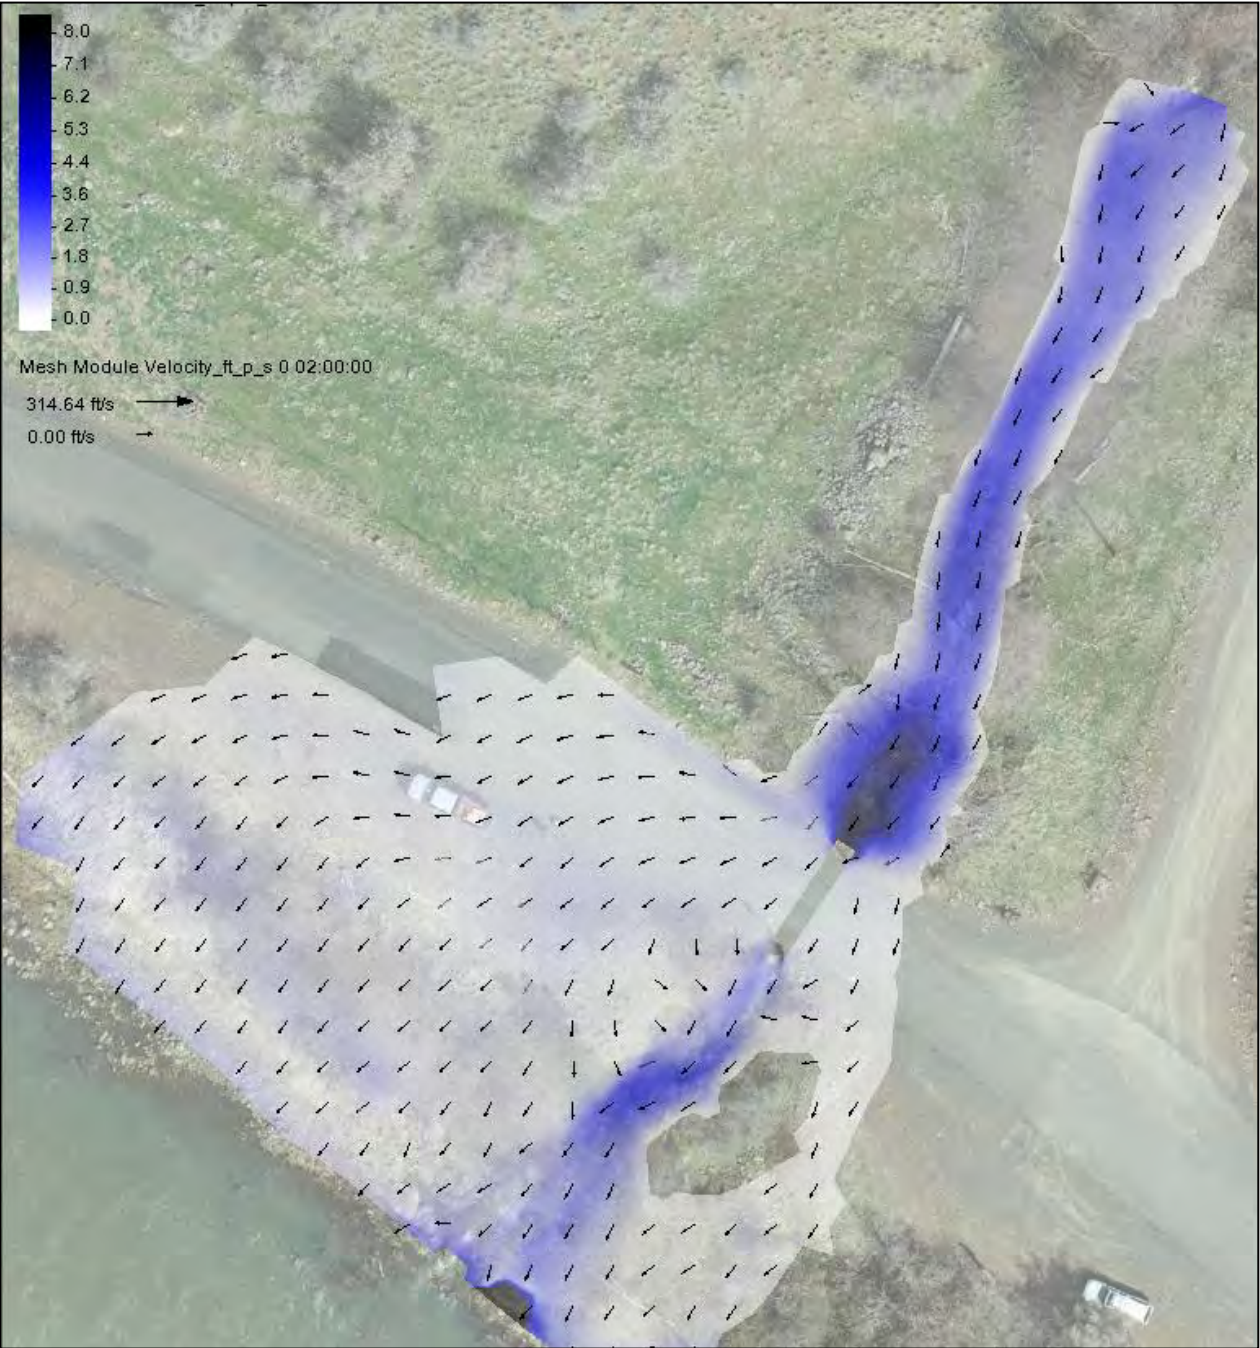
Existing Conditions Plan Views 100-year Event (355 cfs)	
Cougar Creek Fish Passage Barrier Asotin County, Washington	
GEOENGINEERS	Figure C-7
