Cougar Creek Fish Passage Barrier Removal  
Asotin County, Washington

### **Hydrologic and Hydraulic Analysis**

The Asotin County Conservation District (ACCD) proposes the removal of a fish passage barrier at the crossing of Cougar Creek and Grande Ronde Road. The fish passage barrier limits access to spawning and rearing habitat for anadromous salmonids, including Endangered Species Act-listed (ESA) Steelhead within Cougar Creek. To restore fish passage, this project proposes to replace the currently undersized culvert with a fish passable crossing structure and restoring the roadway.

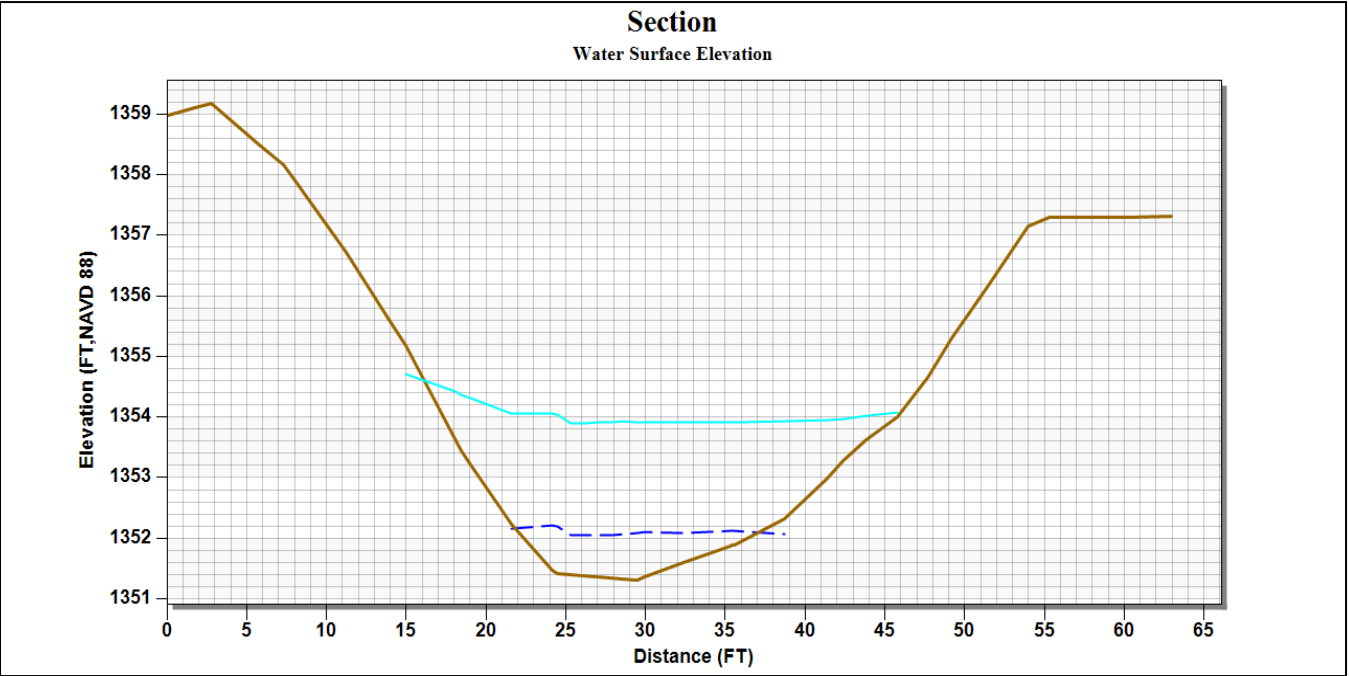
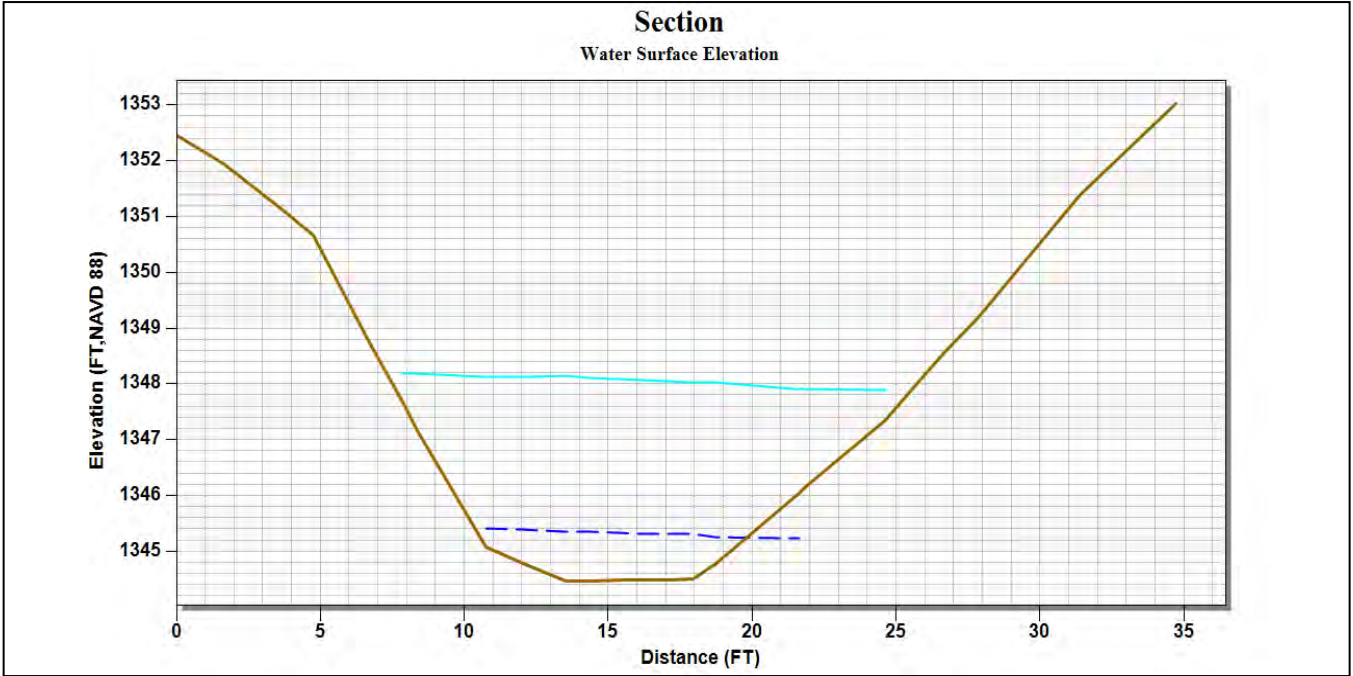
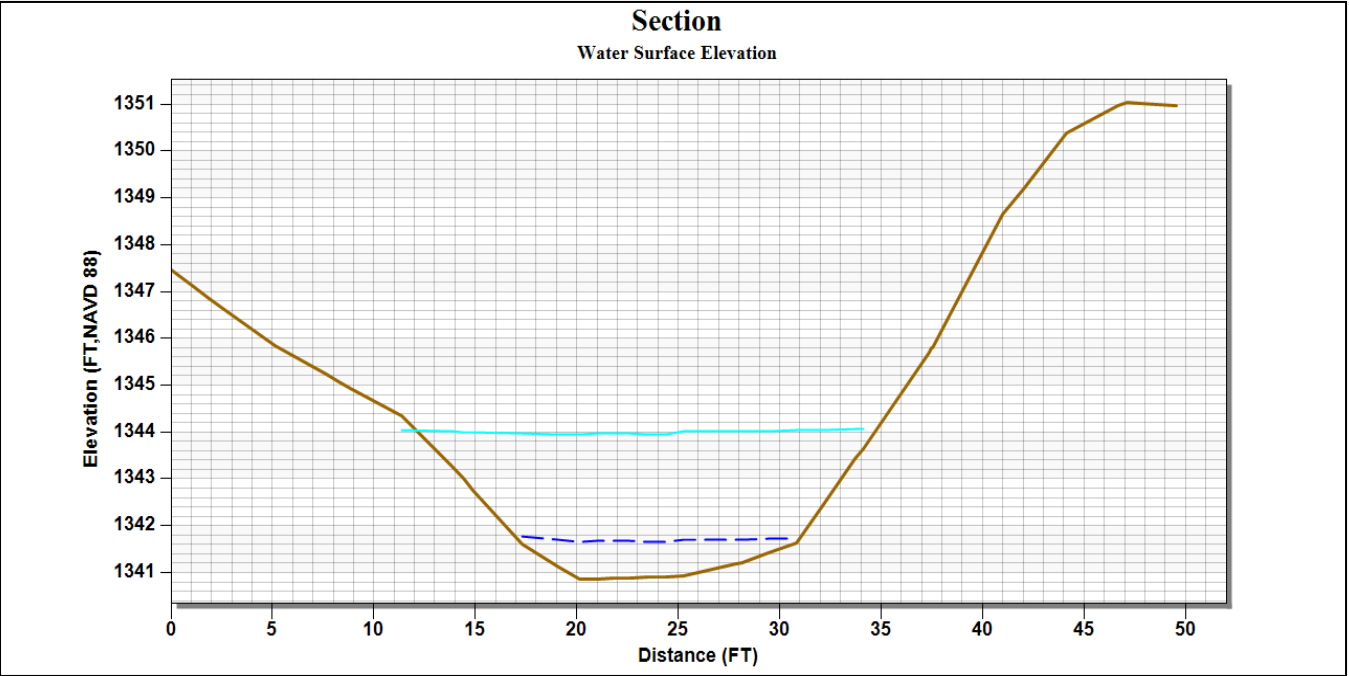
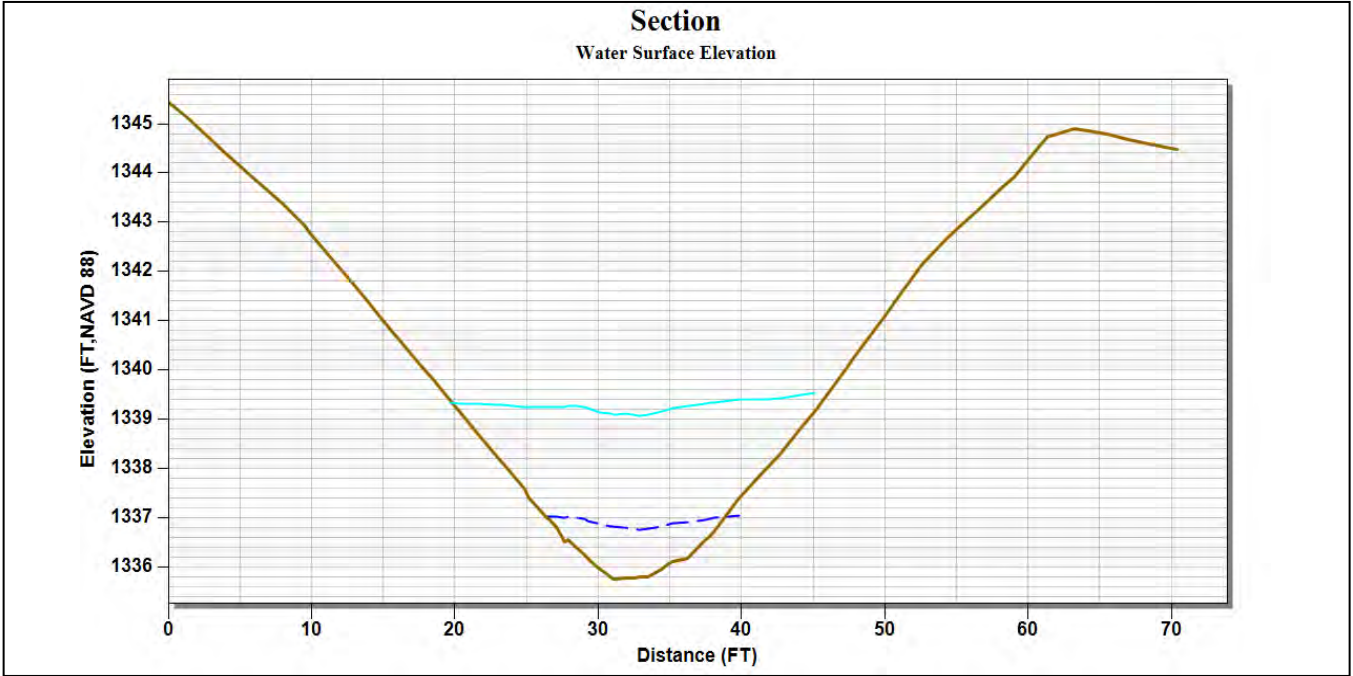
Proposed Conditions 2-year and 100-year Water Surface Elevations at Upstream Cross Sections	
Cougar Creek Fish Passage Barrier Asotin County, Washington	
GEOENGINEERS	Figure C-8

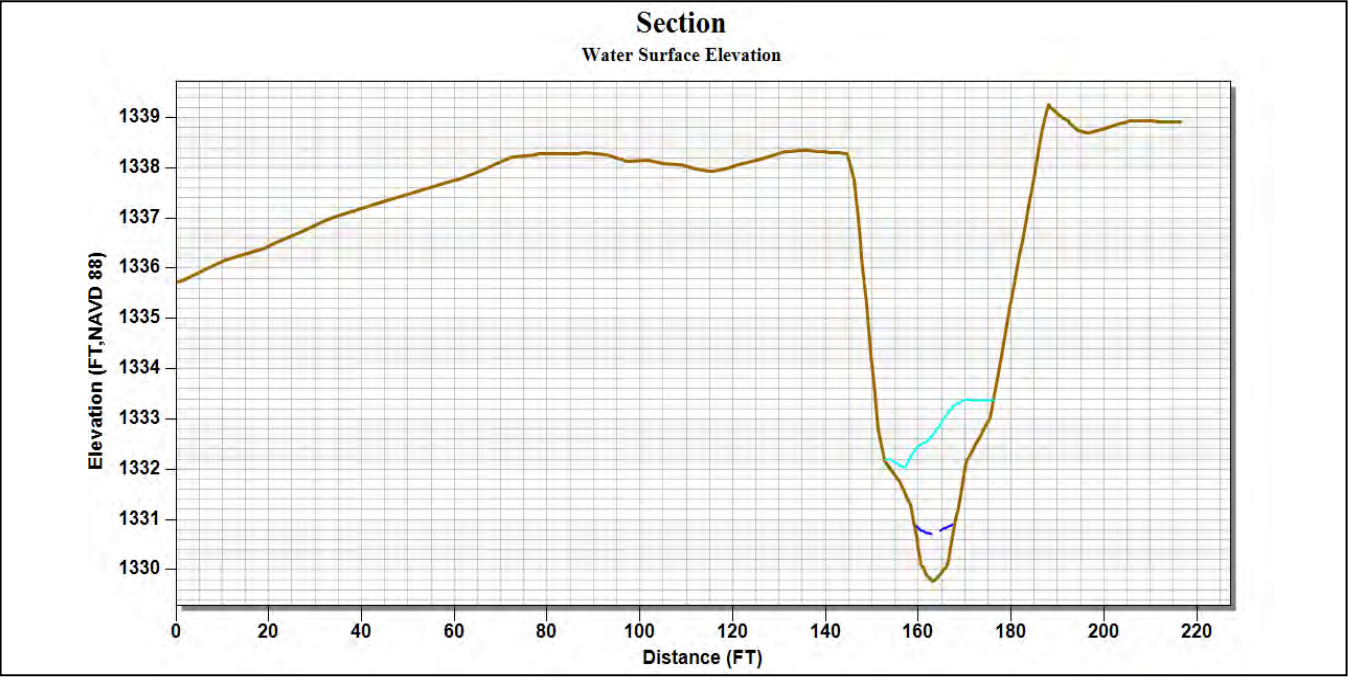
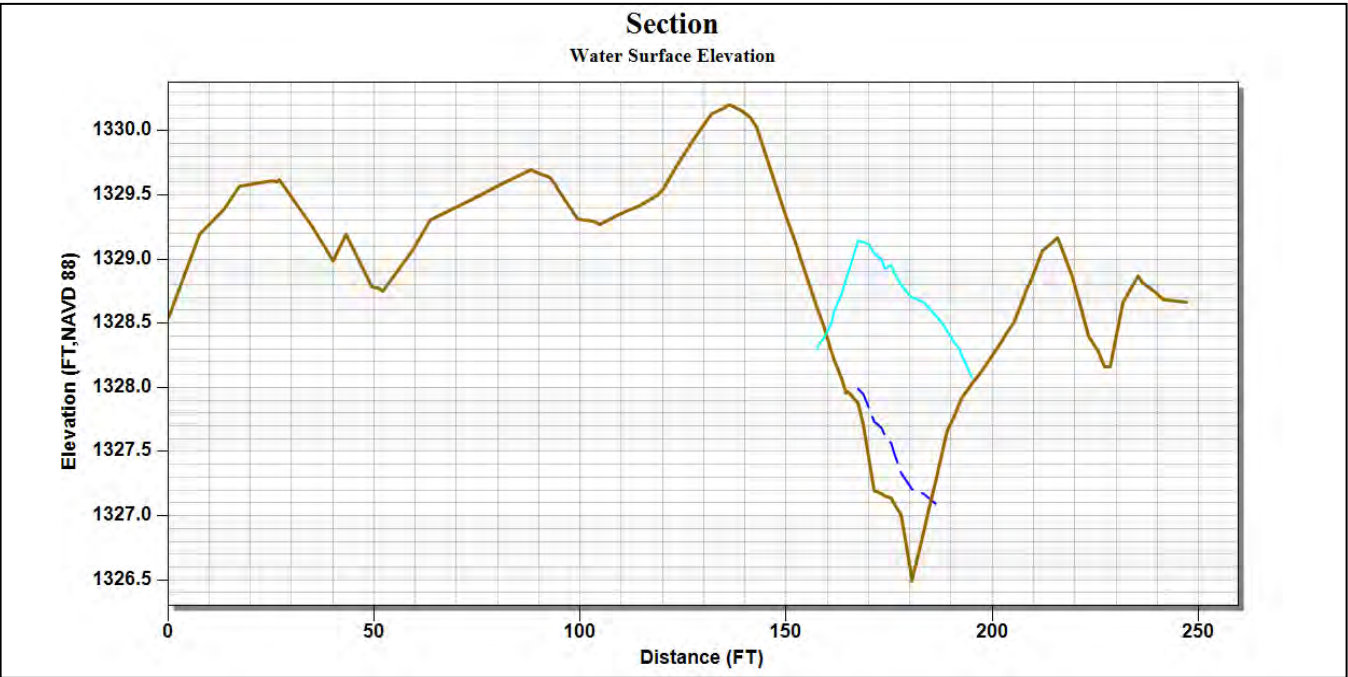
Figure C-9

Proposed Conditions 2-year and 100-year Water Surface Elevation at Downstream Cross Sections	
Cougar Creek Fish Passage Barrier Asotin County, Washington

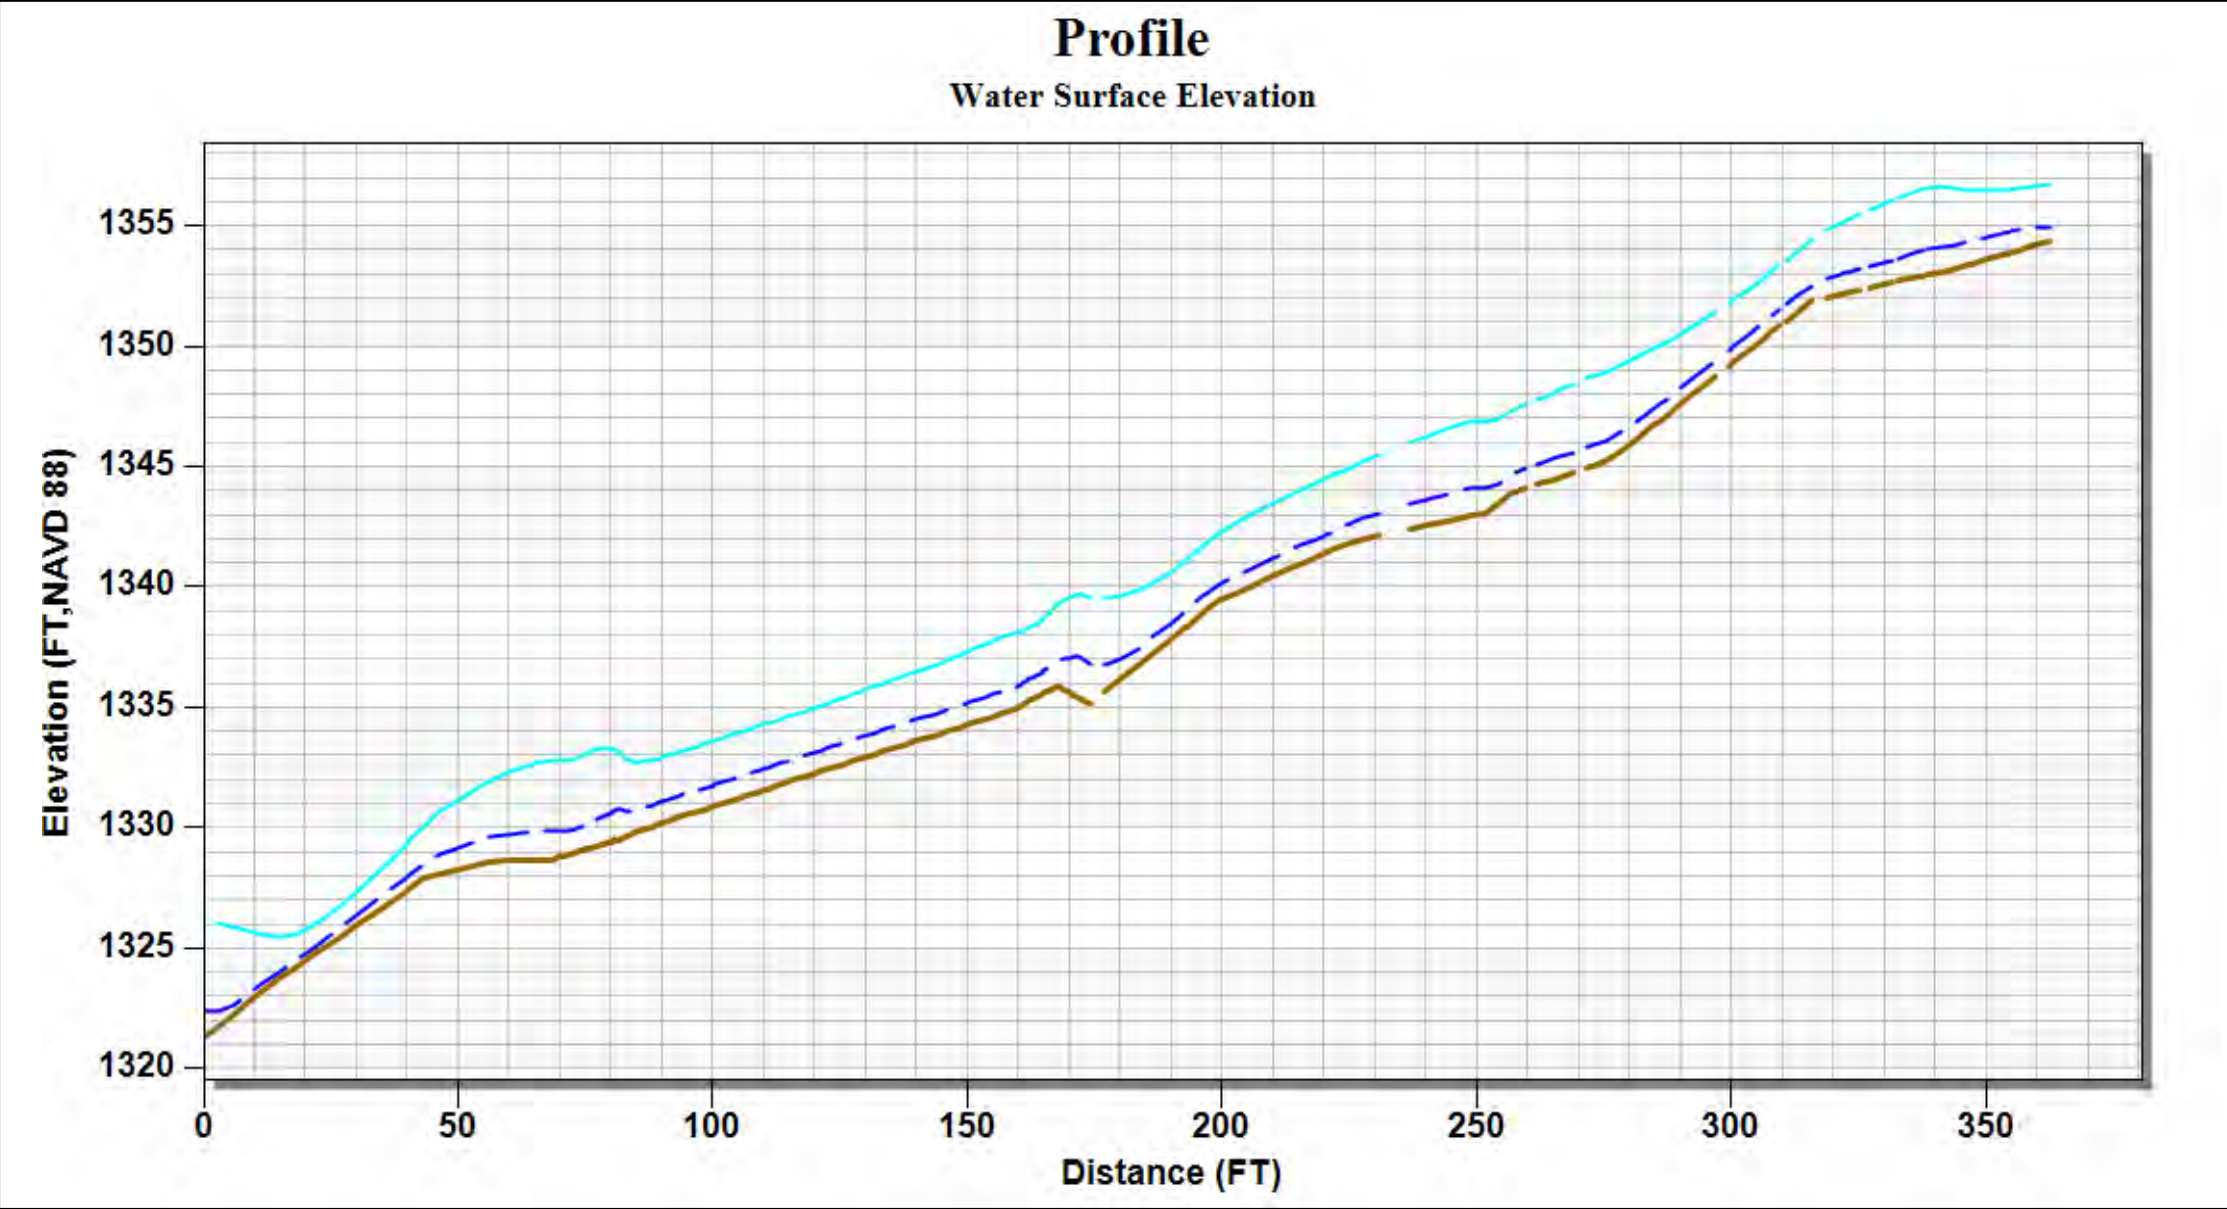
Figure C-10

Proposed Conditions 2-year and 100-year Water Surface Elevation Profiles	
Cougar Creek Fish Passage Barrier Asotin County, Washington

The longitudinal slope through the culvert was designed to be 6.9 percent to mimic the reference reach slope upstream of the culvert and maintain fish passage and material passage through the crossing (BPA 2021). Maintaining a channel slope within 25 percent of the reference channel slope is recommended to maintain geomorphic processes through the crossing (R. Barnard, et al. 2013). Based on those criteria, the minimum allowable slope is 5.2 percent, and the maximum allowable slope is 8.6 percent. Because the culvert slope is equal to 6.9 percent, the measurements will indicate variations from the baseline condition. To calculate the variation in longitudinal slope, use the vertical clearance monitoring measurements and divide the difference by the culvert length of 50 feet. The slope calculated by dividing the difference the upstream and downstream measurements shall be either added or subtracted from 6.9 percent to document longitudinal slope.

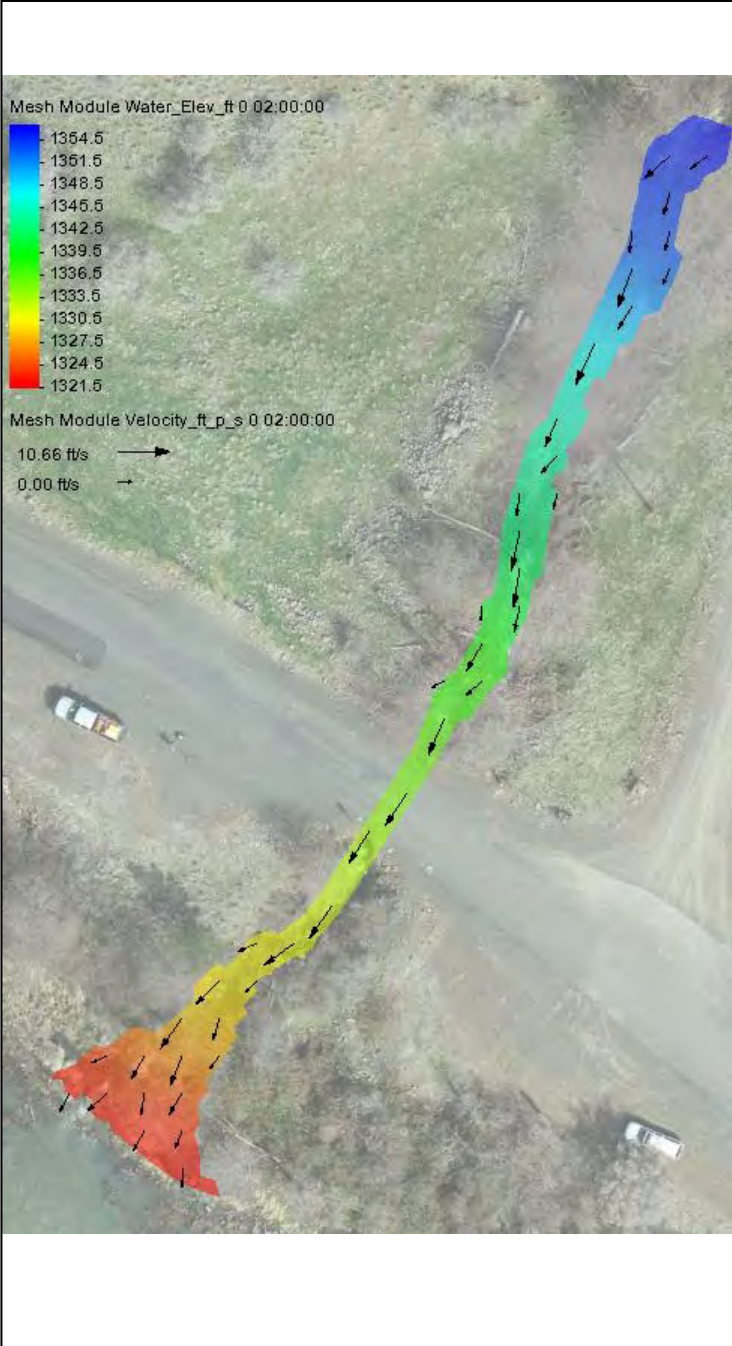
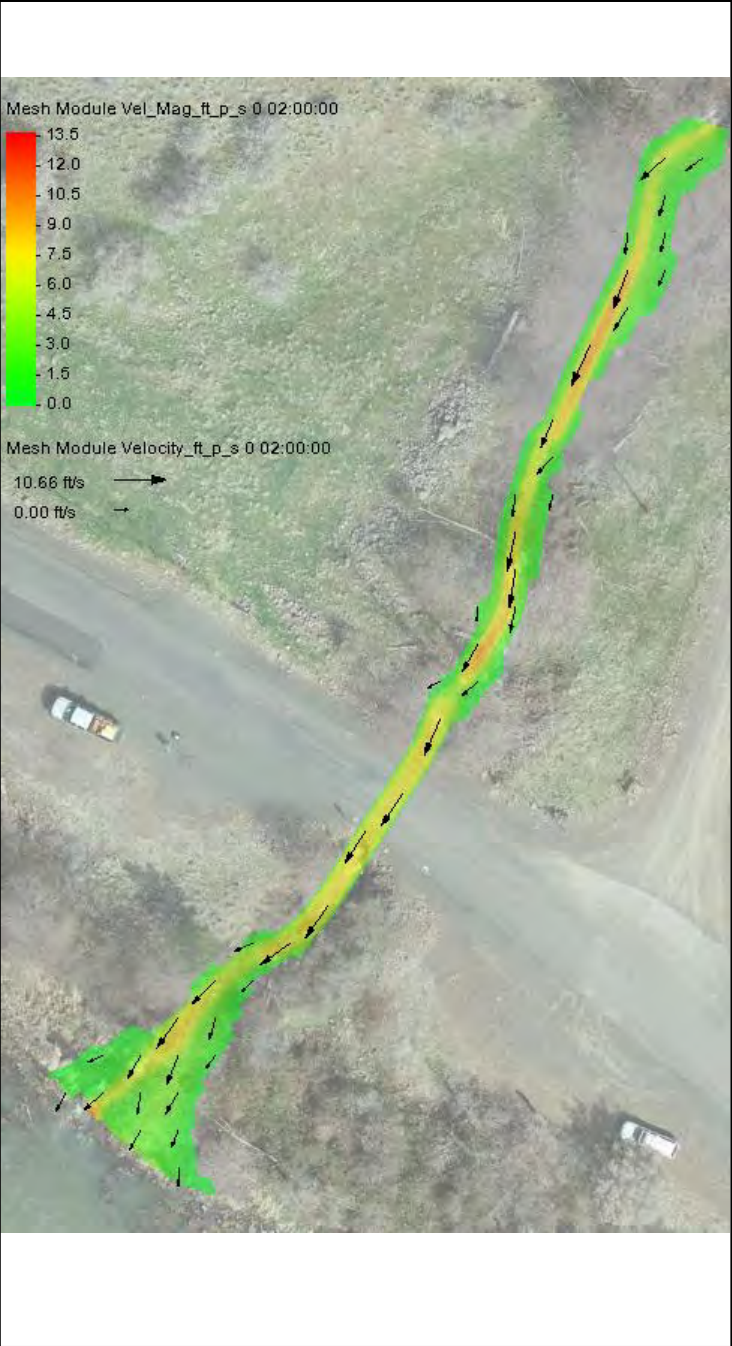
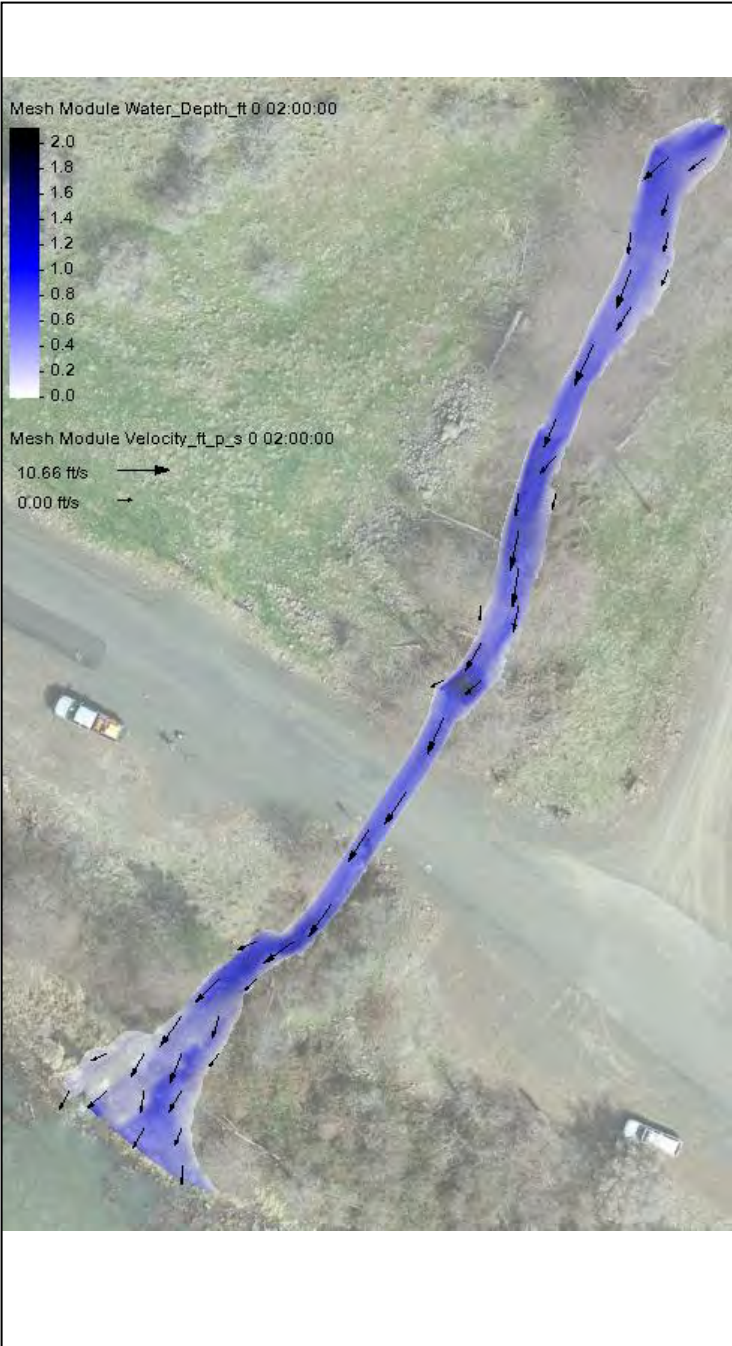
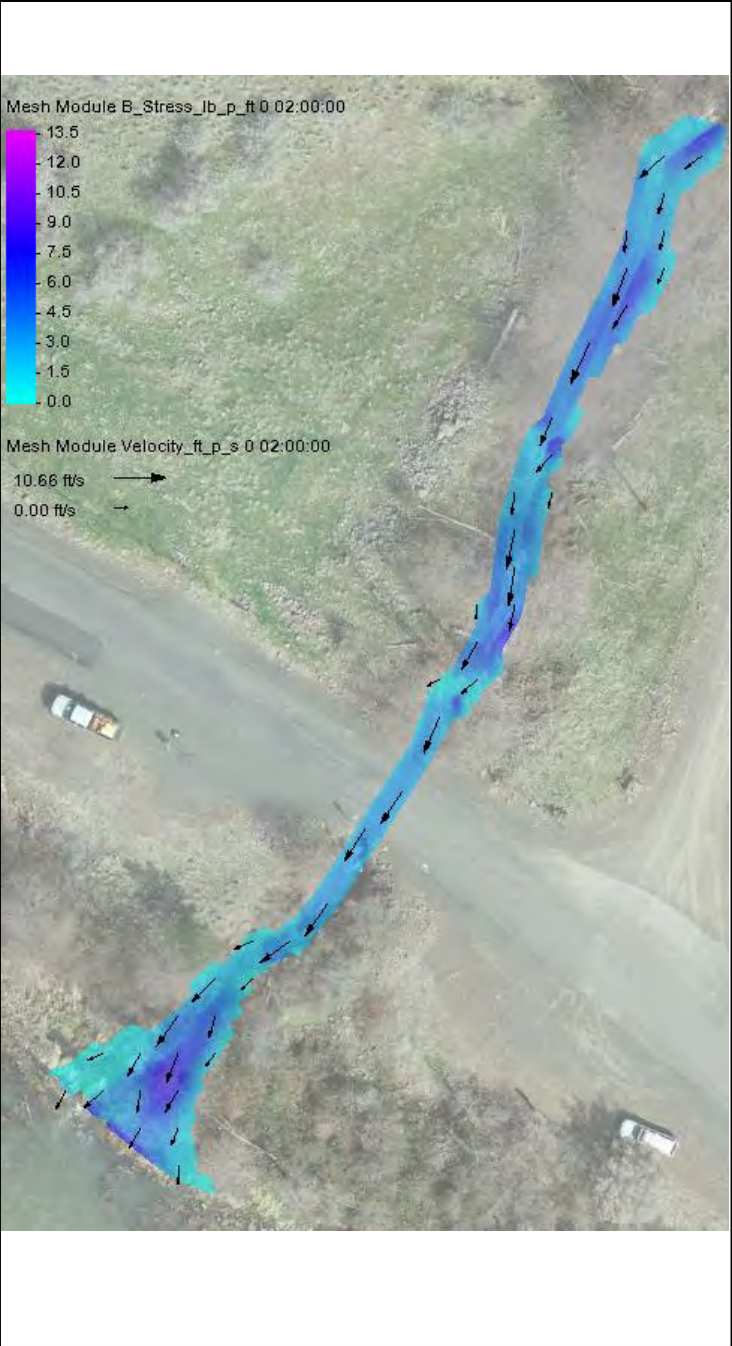
Figure C-11

Proposed Conditions Plan Views  
2-year Flow (36 cfs)

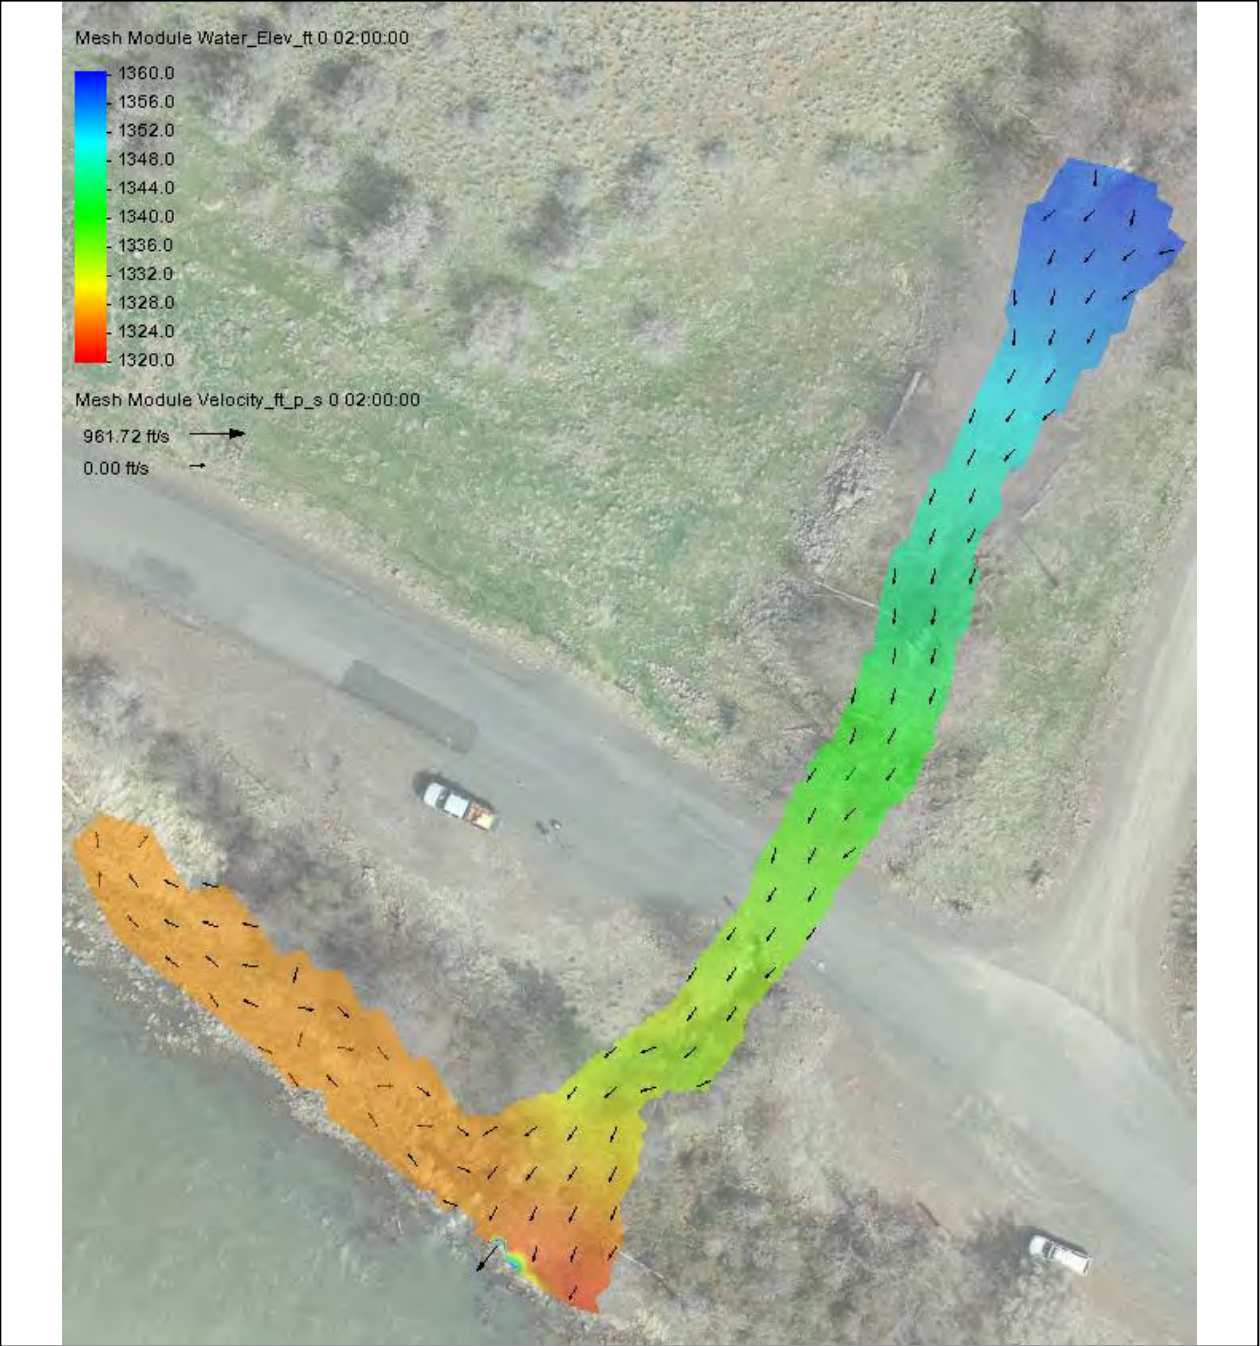
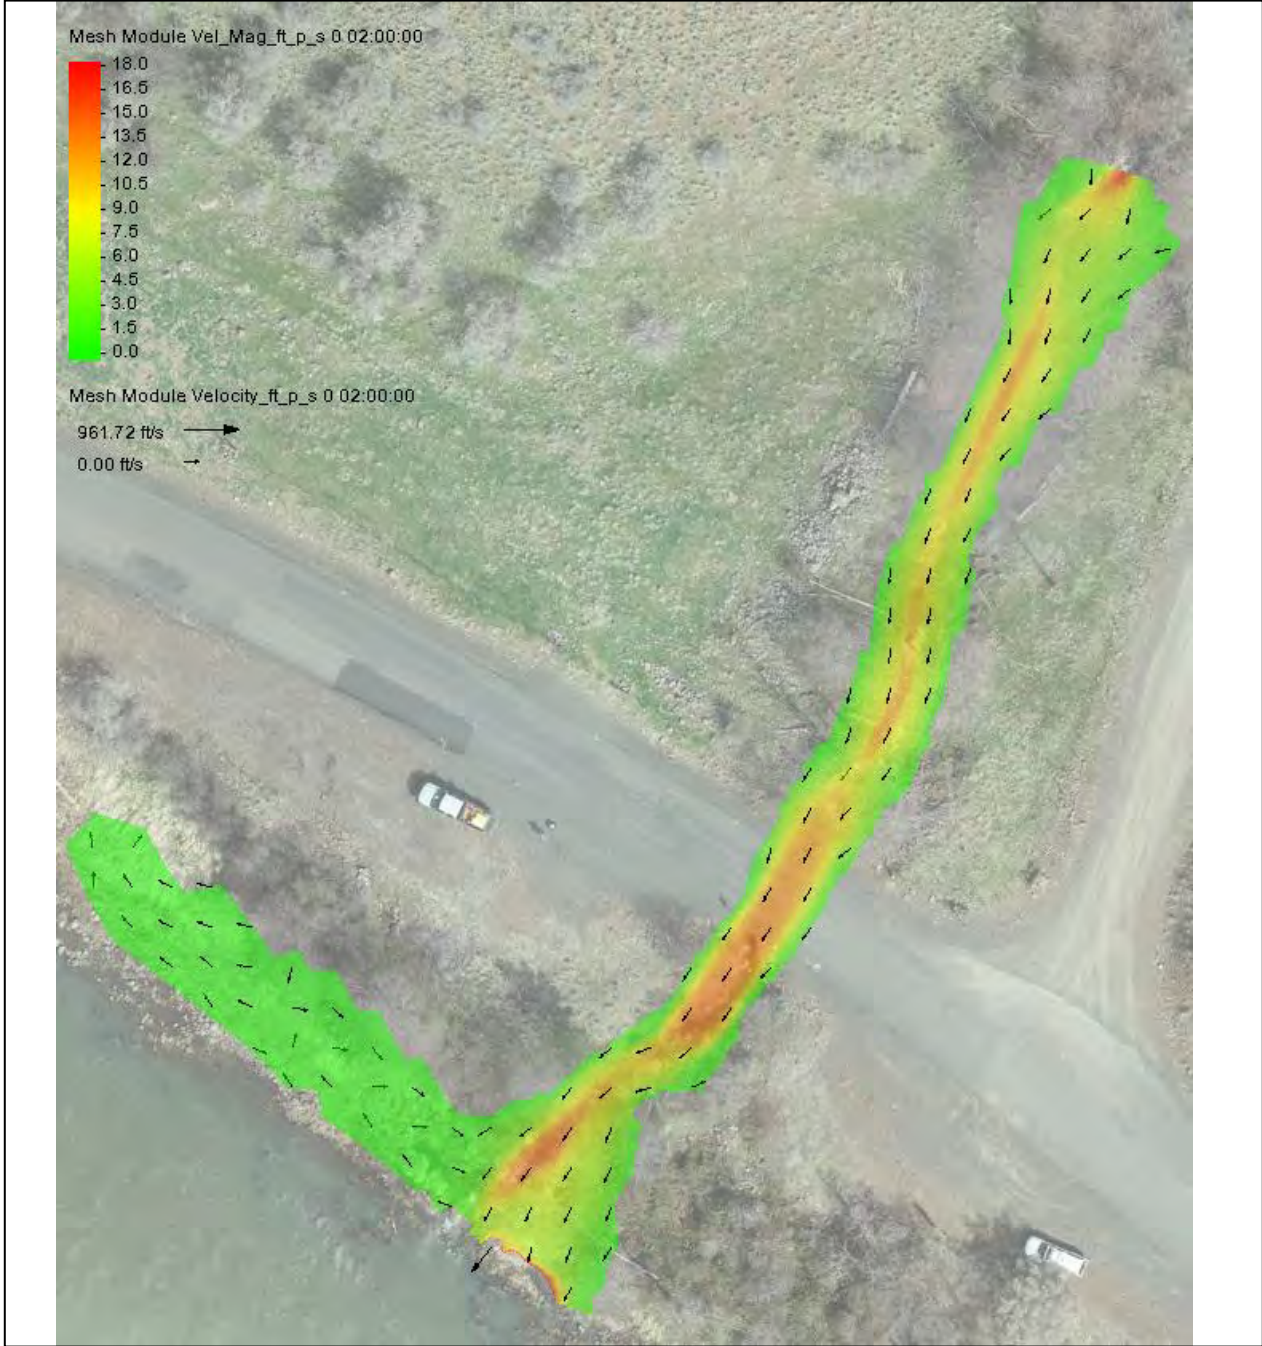
Proposed Conditions Plan Views 100-year Flow (355 cfs)	
Cougar Creek Fish Passage Barrier Asotin County, Washington	
GEOENGINEERS	Figure C-12

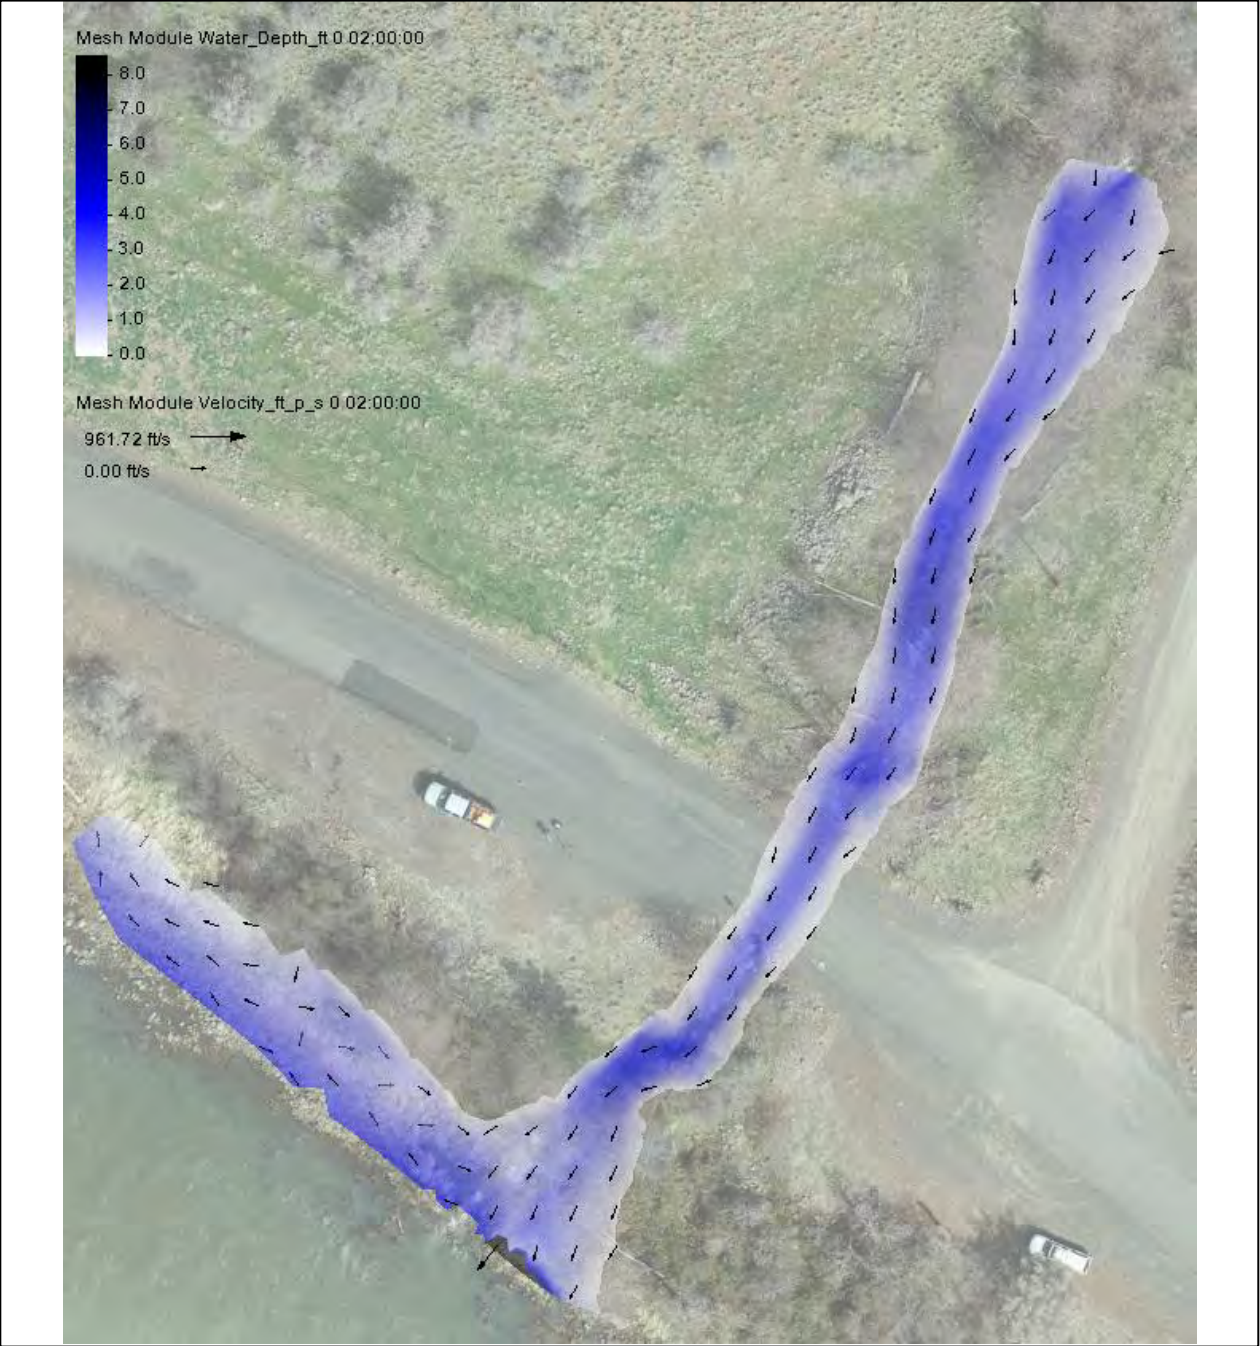
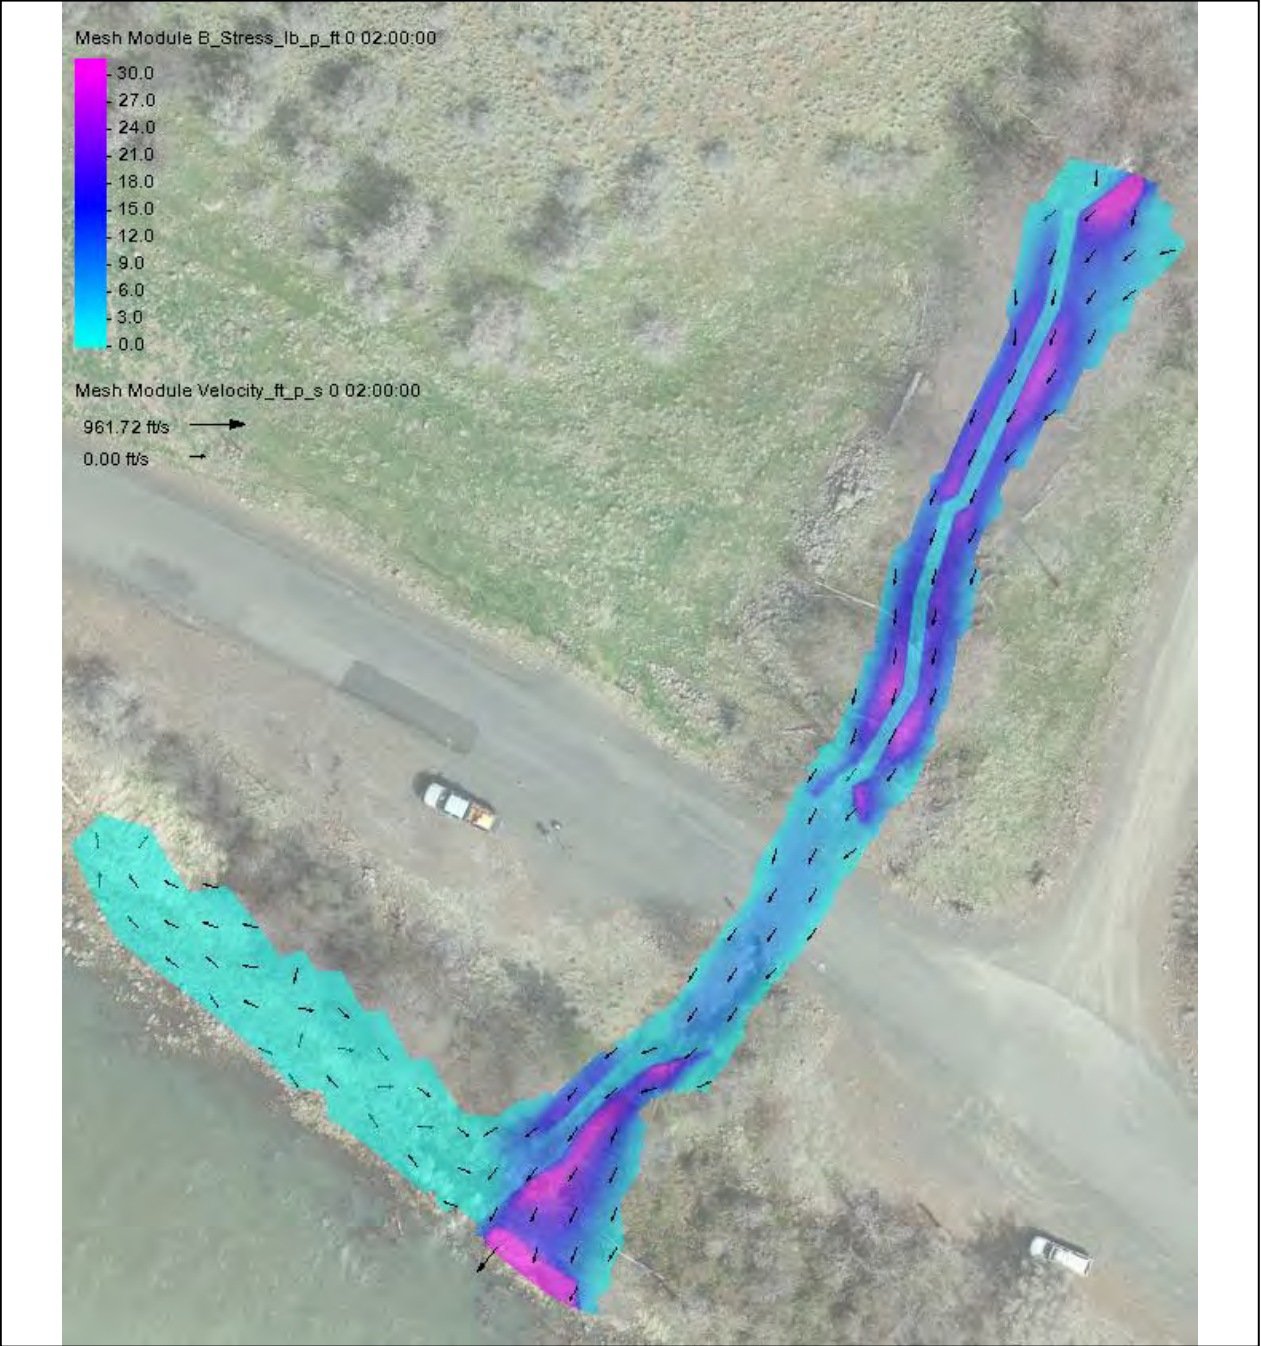
Proposed Conditions Plan Views 100-year Event (355 cfs)	
Cougar Creek Fish Passage Barrier Asotin County, Washington	
GEOENGINEERS	Figure C-13

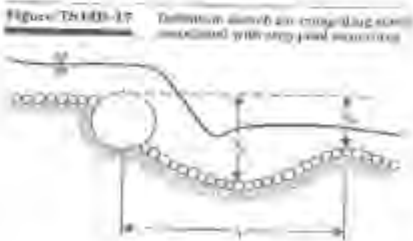
Figure C-17

- The scour equations in this workbook apply to coarse grained mountain streams (8 streamd in study), originally studied in Colorado.
- Equations and methods are from TS14B, page 23.
- This workbook is intended for English units

Z <sub>s</sub> /W	0.06	
Z <sub>s</sub>	1.5	Depth of scour downstream from structure, (ft), measured from crest of the structure to the lowest point within the scour pool
l <sub>p</sub> /W	0.81	
l <sub>p</sub>	19.5	Length of scour pool, (ft)

### Porous Weir Scour Results

The proposed reconstructed channel will consist of channel-spanning porous weirs. Porous weirs are proposed with a longitudinal spacing of approximately twice the bankfull width to approximately match conditions observed in the reference reach. Hydraulic drop heights are limited to 0.5 feet to provide fish passage (NMFS 2011).
