May 2021
Lower Grande Ronde Basin Habitat Restoration

Geomorphic Assessment and Restoration Prioritization – Final Draft

Prepared for Asotin County Conservation District

Anchor QEA, LLC
1605 Cornwall Avenue
Bellingham, Washington 98225

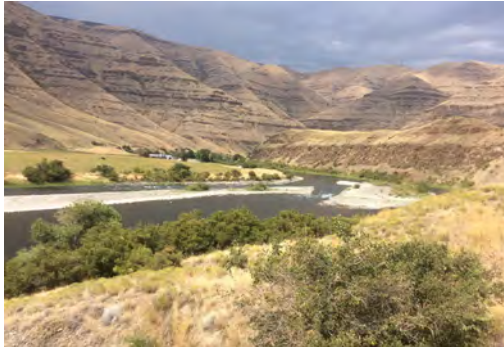
Island Complex RM 3.6-3.9

River Mile Start	3.6
River Mile Stop	3.9
River Length (mi)	0.3
Est. Vegetation and Large Wood	4/5
Promote Complexity/Connectivity	5/5
Summer Water Temperature	1/5
Fish Life Stage Benefit	2/5
Ease of Access	4/5

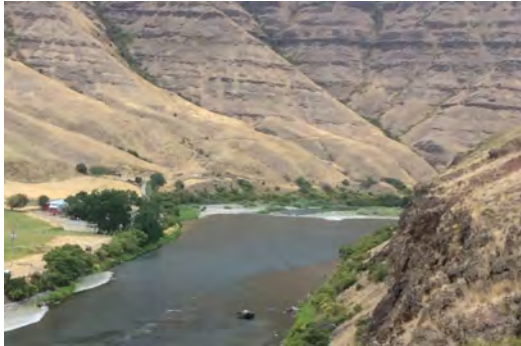
Island Complex RM 3.2-3.3

River Mile Start	3.2
River Mile Stop	3.3
River Length (mi)	0.1
Est. Vegetation and Large Wood	4/5
Promote Complexity/Connectivity	3/5
Summer Water Temperature	1/5
Fish Life Stage Benefit	2/5
Ease of Access	4/5

- Pile field and wood collecting features to stabilize islands and promote split flow
- Riparian planting on islands

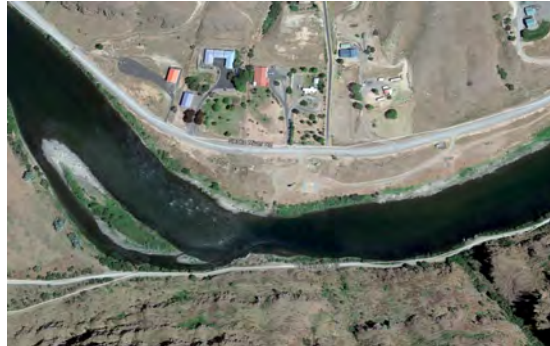
Wild Steelhead Coalition Property

River Mile Start	1.9
River Mile Stop	2.3
River Length (mi)	0.4
Est. Vegetation and Large Wood	3/5
Promote Complexity/Connectivity	2/5
Summer Water Temperature	1/5
Fish Life Stage Benefit	2/5
Ease of Access	5/5

- Wood collecting features to stabilize island and promote split flow
- Riparian planting on islands and left bank

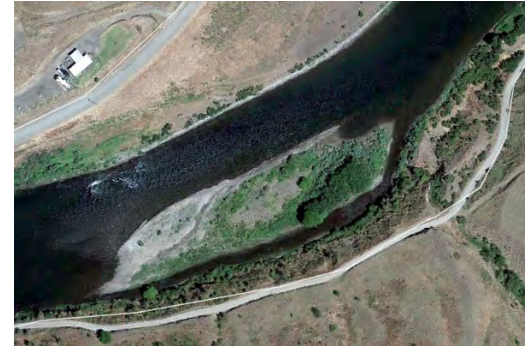
Island RM 1.6-1.7

River Mile Start	1.6
River Mile Stop	1.7
River Length (mi)	0.1
Est. Vegetation and Large Wood	3/5
Promote Complexity/Connectivity	2/5
Summer Water Temperature	1/5
Fish Life Stage Benefit	2/5
Ease of Access	4/5

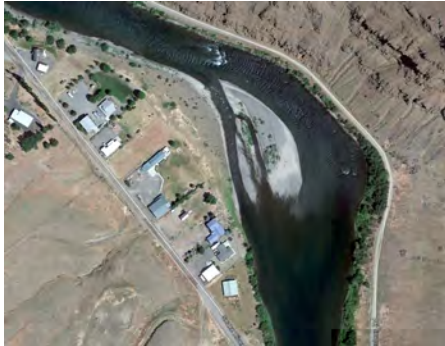
Island RM 0.9-1.0

River Mile Start	0.9
River Mile Stop	1.0
River Length (mi)	0.1
Est. Vegetation and Large Wood	3/5
Promote Complexity/Connectivity	2/5
Summer Water Temperature	1/5
Fish Life Stage Benefit	2/5
Ease of Access	3/5

- Wood collecting features to stabilize and help vegetate island
- LWM to establish channel migration boundary between residences and floodplain

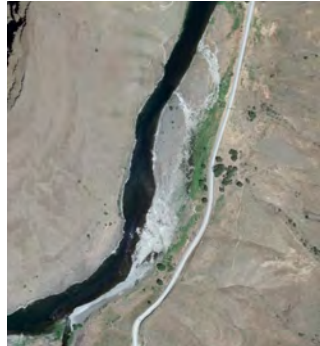
Joseph Creek Beach

River Mile Start	4.0
River Mile Stop	4.4
River Length (mi)	0.4
Est. Vegetation and Large Wood	1/5
Promote Complexity/Connectivity	2/5
Summer Water Temperature	1/5
Fish Life Stage Benefit	2/5
Ease of Access	4/5

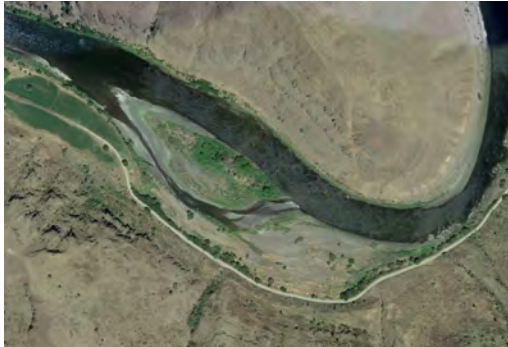
Island RM 6.6-6.9

River Mile Start	6.6
River Mile Stop	6.9
River Length (mi)	0.3
Est. Vegetation and Large Wood	4/5
Promote Complexity/Connectivity	4/5
Summer Water Temperature	1/5
Fish Life Stage Benefit	2/5
Ease of Access	1/5

- Wood collecting feature to promote split flow and stabilize island
- Riparian planting on island
- LWM additions to side channel

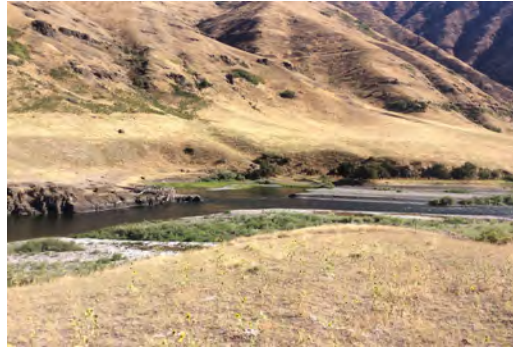
Myers Creek Site

River Mile Start	14.0
River Mile Stop	14.6
River Length (mi)	0.6
Est. Vegetation and Large Wood	3/5
Promote Complexity/Connectivity	3/5
Summer Water Temperature	2/5
Fish Life Stage Benefit	2/5
Ease of Access	3/5

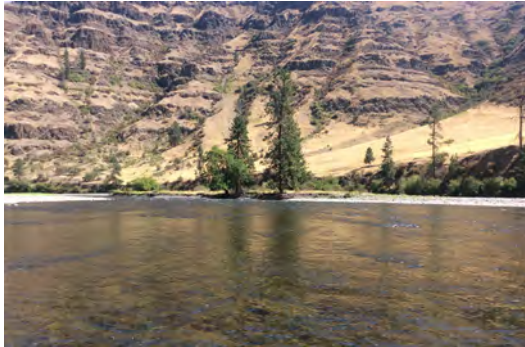
Island RM 8.2-8.4

River Mile Start	8.2
River Mile Stop	8.4
River Length (mi)	0.2
Est. Vegetation and Large Wood	4/5
Promote Complexity/Connectivity	3/5
Summer Water Temperature	1/5
Fish Life Stage Benefit	2/5
Ease of Access	1/5

- Wood collecting features to stabilize island
- Riparian planting on island
- LWM additions to side channel

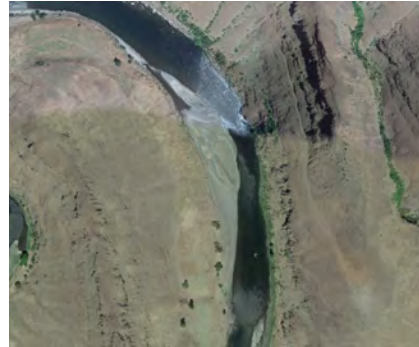
Beach RM 11.9-12.1

River Mile Start	11.9
River Mile Stop	12.1
River Length (mi)	0.2
Est. Vegetation and Large Wood	2/5
Promote Complexity/Connectivity	2/5
Summer Water Temperature	1/5
Fish Life Stage Benefit	2/5
Ease of Access	1/5

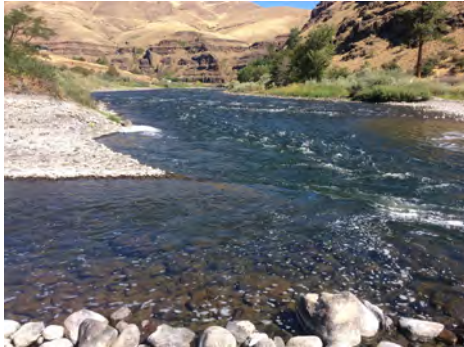
Buford Creek Mouth and Island

River Mile Start	25.9
River Mile Stop	26.3
River Length (mi)	0.4
Est. Vegetation and Large Wood	4/5
Promote Complexity/Connectivity	4/5
Summer Water Temperature	3/5
Fish Life Stage Benefit	3/5
Ease of Access	4/5

- Wood collecting features to stabilize island and promote split flow
- Improve tributary fish passage connection
- Riparian planting on islands

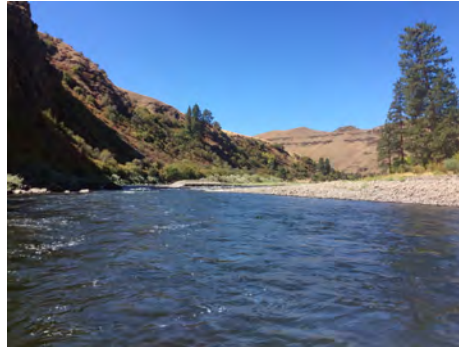
Island Complex RM 24.5-24.6

River Mile Start	24.5
River Mile Stop	24.6
River Length (mi)	0.1
Est. Vegetation and Large Wood	4/5
Promote Complexity/Connectivity	4/5
Summer Water Temperature	3/5
Fish Life Stage Benefit	3/5
Ease of Access	3/5

- Pile field to stabilize islands and promote establishment of vegetation
- Riparian planting on islands

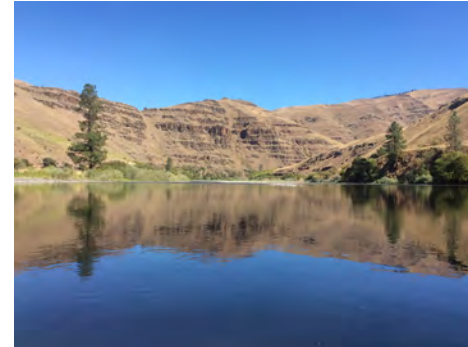
Island Complex RM 25.1-25.4

River Mile Start	25.1
River Mile Stop	25.4
River Length (mi)	0.3
Est. Vegetation and Large Wood	3/5
Promote Complexity/Connectivity	4/5
Summer Water Temperature	3/5
Fish Life Stage Benefit	3/5
Ease of Access	4/5

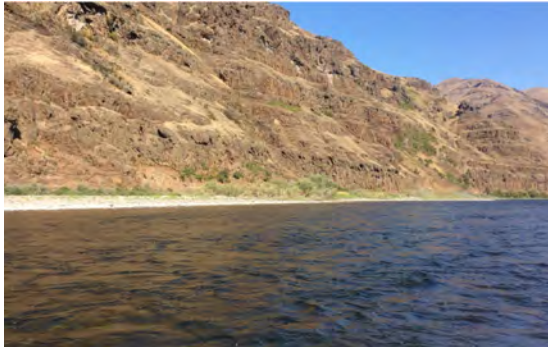
Island RM 17.0-17.2

River Mile Start	17.0
River Mile Stop	17.2
River Length (mi)	0.2
Est. Vegetation and Large Wood	2/5
Promote Complexity/Connectivity	2/5
Summer Water Temperature	2/5
Fish Life Stage Benefit	2/5
Ease of Access	3/5

- Wood collection feature on island
- Riparian planting on island
- LWM along road bank to provide cover

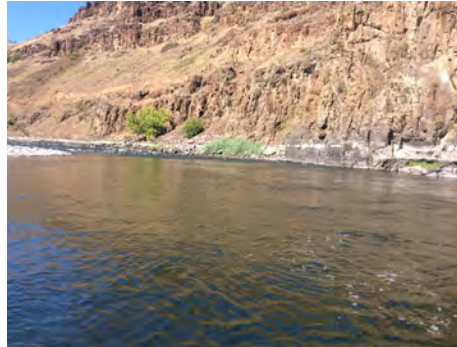
Shumaker Take Out Gravel Bar

River Mile Start	17.7
River Mile Stop	18.0
River Length (mi)	0.3
Est. Vegetation and Large Wood	2/5
Promote Complexity/Connectivity	2/5
Summer Water Temperature	2/5
Fish Life Stage Benefit	2/5
Ease of Access	3/5

- Wood collecting features to promote split flow and help vegetate gravel bars
- Riparian planting

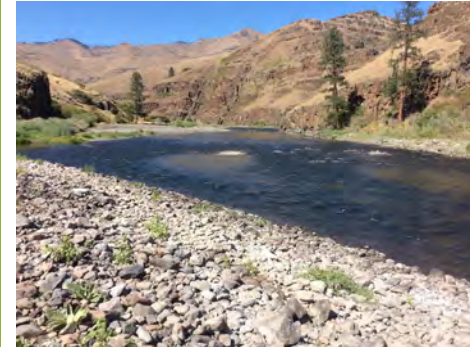
Deer Creek Mouth and Bar

River Mile Start	19.5
River Mile Stop	19.7
River Length (mi)	0.2
Est. Vegetation and Large Wood	3/5
Promote Complexity/Connectivity	3/5
Summer Water Temperature	2/5
Fish Life Stage Benefit	2/5
Ease of Access	1/5

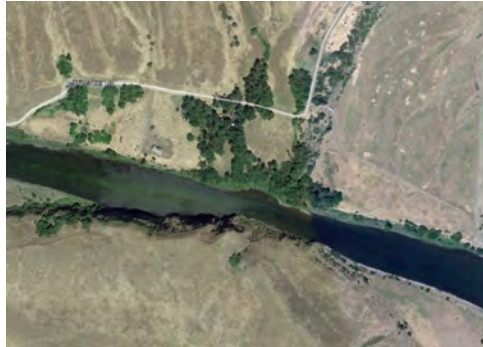
Shumaker Creek Mouth

River Mile Start	15.8
River Mile Stop	15.9
River Length (mi)	0.1
Est. Vegetation and Large Wood	2/5
Promote Complexity/Connectivity	1/5
Summer Water Temperature	2/5
Fish Life Stage Benefit	2/5
Ease of Access	3/5

- Improve tributary fish passage connection
- Wood collecting features along left bank to promote flow structure complexity

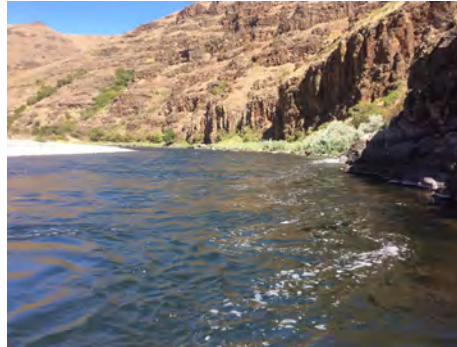
Gravel Bar RM 23.9-24.1

River Mile Start	23.9
River Mile Stop	24.1
River Length (mi)	0.2
Est. Vegetation and Large Wood	2/5
Promote Complexity/Connectivity	1/5
Summer Water Temperature	3/5
Fish Life Stage Benefit	3/5
Ease of Access	1/5

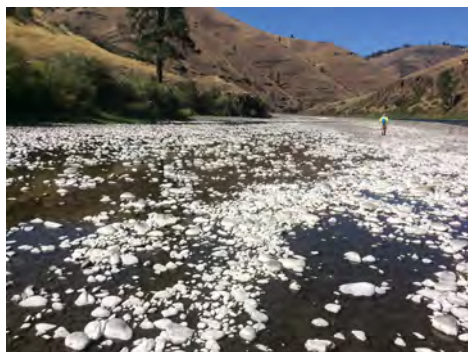
Gravel Bar RM 36.7-36.9

River Mile Start	36.7
River Mile Stop	36.9
River Length (mi)	0.2
Est. Vegetation and Large Wood	3/5
Promote Complexity/Connectivity	4/5
Summer Water Temperature	4/5
Fish Life Stage Benefit	5/5
Ease of Access	4/5

- Wood collecting features to promote aggradation and develop a vegetated island
- Riparian planting

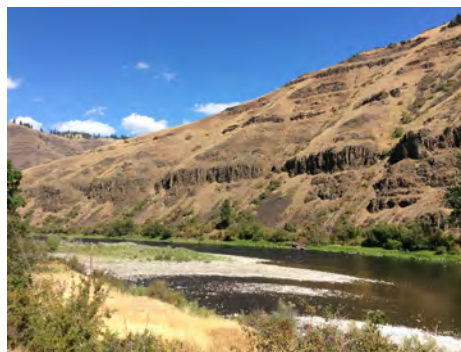
4-0 Land and Livestock Ranch and Island

River Mile Start	34.9
River Mile Stop	35.2
River Length (mi)	0.3
Est. Vegetation and Large Wood	3/5
Promote Complexity/Connectivity	4/5
Summer Water Temperature	4/5
Fish Life Stage Benefit	5/5
Ease of Access	3/5

- Wood collecting feature to promote island aggradation and help develop vegetation
- LWM for bank stabilization along left bank and establishment of channel migration boundary

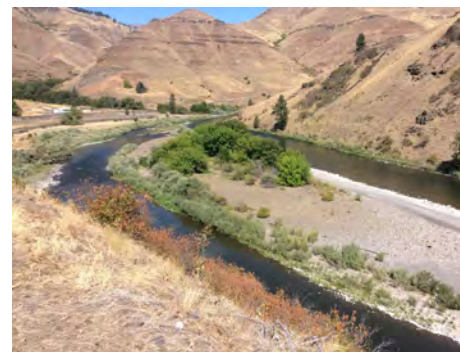
Cottonwood Creek Mouth

River Mile Start	28.9
River Mile Stop	29.2
River Length (mi)	0.3
Est. Vegetation and Large Wood	3/5
Promote Complexity/Connectivity	3/5
Summer Water Temperature	4/5
Fish Life Stage Benefit	4/5
Ease of Access	4/5

- Pile field to help vegetate islands
- Wood collecting features in side channel to help engage left floodplain
- Culvert replacement at creek mouth

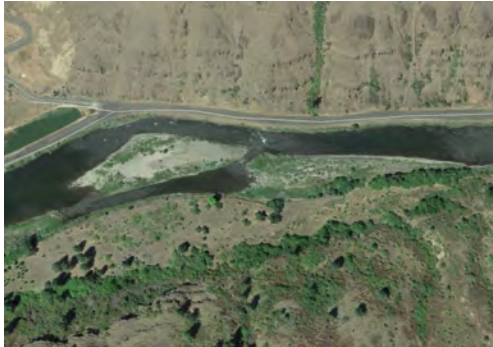
Island RM 29.9-30.1

River Mile Start	29.9
River Mile Stop	30.1
River Length (mi)	0.2
Est. Vegetation and Large Wood	2/5
Promote Complexity/Connectivity	3/5
Summer Water Temperature	4/5
Fish Life Stage Benefit	4/5
Ease of Access	4/5

- Wood collecting feature to promote aggradation and establishment of riparian trees
- LWM along left bank road to provide stabilization and habitat structure

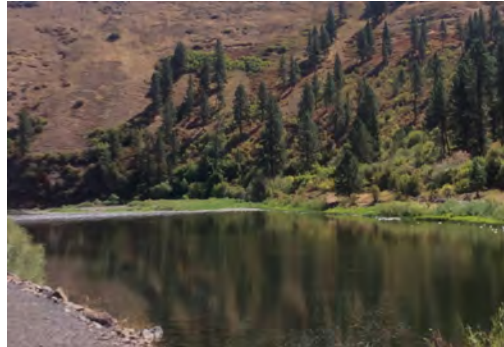
Beach RM 31.9-32.1

River Mile Start	31.9
River Mile Stop	32.1
River Length (mi)	0.2
Est. Vegetation and Large Wood	2/5
Promote Complexity/Connectivity	2/5
Summer Water Temperature	4/5
Fish Life Stage Benefit	4/5
Ease of Access	4/5

- Wood collecting features to promote split flow into right high flow channel
- Riparian planting

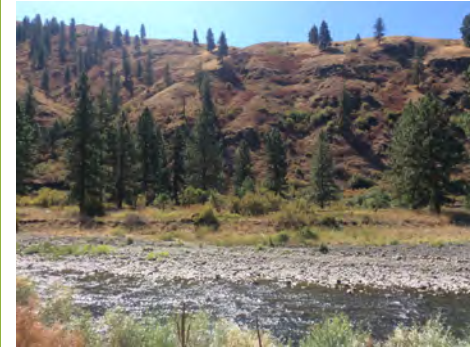
McNeill Island RM 33.5-33.6

River Mile Start	33.5
River Mile Stop	33.6
River Length (mi)	0.1
Est. Vegetation and Large Wood	2/5
Promote Complexity/Connectivity	2/5
Summer Water Temperature	4/5
Fish Life Stage Benefit	4/5
Ease of Access	4/5

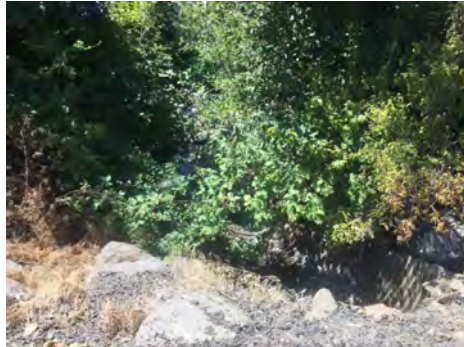
Cougar Creek Mouth

River Mile Start	30.9
River Mile Stop	31.0
River Length (mi)	0.1
Est. Vegetation and Large Wood	2/5
Promote Complexity/Connectivity	1/5
Summer Water Temperature	4/5
Fish Life Stage Benefit	4/5
Ease of Access	4/5

- Replace culvert to improve fish passage
- LWM to help engage floodplain on both banks

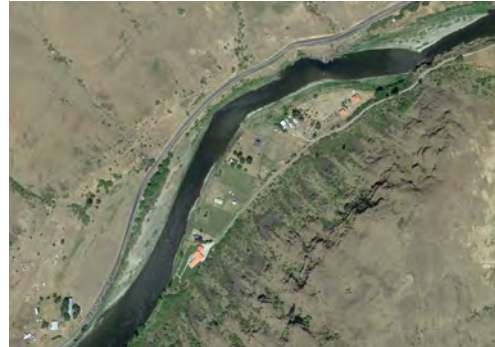
Beach RM 27.0-27.3

River Mile Start	27.0
River Mile Stop	27.3
River Length (mi)	0.3
Est. Vegetation and Large Wood	2/5
Promote Complexity/Connectivity	2/5
Summer Water Temperature	3/5
Fish Life Stage Benefit	4/5
Ease of Access	3/5

- LWM along right bank to establish channel migration boundary between residences and floodplain
- Remove or set back levees where applicable

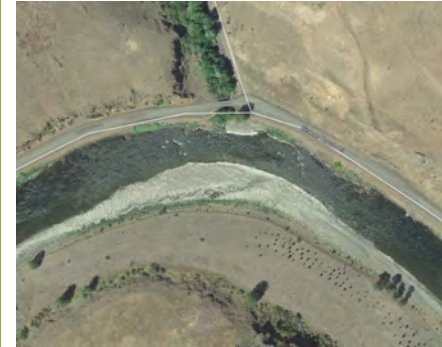
Menatchee Creek Mouth

River Mile Start	36.2
River Mile Stop	36.3
River Length (mi)	0.1
Est. Vegetation and Large Wood	2/5
Promote Complexity/Connectivity	1/5
Summer Water Temperature	4/5
Fish Life Stage Benefit	4/5
Ease of Access	4/5

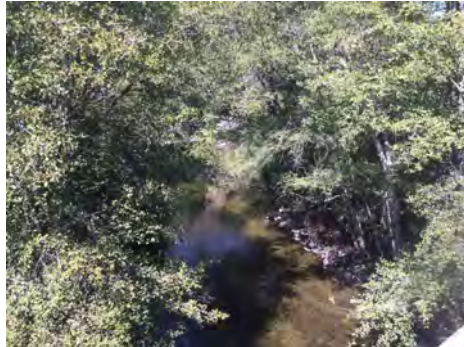
Project Area JC-2

River Length (mi)	0.75
Valley Length (mi)	0.73
Sinuosity	1.02
Average Slope	0.92%
Total Levee Length (mi)	0.94
Road/Encroachment Length (mi)	0.09
Bank Incision Length (mi)	0.61
Restore Connectivity Score	5/5
Add Complexity Score	5/5

- Remove or breach levees through RM 1.4 to 2.0
- Pilot cuts to reconnect right side channels
- ELJs to promote split flow and deposition

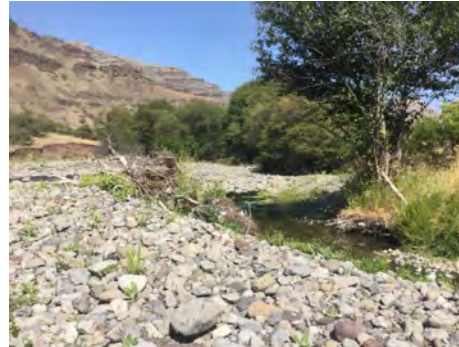
Project Area JC-3

River Length (mi)	1.07
Valley Length (mi)	1.02
Sinuosity	1.04
Average Slope	0.90%
Total Levee Length (mi)	0.59
Road/Encroachment Length (mi)	0.59
Bank Incision Length (mi)	1.46
Restore Connectivity Score	4/5
Add Complexity Score	5/5

- Remove or breach levees through RM 2.1 to 2.6
- ELJs to promote floodplain connectivity and help vegetate large gravel bars

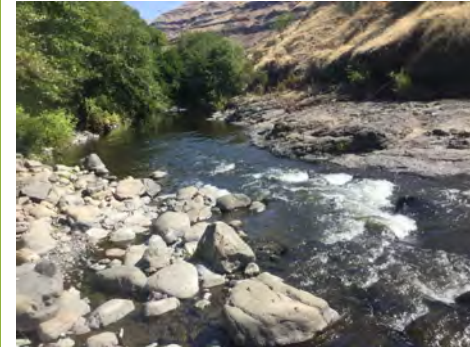
Project Area JC-5

River Length (mi)	0.56
Valley Length (mi)	0.54
Sinuosity	1.04
Average Slope	0.91%
Total Levee Length (mi)	0.08
Road/Encroachment Length (mi)	0.19
Bank Incision Length (mi)	0.66
Restore Connectivity Score	4/5
Add Complexity Score	3/5

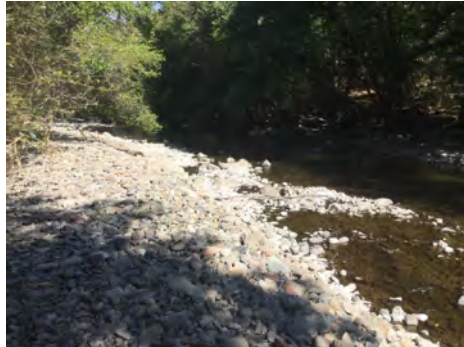
Project Area JC-4

River Length (mi)	0.84
Valley Length (mi)	0.66
Sinuosity	1.27
Average Slope	0.83%
Total Levee Length (mi)	0.06
Road/Encroachment Length (mi)	0.00
Bank Incision Length (mi)	0.73
Restore Connectivity Score	4/5
Add Complexity Score	2/5

- ELJs to promote split flow and help vegetate large gravel bars
- Remove levees RM 3.4 to 3.6

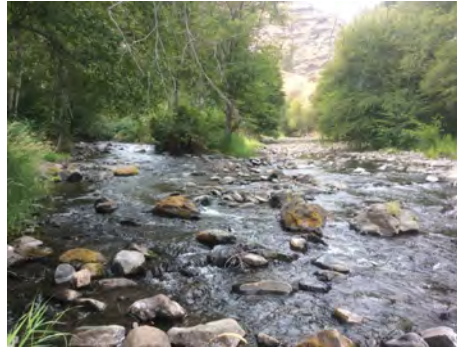
Project Area JC-6

River Length (mi)	1.07
Valley Length (mi)	1.05
Sinuosity	1.01
Average Slope	1.12%
Total Levee Length (mi)	0.04
Road/Encroachment Length (mi)	0.38
Bank Incision Length (mi)	0.66
Restore Connectivity Score	2/5
Add Complexity Score	3/5

found at RM 5.0, and multiple natural log jams occurred in this portion of project area JC-6. These jams were contributing to pool formation. Most of this section was shaded by trees, and pool density was much greater than in the lower section. Evidence of flood water levels in the form of woody material and twigs was observed in floodplain high-flow channels, but these channels were dry during low flow.

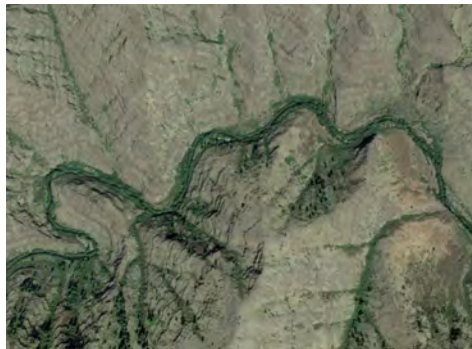
Project Area JC-7

River Length (mi)	1.38
Valley Length (mi)	1.31
Sinuosity	1.05
Average Slope	1.08%
Total Levee Length (mi)	0.00
Road/Encroachment Length (mi)	0.00
Bank Incision Length (mi)	0.36
Restore Connectivity Score	1/5
Add Complexity Score	2/5

- ELJs to promote complexity and sediment deposition

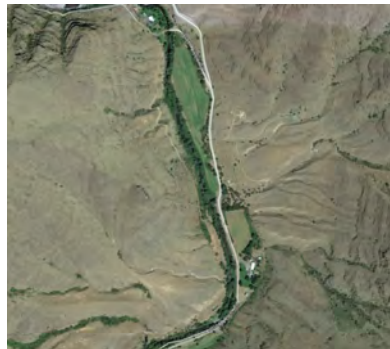
Project Area JC-1

River Length (mi)	1.20
Valley Length (mi)	1.16
Sinuosity	1.03
Average Slope	1.23%
Total Levee Length (mi)	0.50
Road/Encroachment Length (mi)	0.40
Bank Incision Length (mi)	0.90
Restore Connectivity Score	1/5
Add Complexity Score	1/5

- ELJs to promote sinuosity and pool formation
- Remove or breach levees through RM 0.6 to 0.8
- Blackberry removal and riparian planting

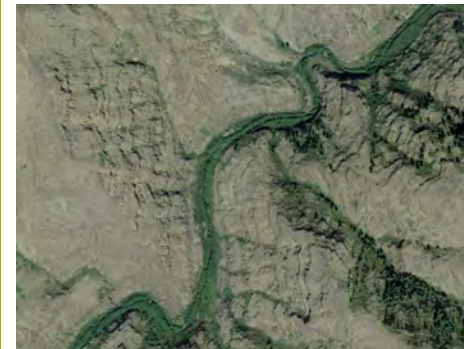
Project Area JC-8

River Length (mi)	1.59
Valley Length (mi)	1.49
Sinuosity	1.06
Average Slope	1.10%
Total Levee Length (mi)	0.00
Road/Encroachment Length (mi)	0.00
Bank Incision Length (mi)	0.29
Restore Connectivity Score	1/5
Add Complexity Score	1/5

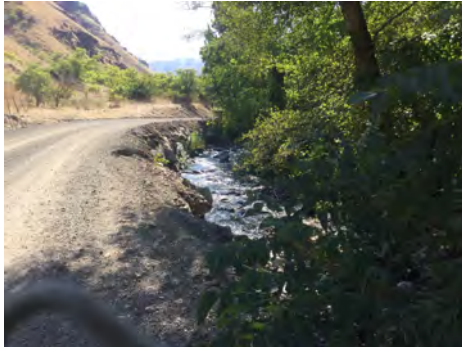
Project Area CJC-1

River Length (mi)	0.62
Valley Length (mi)	0.57
Sinuosity	1.09
Average Slope	2.82%
Total Levee Length (mi)	0.22
Road/Encroachment Length (mi)	0.37
Bank Incision Length (mi)	0.37
Road Setback Score	3/5
Levee Setback Score	2/5
Establish Vegetation Score	1/5
In-Channel Complexity Score	3/5

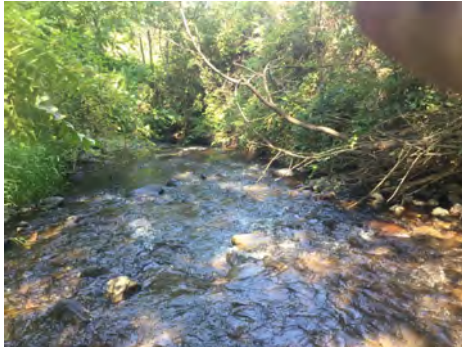
Project Area CJC-2

River Length (mi)	0.31
Valley Length (mi)	0.27
Sinuosity	1.14
Average Slope	2.06%
Total Levee Length (mi)	0.00
Road/Encroachment Length (mi)	0.00
Bank Incision Length (mi)	0.03
Road Setback Score	0/5
Levee Setback Score	0/5
Establish Vegetation Score	1/5
In-Channel Complexity Score	3/5

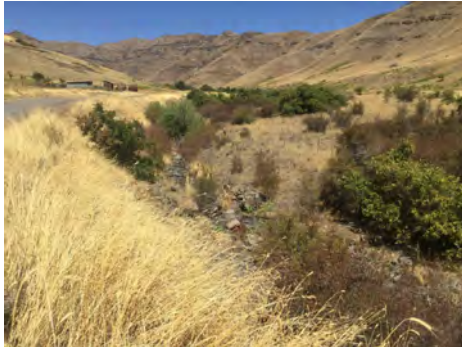
Project Area SC-1

River Length (mi)	0.32
Valley Length (mi)	0.31
Sinuosity	1.03
Average Slope	7.00%
Total Levee Length (mi)	0.31
Road/Encroachment Length (mi)	0.20
Bank Incision Length (mi)	0.30
Road Setback Score	1/5
Levee Setback Score	2/5
Establish Vegetation Score	4/5
In-Channel Complexity Score	3/5

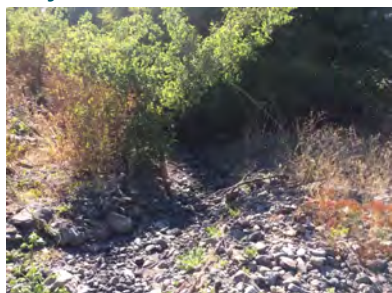
Project Area DC-1

River Length (mi)	0.27
Valley Length (mi)	0.24
Sinuosity	1.11
Average Slope	6.17%
Total Levee Length (mi)	0.03
Road/Encroachment Length (mi)	0.00
Bank Incision Length (mi)	0.15
Road Setback Score	0/5
Levee Setback Score	0/5
Establish Vegetation Score	3/5
In-Channel Complexity Score	3/5

- BDAs or PALS to promote aggradation, complexity, and floodplain water storage
- Create protected inlet to improve fish passage connectivity to mainstem

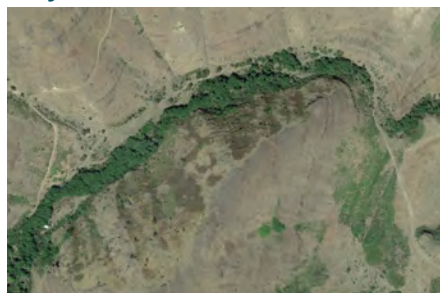
Project Area DC-2

River Length (mi)	0.70
Valley Length (mi)	0.63
Sinuosity	1.11
Average Slope	5.57%
Total Levee Length (mi)	0.12
Road/Encroachment Length (mi)	0.00
Bank Incision Length (mi)	0.13
Road Setback Score	0/5
Levee Setback Score	0/5
Establish Vegetation Score	3/5
In-Channel Complexity Score	3/5

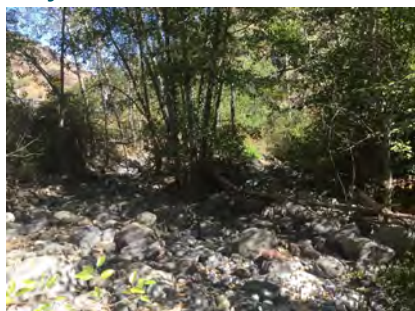
Project Area BC-3

River Length (mi)	1.13
Valley Length (mi)	1.08
Sinuosity	1.05
Average Slope	4.45%
Total Levee Length (mi)	0.30
Road/Encroachment Length (mi)	1.01
Bank Incision Length (mi)	0.87
Road Setback Score	4/5
Levee Setback Score	3/5
Establish Vegetation Score	3/5
In-Channel Complexity Score	4/5

- Remove or breach levees and road through RM 1.5 to 1.6
- ELJs to promote complexity, sediment storage, and pool formation

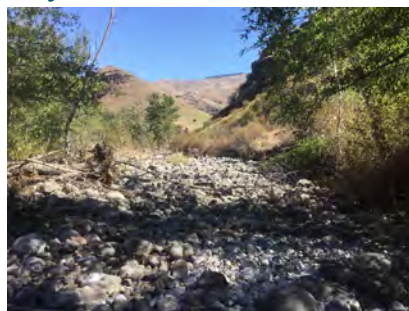
Project Area BC-1

River Length (mi)	0.29
Valley Length (mi)	0.29
Sinuosity	1.02
Average Slope	4.48%
Total Levee Length (mi)	0.06
Road/Encroachment Length (mi)	0.05
Bank Incision Length (mi)	0.20
Road Setback Score	1/5
Levee Setback Score	4/5
Establish Vegetation Score	4/5
In-Channel Complexity Score	3/5

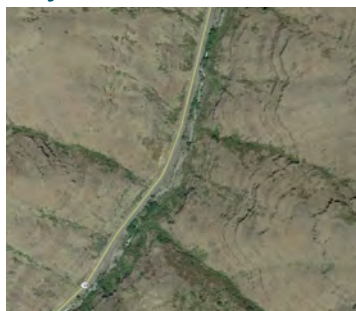
Project Area BC-2

River Length (mi)	0.68
Valley Length (mi)	0.66
Sinuosity	1.03
Average Slope	4.09%
Total Levee Length (mi)	0.00
Road/Encroachment Length (mi)	0.66
Bank Incision Length (mi)	0.39
Road Setback Score	5/5
Levee Setback Score	0/5
Establish Vegetation Score	3/5
In-Channel Complexity Score	4/5

- ELJs to promote aggradation and complexity in incised areas
- Riparian planting in reconnected floodplain

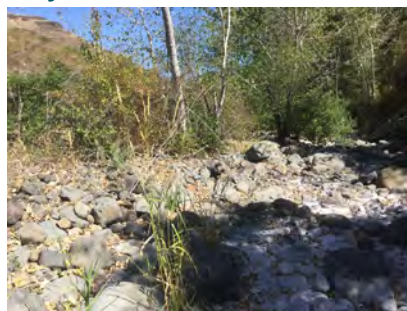
Project Area BC-4

River Length (mi)	1.06
Valley Length (mi)	1.00
Sinuosity	1.06
Average Slope	4.58%
Total Levee Length (mi)	0.09
Road/Encroachment Length (mi)	0.19
Bank Incision Length (mi)	1.03
Road Setback Score	0/5
Levee Setback Score	0/5
Establish Vegetation Score	3/5
In-Channel Complexity Score	5/5

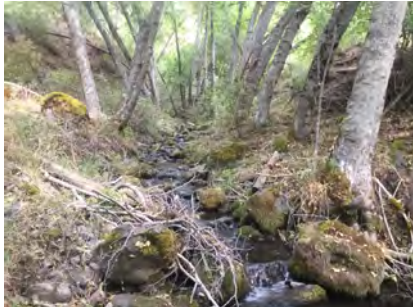
Project Area WFRC-3

River Length (mi)	0.46
Valley Length (mi)	0.45
Sinuosity	1.03
Average Slope	7.67%
Total Levee Length (mi)	0.11
Road/Encroachment Length (mi)	0.09
Bank Incision Length (mi)	0.06
Road Setback Score	3/5
Levee Setback Score	3/5
Establish Vegetation Score	1/5
In-Channel Complexity Score	3/5

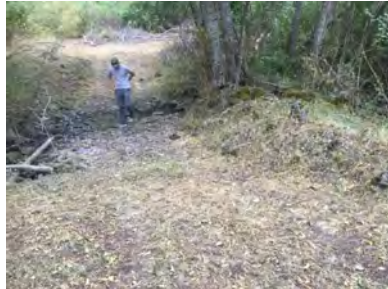
Project Area WFRC-4

River Length (mi)	0.56
Valley Length (mi)	0.54
Sinuosity	1.03
Average Slope	9.72%
Total Levee Length (mi)	0.09
Road/Encroachment Length (mi)	0.45
Bank Incision Length (mi)	0.16
Road Setback Score	5/5
Levee Setback Score	1/5
Establish Vegetation Score	1/5
In-Channel Complexity Score	3/5

- Remove or breach levees through RM 1.3 to 1.4
- BDAs or PALS to promote aggradation and increase floodplain water storage

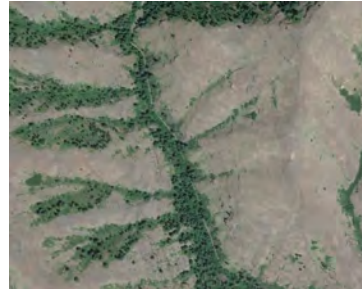
Project Area WFRC-5

River Length (mi)	0.61
Valley Length (mi)	0.58
Sinuosity	1.06
Average Slope	9.34%
Total Levee Length (mi)	0.04
Road/Encroachment Length (mi)	0.36
Bank Incision Length (mi)	0.13
Road Setback Score	3/5
Levee Setback Score	2/5
Establish Vegetation Score	1/5
In-Channel Complexity Score	2/5

- Remove or breach levee through RM 2.0 to 2.1
- BDAs and PALS to promote complexity and floodplain inundation

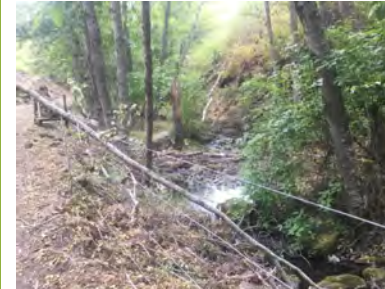
Project Area WFRC-2

River Length (mi)	0.38
Valley Length (mi)	0.37
Sinuosity	1.05
Average Slope	7.17%
Total Levee Length (mi)	0.00
Road/Encroachment Length (mi)	0.29
Bank Incision Length (mi)	0.05
Road Setback Score	4/5
Levee Setback Score	1/5
Establish Vegetation Score	1/5
In-Channel Complexity Score	3/5

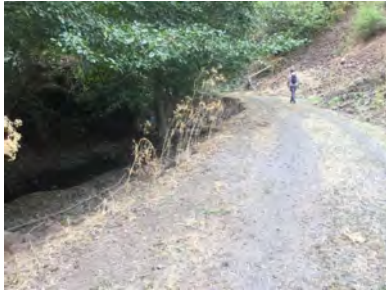
Project Area WFRC-1

River Length (mi)	0.33
Valley Length (mi)	0.33
Sinuosity	1.00
Average Slope	8.45%
Total Levee Length (mi)	0.00
Road/Encroachment Length (mi)	0.30
Bank Incision Length (mi)	0.10
Road Setback Score	5/5
Levee Setback Score	0/5
Establish Vegetation Score	1/5
In-Channel Complexity Score	2/5

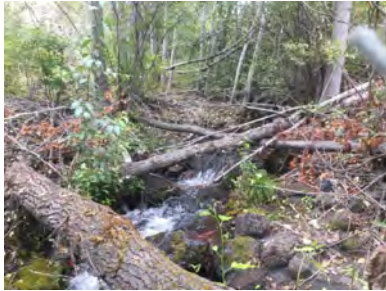
Project Area CCGR-1

River Length (mi)	0.61
Valley Length (mi)	0.57
Sinuosity	1.07
Average Slope	5.28%
Total Levee Length (mi)	0.73
Road/Encroachment Length (mi)	0.00
Bank Incision Length (mi)	0.07
Road Setback Score	0/5
Levee Setback Score	5/5
Establish Vegetation Score	2/5
In-Channel Complexity Score	5/5

- Remove or breach levees through RM 0.2 to 0.6
- ELJs to promote sediment storage and pool formation

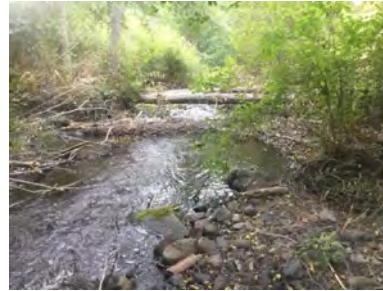
Project Area CCGR-2

River Length (mi)	0.92
Valley Length (mi)	0.82
Sinuosity	1.12
Average Slope	5.10%
Total Levee Length (mi)	0.51
Road/Encroachment Length (mi)	0.00
Bank Incision Length (mi)	0.31
Road Setback Score	0/5
Levee Setback Score	5/5
Establish Vegetation Score	1/5
In-Channel Complexity Score	5/5

- Remove or breach levees through RM 0.6 to 1.0 and RM 1.1 to 1.4
- ELJs to promote floodplain connectivity

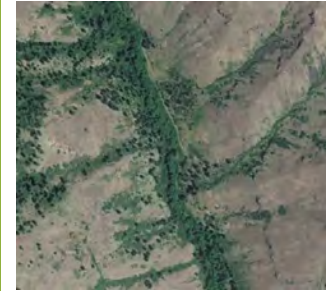
Project Area CCGR-3

River Length (mi)	0.80
Valley Length (mi)	0.73
Sinuosity	1.10
Average Slope	4.95%
Total Levee Length (mi)	0.15
Road/Encroachment Length (mi)	0.00
Bank Incision Length (mi)	0.47
Road Setback Score	0/5
Levee Setback Score	3/5
Establish Vegetation Score	1/5
In-Channel Complexity Score	5/5

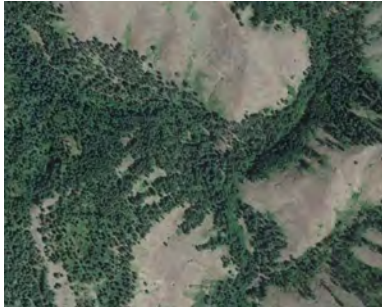
Project Area CCGR-5

River Length (mi)	0.50
Valley Length (mi)	0.48
Sinuosity	1.04
Average Slope	6.67%
Total Levee Length (mi)	0.15
Road/Encroachment Length (mi)	0.00
Bank Incision Length (mi)	0.19
Road Setback Score	0/5
Levee Setback Score	3/5
Establish Vegetation Score	1/5
In-Channel Complexity Score	4/5

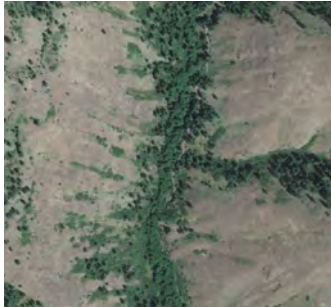
Project Area CCGR-4

River Length (mi)	0.40
Valley Length (mi)	0.37
Sinuosity	1.09
Average Slope	5.40%
Total Levee Length (mi)	0.00
Road/Encroachment Length (mi)	0.00
Bank Incision Length (mi)	0.00
Road Setback Score	0/5
Levee Setback Score	1/5
Establish Vegetation Score	1/5
In-Channel Complexity Score	3/5

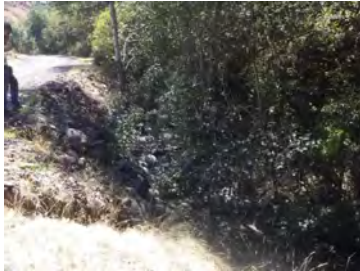
Project Area CC-1

River Length (mi)	0.67
Valley Length (mi)	0.66
Sinuosity	1.01
Average Slope	9.37%
Total Levee Length (mi)	0.31
Road/Encroachment Length (mi)	0.35
Bank Incision Length (mi)	0.17
Road Setback Score	3/5
Levee Setback Score	2/5
Establish Vegetation Score	2/5
In-Channel Complexity Score	3/5

- Floodplain benching to expand floodplain just upstream of culvert
- Culvert replacement
- BDAs and PALS to store sediment and wood in floodplain pockets

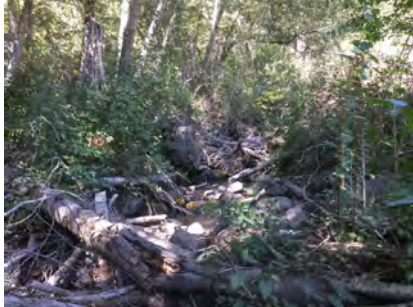
Project Area CC-2

River Length (mi)	0.49
Valley Length (mi)	0.46
Sinuosity	1.06
Average Slope	10.54%
Total Levee Length (mi)	0.10
Road/Encroachment Length (mi)	0.32
Bank Incision Length (mi)	0.19
Road Setback Score	4/5
Levee Setback Score	0/5
Establish Vegetation Score	2/5
In-Channel Complexity Score	2/5

- Remove levee through RM 0.85 to 0.95
- ELJs to promote sediment storage and pool formation and help reconnect side channels

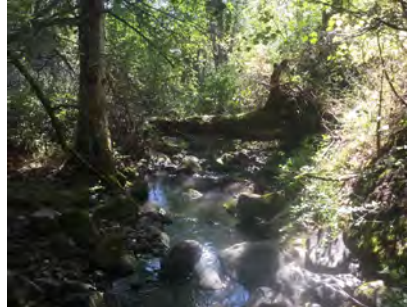
Project Area CC-3

River Length (mi)	0.31
Valley Length (mi)	0.30
Sinuosity	1.03
Average Slope	13.50%
Total Levee Length (mi)	0.00
Road/Encroachment Length (mi)	0.00
Bank Incision Length (mi)	0.04
Road Setback Score	0/5
Levee Setback Score	0/5
Establish Vegetation Score	1/5
In-Channel Complexity Score	1/5

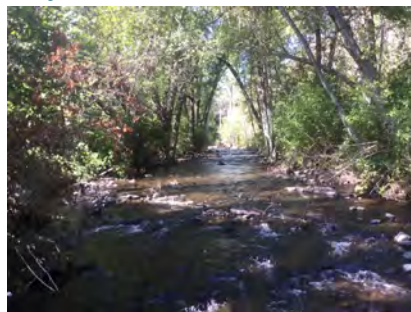
Project Area MC-2

River Length (mi)	0.42
Valley Length (mi)	0.39
Sinuosity	1.07
Average Slope	2.69%
Total Levee Length (mi)	0.40
Road/Encroachment Length (mi)	0.00
Bank Incision Length (mi)	0.19
Road Setback Score	0/5
Levee Setback Score	5/5
Establish Vegetation Score	2/5
In-Channel Complexity Score	5/5
