Asotin Creek Project Area 3.2
Habitat Restoration Design
Asotin County, Washington

Basis of Design
Asotin Creek Project Area 3.2
Habitat Restoration Design
Asotin County, Washington

File No. 22281-009-00

October 3, 2024

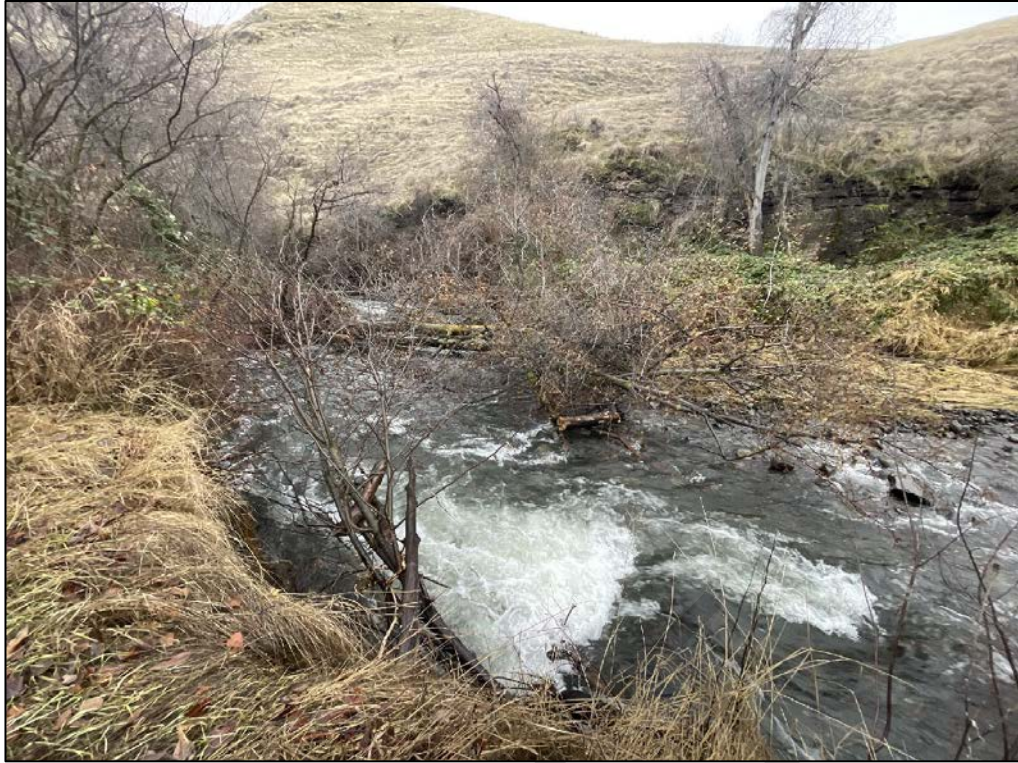
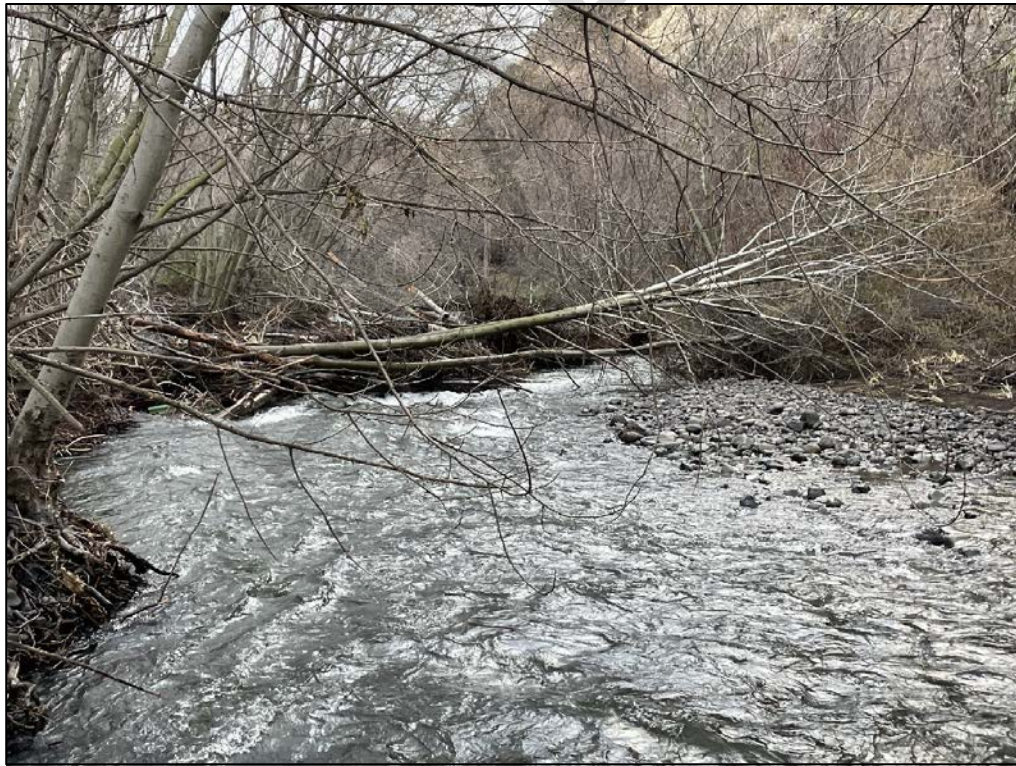
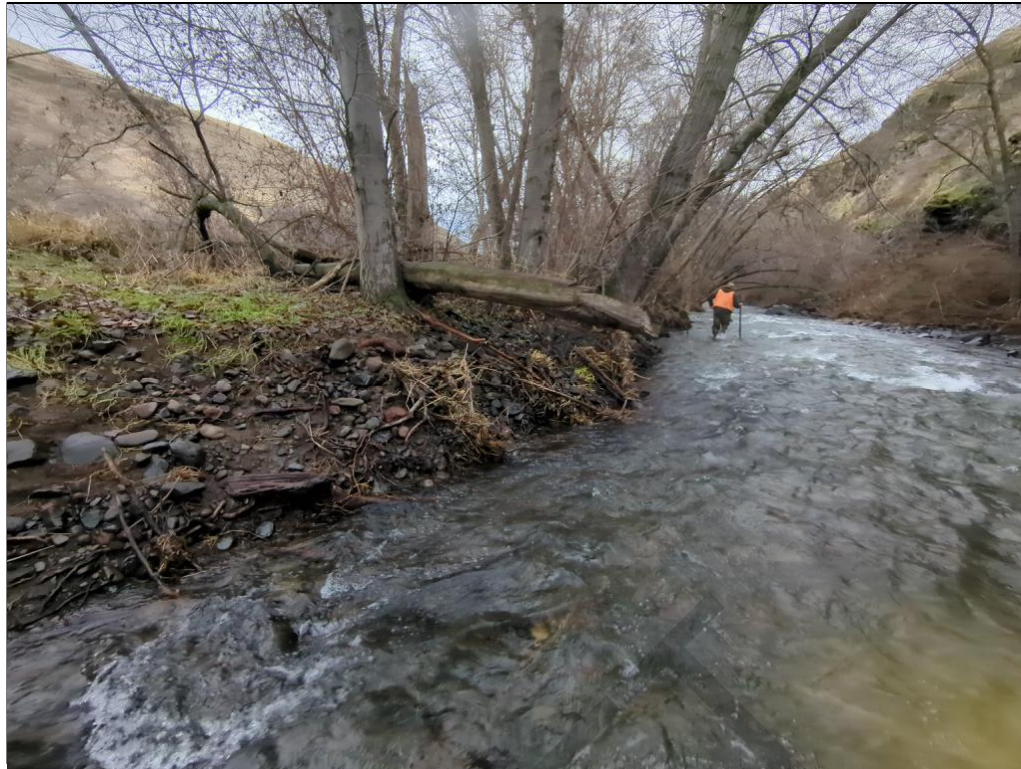
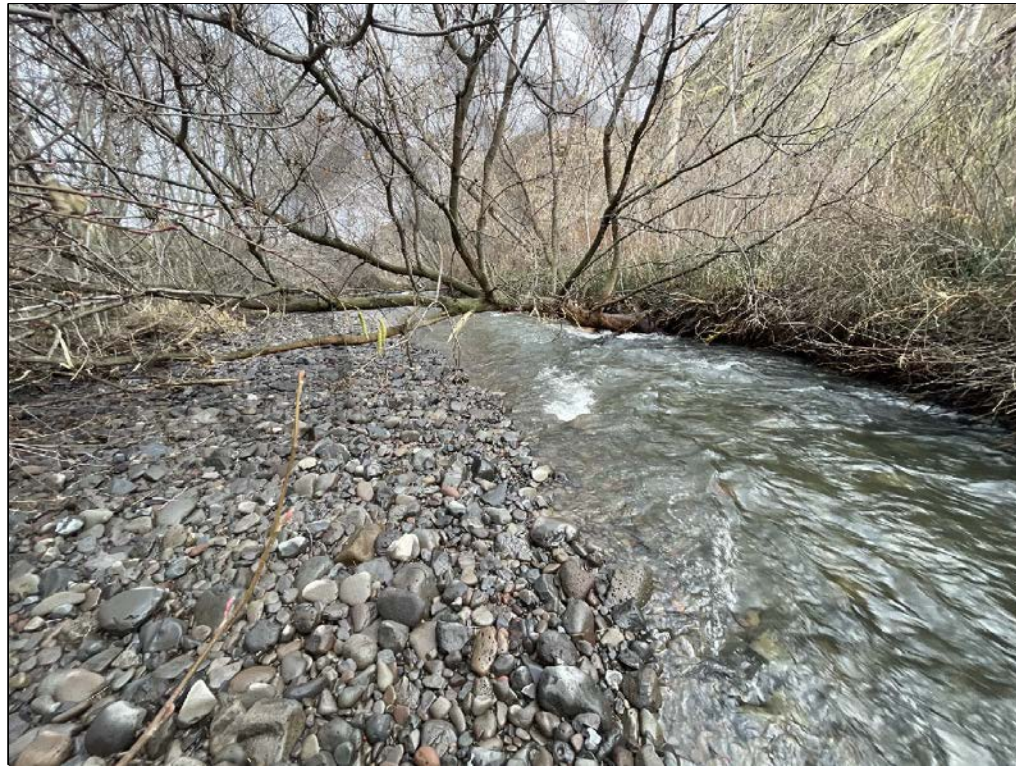
Existing Large Woody Material

GeoEngineers completed a site reconnaissance on January 12, 2023, to observe existing conditions and map locations where additional structures would be most effective and beneficial for native salmonids. Site photographs are included in Figures 1 through 5. LWM was rare throughout the project reach; however, in the few locations where LWM is present, the stream response is creating good habitat conditions for native salmonids (Figures 1 through 3). Boulder clusters (Figures 3 and 4) were observed more frequently and are creating low-velocity refugia and habitat diversity.

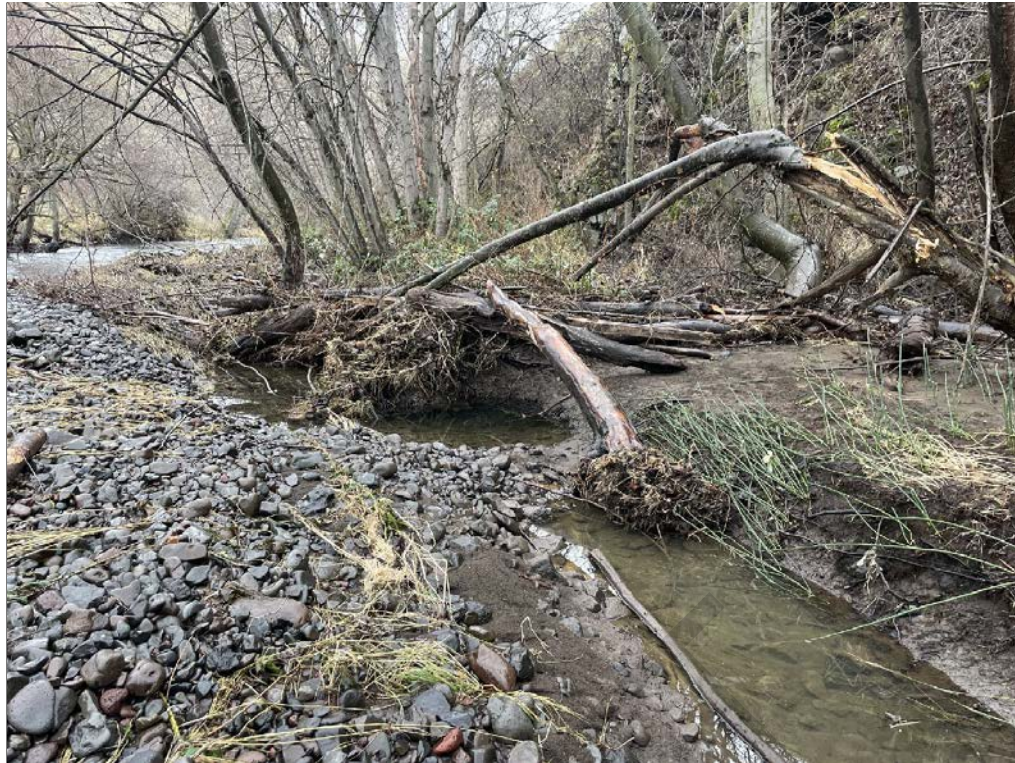
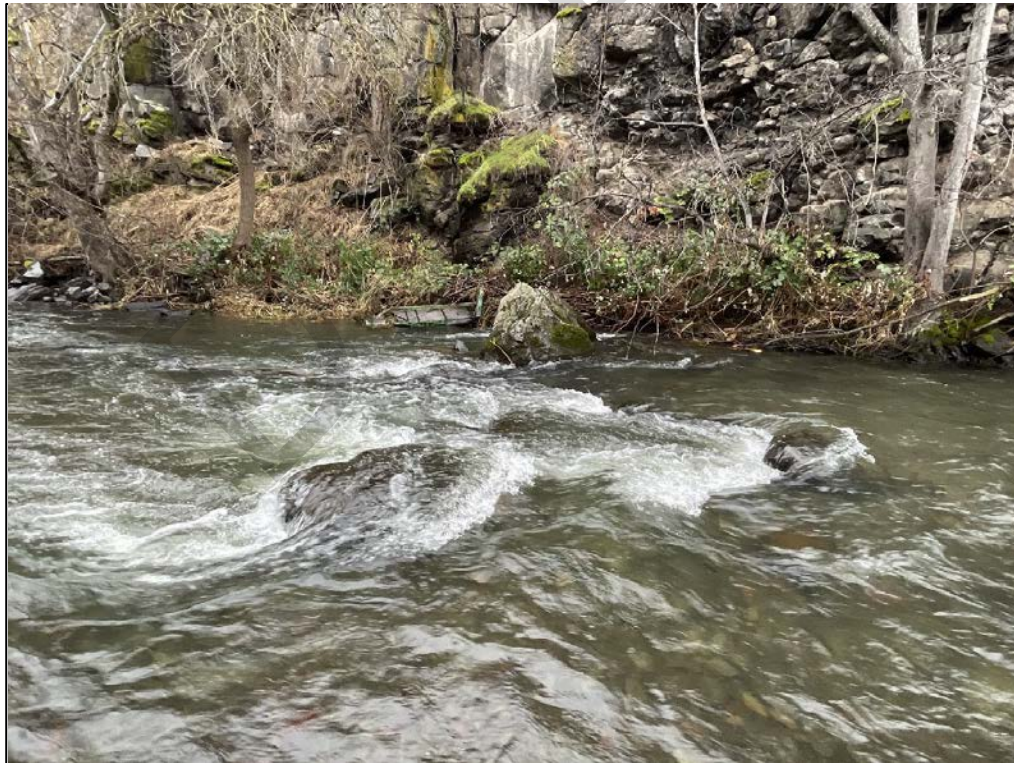
Existing Large Woody Material in Existing Side Channel, Existing Boulders

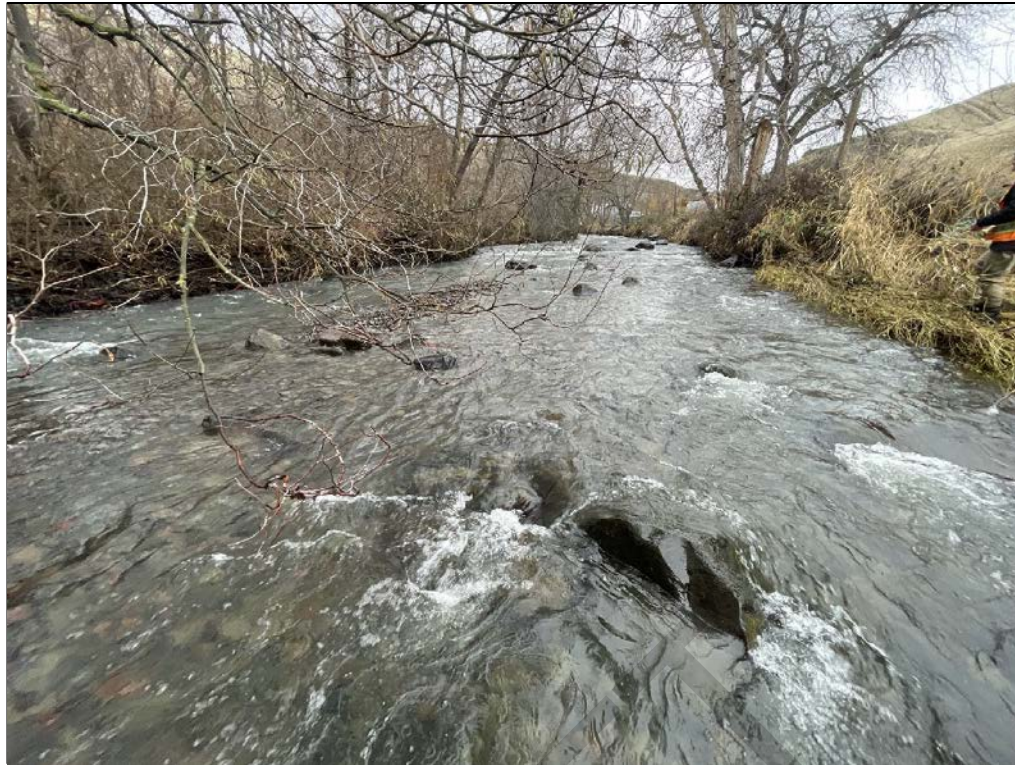
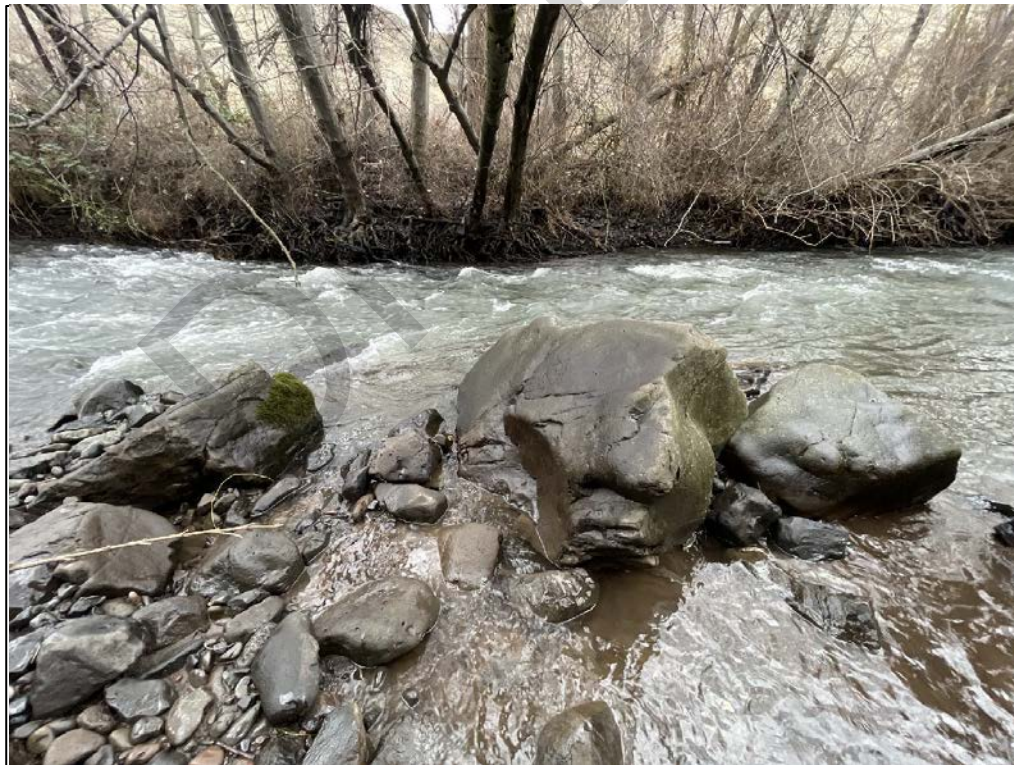
Existing Boulder Clusters

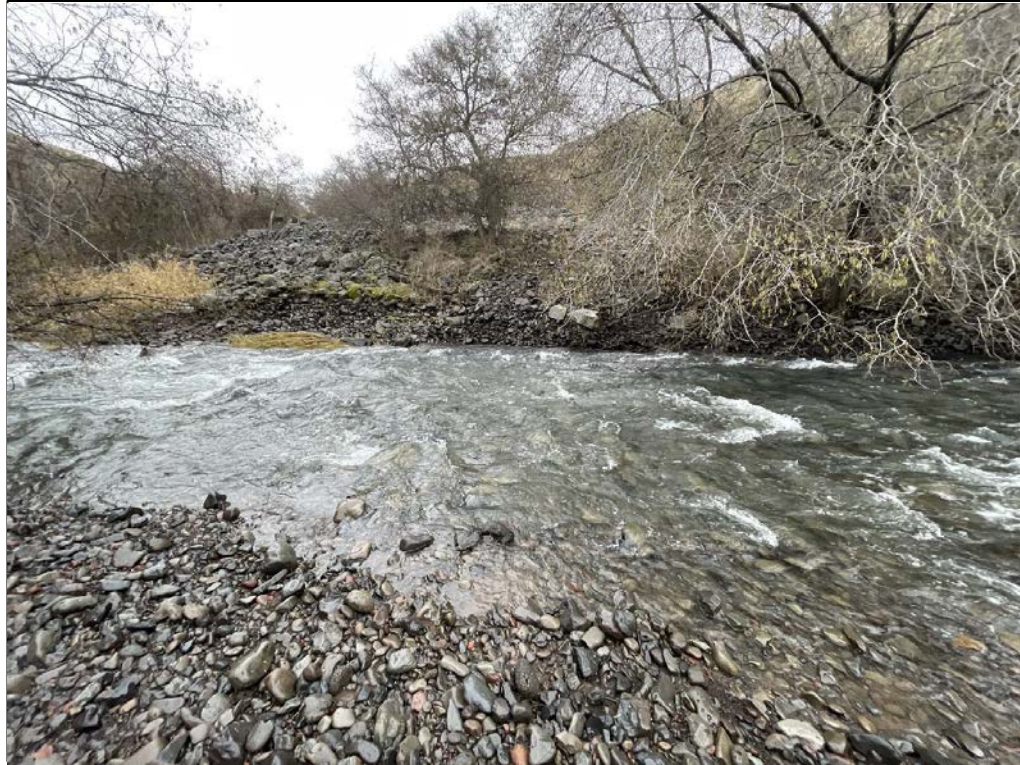
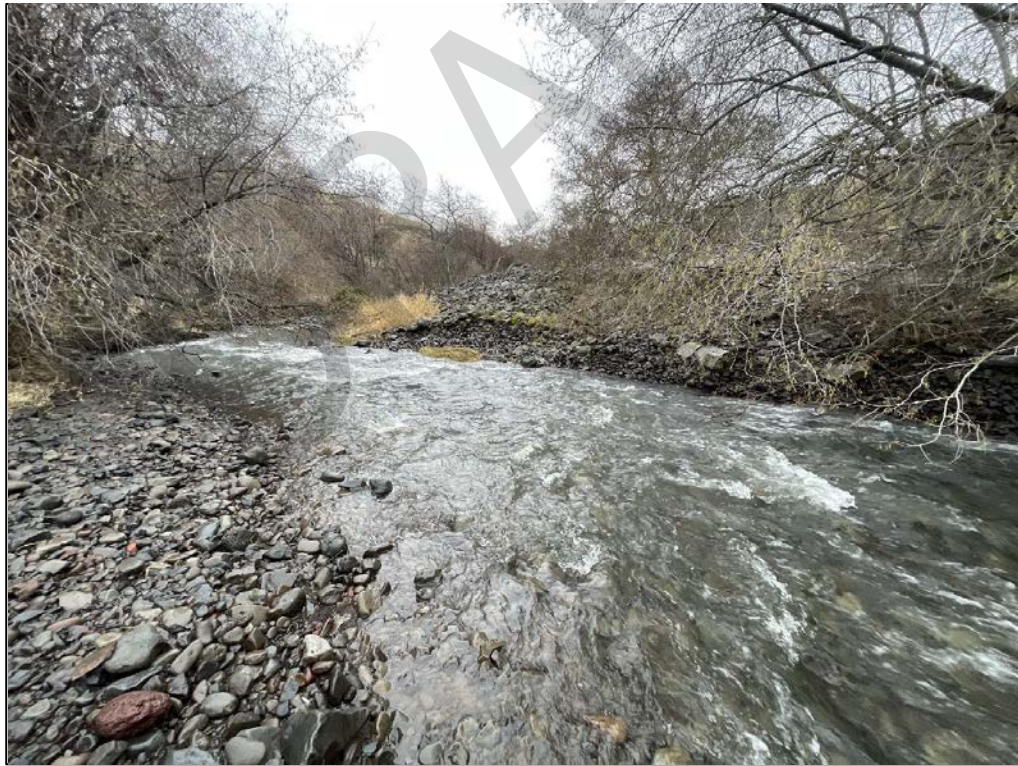
Proposed Bridge Location

Construction of a ford at this location is not a feasible alternative due to the substantial channel and bank excavation, fill, and disturbance and potential that constructing a ford could be a partial passage barrier for juvenile fish during summer low-water conditions when juvenile fish might be migrating to access colder water upstream. Based on the reasons listed above, it is our opinion that constructing a ford crossing would be potentially damaging and not practical.

We evaluated two bridge alternatives (rail car and prefabricated steel) for the design and our recommendations are to advance the prefabricated steel bridge option for the following reasons:
